# VOTIVE FIGURE OF A BAT IVB4168 – GILDED BRASS – MODERN TIMES

**Artefact name** Votive figure of a bat IVb4168

**Authors** Christian. Degriigny (HE-Arc CR, Neuchâtel, Neuchâtel, Switzerland) & Naima. Gutknecht (HE-Arc CR, Neuchâtel, Neuchâtel, Switzerland) & Valentin. Boissonnas (HE-Arc CR, Neuchâtel, Neuchâtel, Switzerland)

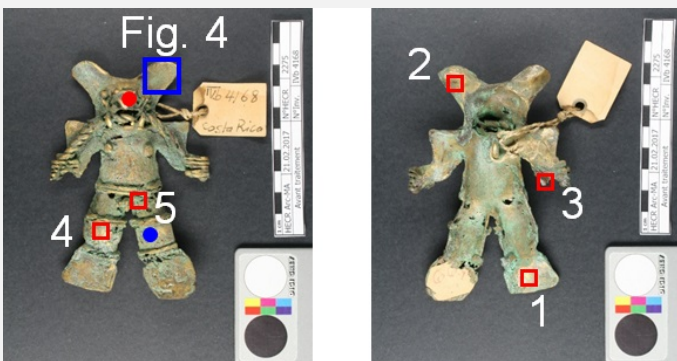
Fig. 2: Bat figure, front (left) and back (right) view with location of XRF analyses (red squares), FTIR analysis with sampling (blue point) and SEM-EDS analysis (red point),

<b>Description of sample</b>	No sample from the metal was cut. Only a sample of the green corrosion product was taken for FTIR analysis (Fig. 2).
<b>Alloy</b>	Gilded brass
<b>Technology</b>	Cast, gilding (electroplating?)
<b>Lab number of sample</b>	
<b>Sample location</b>	None
<b>Responsible institution</b>	Denkmalpflege und Archäologie des Kantons, Luzern
<b>Date and aim of sampling</b>	2017, chemical analyses

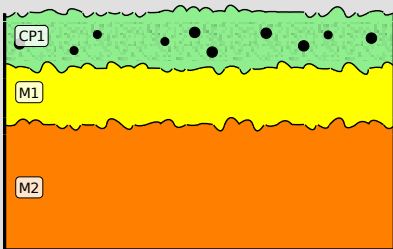
Fig 5: Stratigraphic representation 1 from Fig. 4 using the MiCorr application. The characteristics of the strata are only accessible by clicking on the drawing that redirects you to the search tool by stratigraphy representation, Credit HE-Arc CR, N.Gutknecht.

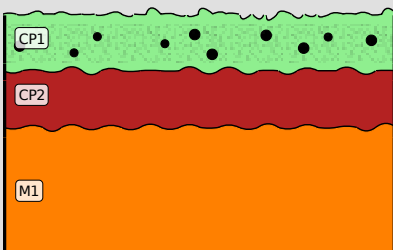
Fig. 6: Stratigraphic representation 2 from Fig. 4 using the MiCorr application. The characteristics of the strata are only accessible by clicking on the drawing that redirects you to the search tool by stratigraphy representation, Credit HE-Arc CR, N.Gutknecht.

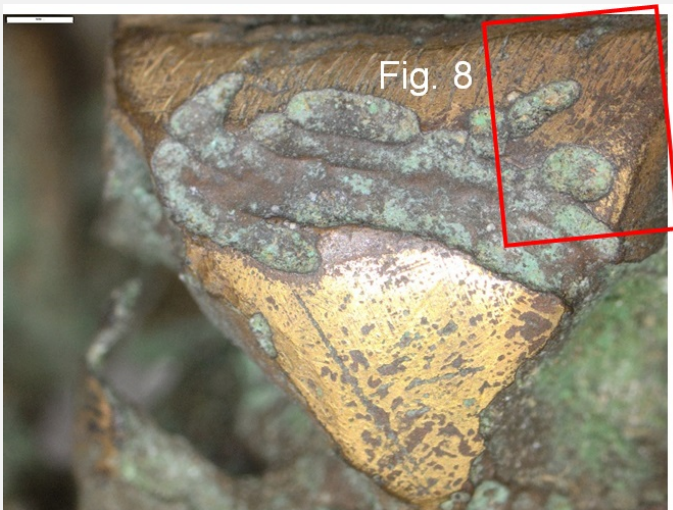
The metal seems to have been heavily attacked (acid dissolution). There are several perforations on the lower part of the object, and where the gold layer is absent the surface is unevenly pitted by corrosion (Figs. 1, 2 and 7). The submetallic core is not visible from the surface.

There are two corrosion products (Figs. 7 and 8). The red one (CP2) has a submetallic brightness and is opaque, non-magnetic, compact, hard and adherent. It is very thin (less than a few microns thick) and only appears where the gold layer has been lost. The EDX spectrum (Fig. 9) shows that it is a Cu- and O rich product, probably cuprite ( $\text{Cu}_2\text{O}$ ). The light green to white corrosion product (CP1) has a waxy consistency and is thin, translucent, non-magnetic, powdery and very soft. It is very loosely bound. It is distributed on the whole object (front and back) as disparate clumps. It is mainly located on the cavities and irregularities of the surface. FTIR analyses (ATR mode) of both green and white areas of CP1 have similar spectra and were identified as copper nitrate (Fig. 10).

Fig. 7: Binocular image of the nose of the bat showing detail of Fig. 8,
