FRAGMENT OF AN AEGIS OF NEÏTH 1886.305.0096 – LEADED BRONZE

Artefact name Fragment of an Aegis of Neïth 1886.305.0096

Authors Line. Pedersen (HE-Arc, Neuchâtel, Neuchâtel, Switzerland) & Christian. Degrigny (HE-Arc CR, Neuchâtel, Neuchâtel, Switzerland) & Valentin. Boissonnas (HE-Arc CR, Neuchâtel, Neuchâtel, Switzerland)

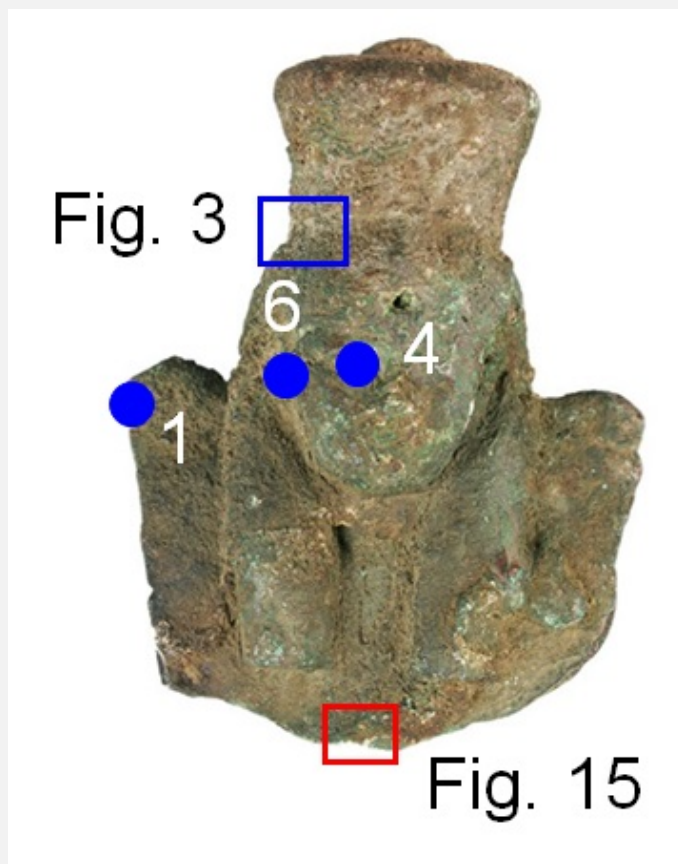
Fig. 2: Front face of the aegis with location of XRF measurements (blue spots), powder sample (red square) and gilding remains on the surface (blue square),

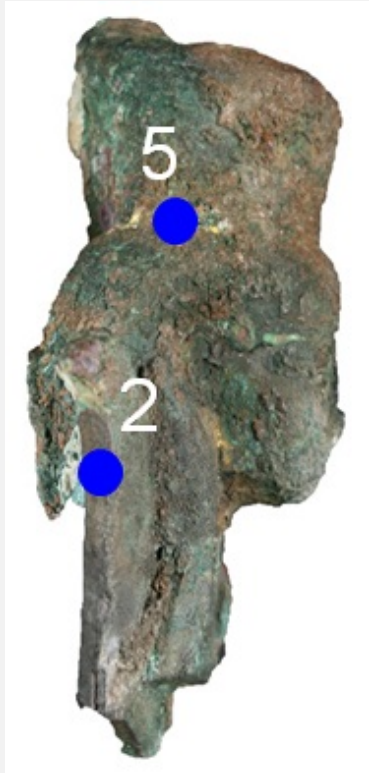
Fig. 4: Side view of the aegis with location of XRF measurements (blue spots),

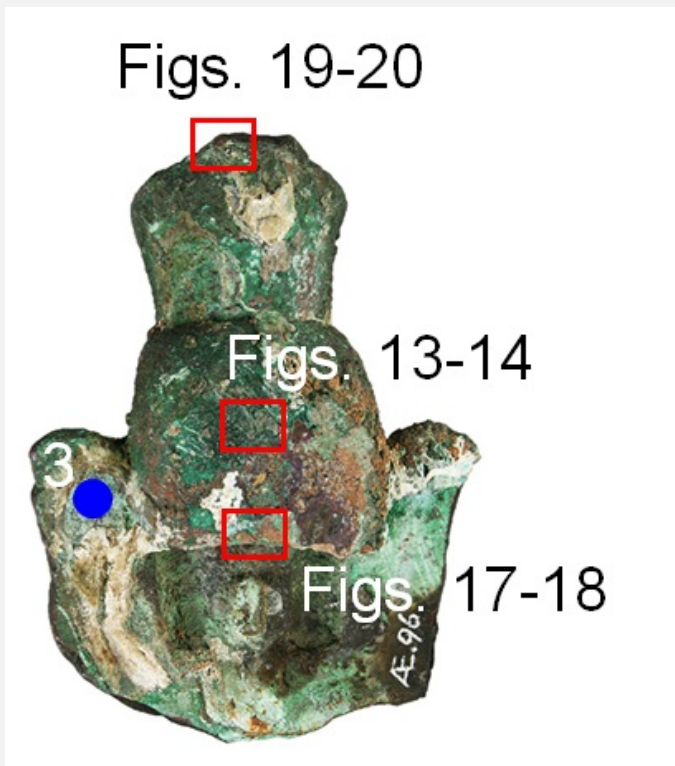
Fig. 5: Back face of the aegis with location of XRF measurement (blue spot) and powder samples (red squares),

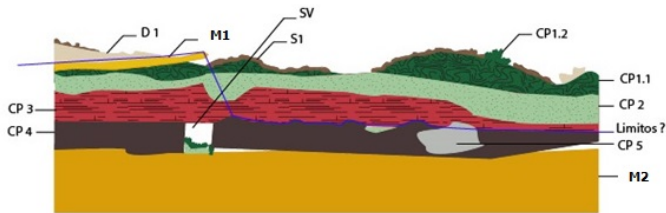
Fig. 6: Preliminary stratigraphy 1, corresponding to the front face of the aegis. S = soil, D = deposit, M = metal, CP = corrosion products, SV = structural void,

Captions	Colour, aspect, hardness and cohesion
S1	Brown, matte, can be scratched with scalpel blade but remains cohesive.
D1	White deposit: shiny, powdery when shaved with scalpel.
M1	Thin gold leaf trapped in corrosion products, brittle, yellow and not adherent.
CP1.1	Dark green corrosion layer, lumpy and matte, thick, hardly scratched by a scalpel blade, cohesive and compact.
CP1.2	Minor stratum of CP1.1. Dark green crystals appearing on the surface of the artefact. Easily scratched under the action a scalpel blade.
CP2	Light green corrosion layer, matte, thick in some places, powdery under the action of a scalpel blade. In some areas it is located directly on CP4.
CP3	Red corrosion layer, lumpy and matte, thick, sometimes hard and sometimes powdery under the action of a scalpel blade.
Limitos	Interface of the limit of the original surface. Shiny, straight and black with manufacturing traces.
CP4	Dark grey with red or green reflection. Shiny, hard, straight, dense and with traces of engraving and possible inlays.

CP5	Isolated white corrosion products: waxy and very soft.
SV	Void in CP4 resulting in loss of the limitos.
M2	Yellow stratum with metallic sheen, dense and hardly scratched by scalpel blade.

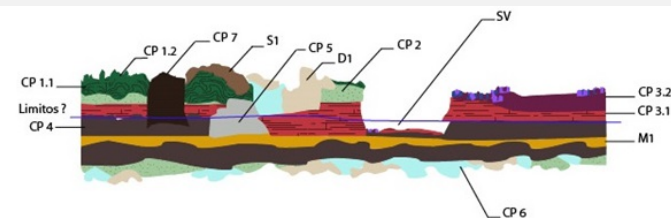
Fig. 7: Preliminary stratigraphy 2, corresponding to the back face of the aegis and interior (below part). S = soil, D = deposit, M = metal, CP = corrosion products, SV = structural void,

Captions	Colour, aspect, hardness and cohesion
S1	Brown, matte, can be scratched with scalpel blade but remains cohesive.
D1	White shiny deposit, powdery when shaved with scalpel.
CP1.1	Dark green corrosion layer, lumpy and matte, thick, hardly scratched by a scalpel blade, cohesive and compact.
CP1.2	Minor stratum of CP1.1. Dark green crystals appearing on the surface of the artefact. Easily scratched by a scalpel blade.
CP2	Light green corrosion layer, matte and thick in some places, powdery under the action of a scalpel blade. Sometimes located directly on CP4.
CP3.1	Red corrosion layer, lumpy and matte, thick, sometimes hard and sometimes powdery under the action of a scalpel blade.
CP3.2	Minor stratum of CP3.1. Purple with blue-purple crystals, hard and cohesive.
Limitos	Interface of the limit of the original surface. Shiny, straight, black, manufacturing traces.
CP4	Dark grey with red or green reflection. Shiny, hard, straight, dense and with traces of engraving and possible inlays.

CP5	Isolated white stratum: waxy and very soft.
CP6	Light blue stratum, chalky. Isolated on the exterior surface and extends on the interior surface.
CP7	Isolated black stratum, very hard, straight and shiny.
SV:	Void in CP4, resulting in loss of the limitos. Presence of CP1.2 crystals inside the void.
Structural Void	
M1	Yellow stratum with metallic sheen, dense and hardly scratched by scalpel blade.

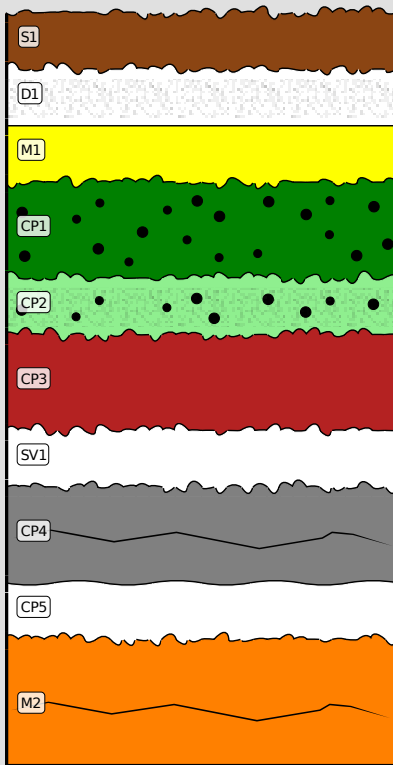
Fig.9: Schematic representation combining stratigraphies 1 and 2 using the MiCorr application. The characteristics of the strata are only accessible by clicking on the drawing that redirects you to the search tool by stratigraphy representation, Credit He-Arc CR, L.Pedersen.

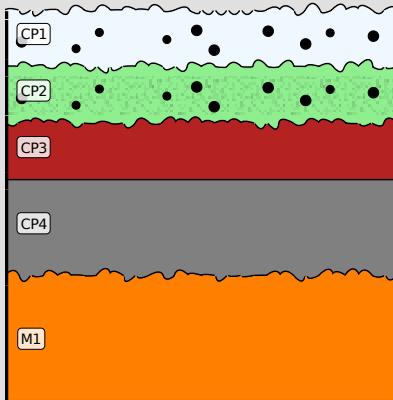
Fig.10: Schematic representation of stratigraphy 3 using the MiCorr application. CP1 is CP6 in Fig. 8. The characteristics of the strata are only accessible by clicking on the drawing that redirects you to the search tool by stratigraphy representation, Credit He-Arc CR, L. Pedersen.

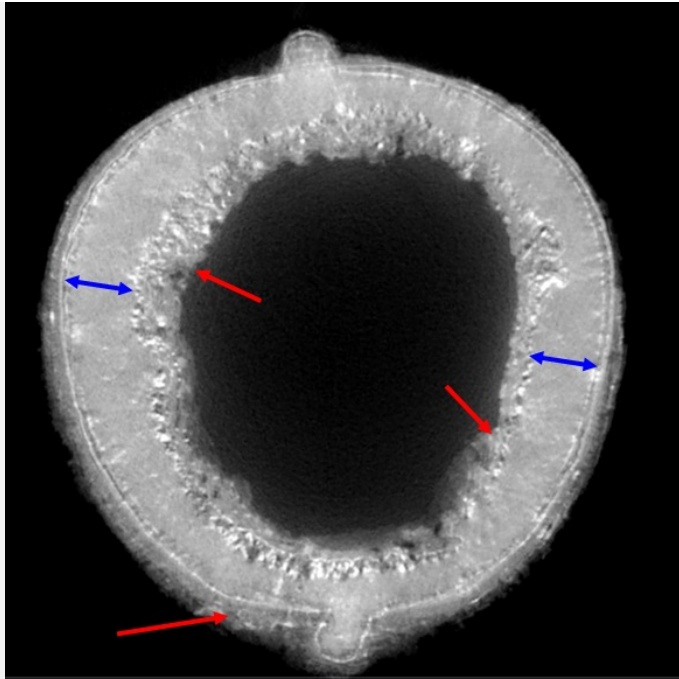
As indicated by the X-ray tomography, the metal of the aegis seems to be well preserved (Figs. 11-12). The metal (M2 in Fig.9 and M1 in Fig. 10) was analysed on the broken edge of the bottom of the artefact where despite a highly corroded surface, the metal seems to be the best preserved. The XRF analyses revealed that the metal is a leaded bronze with remains of gold leaf on the surface (Table 1, Au was detected in the measurement spots 4,5 and 6) (Scott 2002; Gouda 2012; Mohammed 2012).

Fig. 11: X-ray tomography by cross section of the crown showing a dense and non-porous metal core (blue arrows). The corrosion products however are porous (red arrows). The

external limitos is visible as a fine line preserved under corrosion layers,

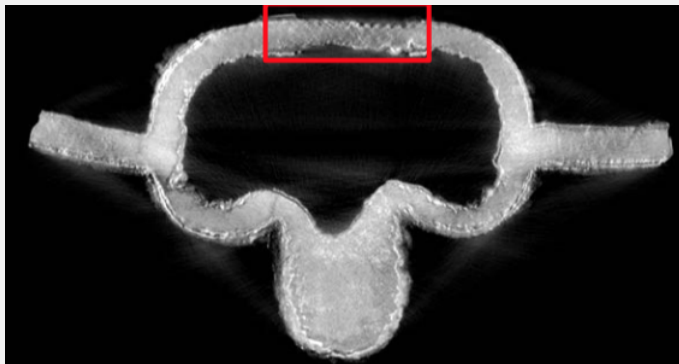
Fig. 12: X-ray tomography by cross section of the lower part showing that there are losses of the original surface (red square),

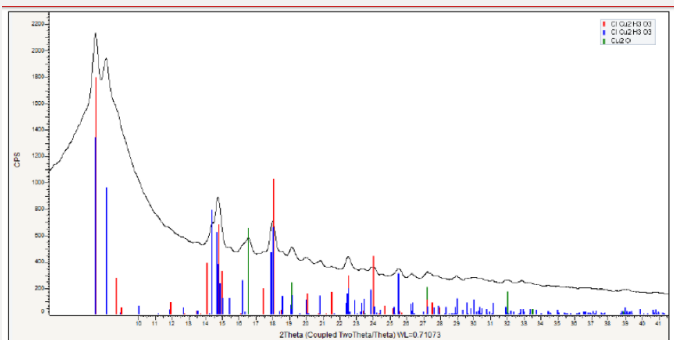
Fig. 21: XRD spectrum of the sample of the dark green corrosion product showing the presence of atacamite and paratacamite ($\text{Cu}_2\text{Cl}(\text{OH})_3$) as major compound and cuprite (Cu_2O) as minor compound,

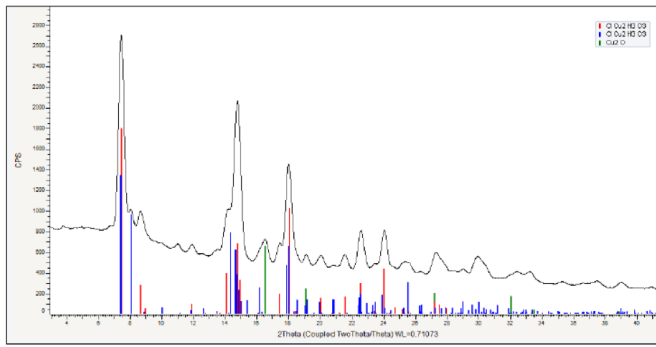
Fig. 22: XRD spectrum of the sample from the light green corrosion product showing the presence of atacamite and paratacamite ($\text{Cu}_2\text{Cl}(\text{OH})_3$) as major compound and cuprite (Cu_2O) as minor compound,

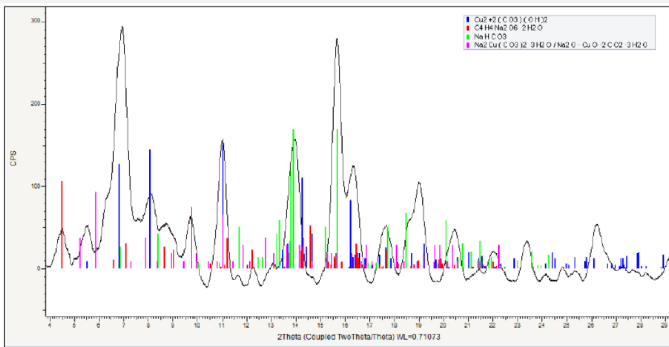
Fig. 23: XRD spectrum of the sample from the light blue corrosion product showing the presence of chalconatronite ($\text{Na}_2\text{Cu}(\text{CO}_3)_2 \cdot 3\text{H}_2\text{O}$). The other compounds are analysis supposition, but are not relevant,

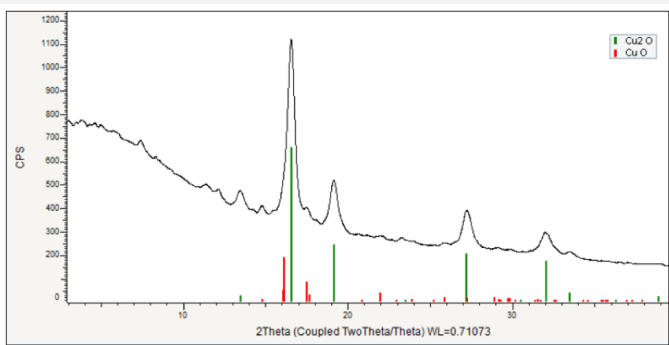
Fig. 24: XRD spectrum of the sample from the dark red corrosion product showing the presence of cuprite (Cu_2O) as major compound and tenorite (CuO) as minor compound,
