FRAGMENT OF AN AEGIS OF NEÏTH 1886.305.0096 – LEADED BRONZE

Artefact name Fragment of an Aegis of Neïth 1886.305.0096

Authors Line. Pedersen (HE-Arc, Neuchâtel, Neuchâtel, Switzerland) & Christian. Degrigny (HE-Arc CR, Neuchâtel, Neuchâtel, Switzerland) & Valentin. Boissonnas (HE-Arc CR, Neuchâtel, Neuchâtel, Switzerland)

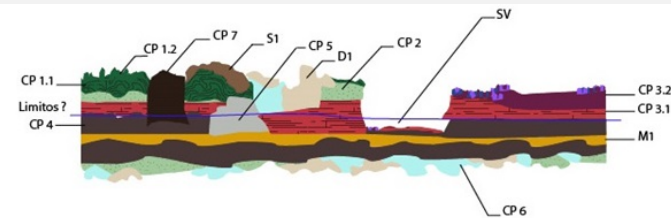
Captions	Colour, aspect, hardness and cohesion
S1	Brown, matte, can be scratched with scalpel blade but remains cohesive.
D1	White shiny deposit, powdery when shaved with scalpel.
CP1.1	Dark green corrosion layer, lumpy and matte, thick, hardly scratched by a scalpel blade, cohesive and compact.
CP1.2	Minor stratum of CP1.1. Dark green crystals appearing on the surface of the artefact. Easily scratched by a scalpel blade.
CP2	Light green corrosion layer, matte and thick in some places, powdery under the action of a scalpel blade. Sometimes located directly on CP4.
CP3.1	Red corrosion layer, lumpy and matte, thick, sometimes hard and sometimes powdery under the action of a scalpel blade.
CP3.2	Minor stratum of CP3.1. Purple with blue-purple crystals, hard and cohesive.
Limitos	Interface of the limit of the original surface. Shiny, straight, black, manufacturing traces.
CP4	Dark grey with red or green reflection. Shiny, hard, straight, dense and with traces of engraving and possible inlays.

CP5	Isolated white stratum: waxy and very soft.
CP6	Light blue stratum, chalky. Isolated on the exterior surface and extends on the interior surface.
CP7	Isolated black stratum, very hard, straight and shiny.
SV:	Void in CP4, resulting in loss of the limitos. Presence of CP1.2 crystals inside the void.
Structural Void	
M1	Yellow stratum with metallic sheen, dense and hardly scratched by scalpel blade.

Fig. 7: Preliminary stratigraphy 2, corresponding to the back face of the aegis and interior (below part). S = soil, D = deposit, M = metal, CP = corrosion products, SV = structural void,

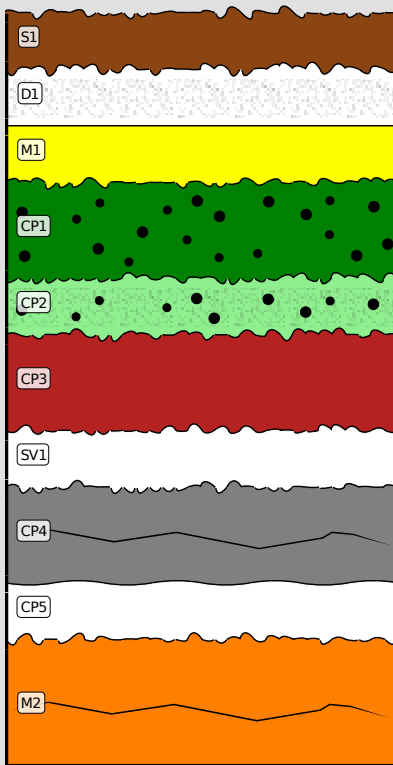
Fig.9: Schematic representation combining stratigraphies 1 and 2 using the MiCorr application. The characteristics of the strata are only accessible by clicking on the drawing that redirects you to the search tool by stratigraphy representation, Credit He-Arc CR, L.Pedersen.

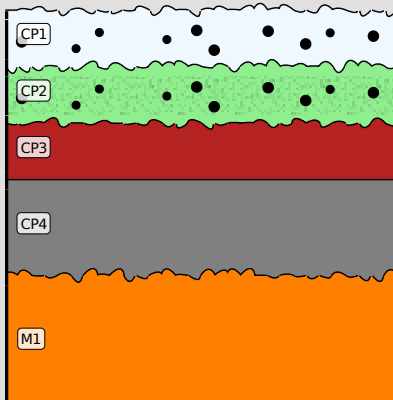
Fig.10: Schematic representation of stratigraphy 3 using the MiCorr application. CP1 is CP6 in Fig. 8. The characteristics of the strata are only accessible by clicking on the drawing that redirects you to the search tool by stratigraphy representation, Credit He-Arc CR, L. Pedersen.
