FRAGMENT OF AN AEGIS OF NEÏTH 1886.305.0096 - LEADED BRONZE

Fragment of an Aegis of Neïth 1886.305.0096 Artefact name

Authors Line. Pedersen (HE-Arc, Neuchâtel, Neuchâtel, Switzerland) & Christian. Degrigny (HE-Arc CR, Neuchâtel,

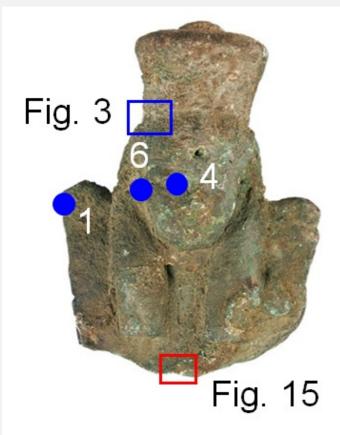
> Traces of leaf gilding is still present in certain areas (Fig. 3). The lower part of the collar and the upper part of the crown are broken (Fig. 2 and 4). The surface is covered with a thick and hard, green-brown corrosion crust (Fig. 2, 3 and 4). A cross-section was studied on the lower edge that was broken after excavation. Dimensions: L = 96mm; W = 72mm; T = 40mm; WT

Fig. 2: Front face of the aegis with location of XRF measurements (blue spots), powder sample (red square) and gilding remains on the surface (blue square),

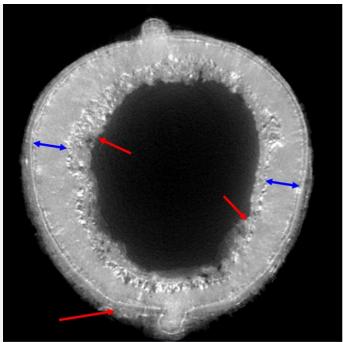
As indicated by the X-ray tomography, the metal of the aegis seems to be well preserved (Figs. 11-12). The metal (M2 in Fig. 9 and M1 in Fig. 10) was analysed on the broken edge of the bottom of the artefact where despite a highly corroded surface, the metal seems to be the best preserved. The XRF analyses revealed that the metal is a leaded bronze with remains of gold leaf on the surface (Table 1, Au was detected in the measurement spots 4,5 and 6) (Scott 2002; Gouda 2012; Mohammed 2012).

Fig. 11: X-ray tomography by cross section of the crown showing a dense and non-porous metal core (blue arrows). The corrosion products however are porous (red arrows). The

external limitos is visible as a fine line preserved under corrosion layers,

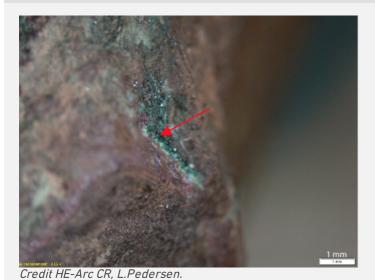
Fig. 13: Observation of the dark green corrosion product,

Fig. 14: Dark green corrosion product identified as paratacamite, atacamite Cu2Cl(OH)3 by XRD. Microscopic examination under polarized light,

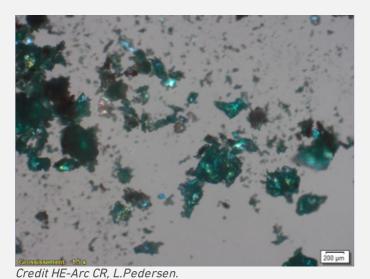
Fig. 16: Light green corrosion product identified as paratacamite, atacamite (Cu2Cl(OH)3) by XRD. Microscopic examination under polarized light,

Fig. 17: Observation of the light blue corrosion product,

Fig. 18: Light blue corrosion product identified as chalconatronite Na2Cu(CO3)2·3H2O by XRD. Microscopic examination under polarized light,
