FRAGMENT OF AN AEGIS OF NEÏTH 1886.305.0096 – LEADED BRONZE

Artefact name	Fragment of an Aegis of Neïth 1886.305.0096
Authors	Line. Pedersen (HE-Arc, Neuchâtel, Neuchâtel, Switzerland) & Christian. Degriigny (HE-Arc CR, Neuchâtel, Neuchâtel, Switzerland) & Valentin. Boissonnas (HE-Arc CR, Neuchâtel, Neuchâtel, Switzerland)
Url	/artefacts/504/

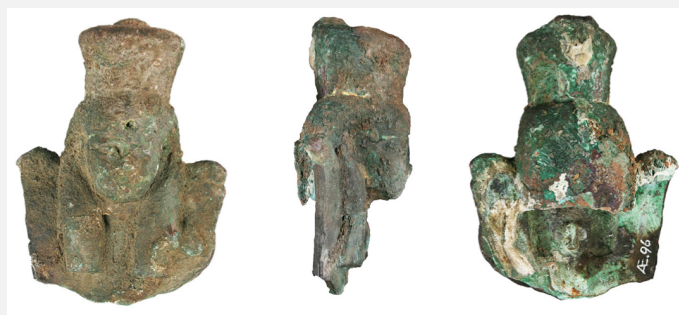
Fig. 1: Fragment of an Aegis of Neïth. From left to right: front, side view and back respectively,

Description of the artefact	Fragment of an aegis surmounted by the head of Neith, the Egyptian goddess of war (Fig. 1). Traces of leaf gilding is still present in certain areas (Fig. 3). The lower part of the collar and the upper part of the crown are broken (Fig. 2 and 4). The surface is covered with a thick and hard, green-brown corrosion crust (Fig. 2, 3 and 4). A cross-section was studied on the lower edge that was broken after excavation. Dimensions: L = 96mm; W = 72mm; T = 40mm; WT = 216g.
Type of artefact	sculpture
Origin	ancient Egypt
Recovering date	Purchased at the end of the 19th, probably from the art market. Date of excavation unknown.
Chronology category	None
chronology tpq	<input type="text"/> ---- ▼
chronology taq	<input type="text"/> ---- ▼
Chronology comment	Unknown
Burial conditions / environment	Unknown

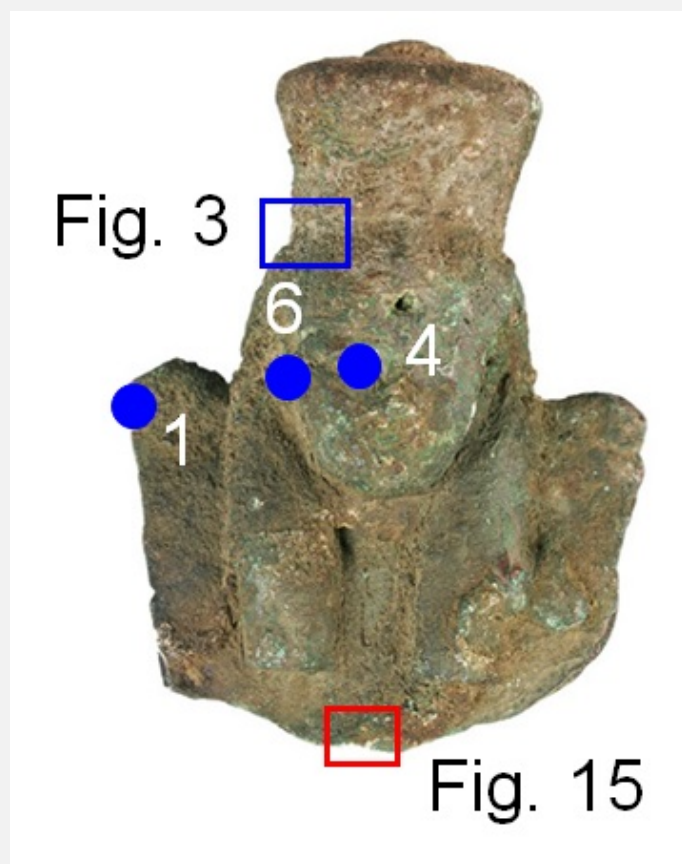
Fig. 2: Front face of the aegis with location of XRF measurements (blue spots), powder sample (red square) and gilding remains on the surface (blue square),

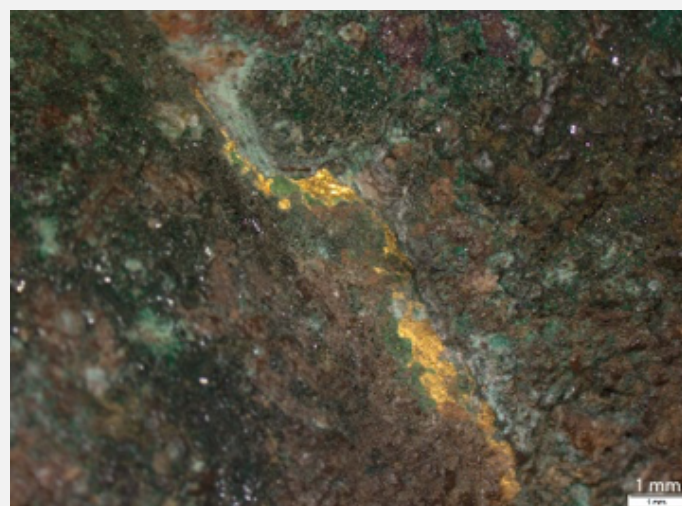
Fig. 3: Remains of foil-gilding on the corroded surface,

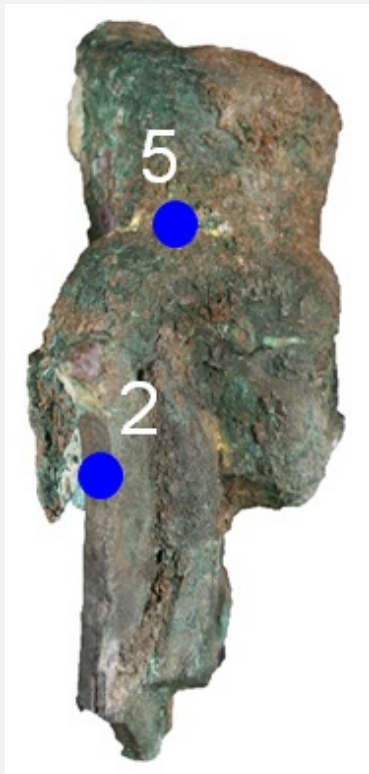
Fig. 4: Side view of the aegis with location of XRF measurements (blue spots),

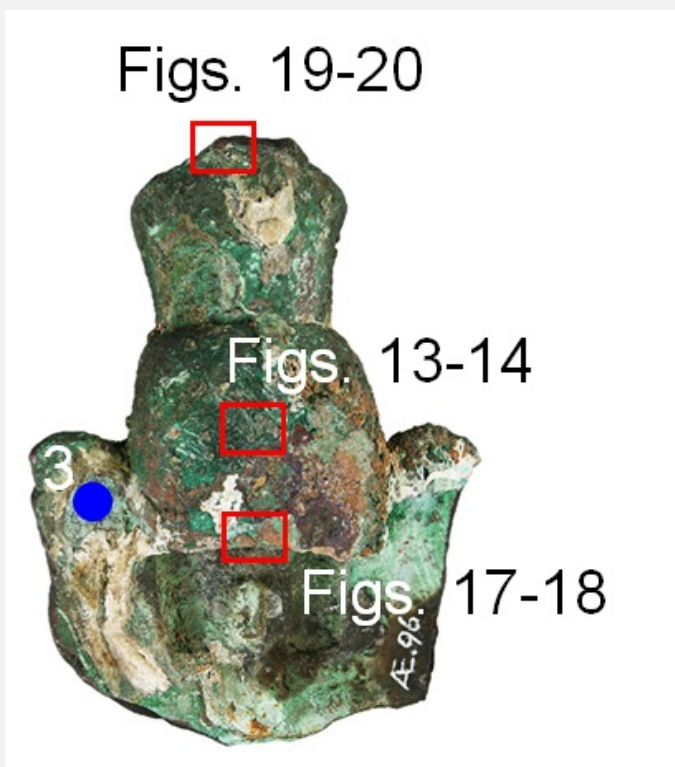
Fig. 5: Back face of the aegis with location of XRF measurement (blue spot) and powder samples (red squares),

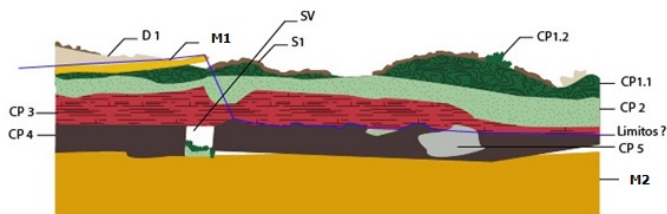
Captions	Colour, aspect, hardness and cohesion
S1	Brown, matte, can be scratched with scalpel blade but remains cohesive.
D1	White deposit: shiny, powdery when shaved with scalpel.
M1	Thin gold leaf trapped in corrosion products, brittle, yellow and not adherent.
CP1.1	Dark green corrosion layer, lumpy and matte, thick, hardly scratched by a scalpel blade, cohesive and compact.
CP1.2	Minor stratum of CP1.1. Dark green crystals appearing on the surface of the artefact. Easily scratched under the action a scalpel blade.
CP2	Light green corrosion layer, matte, thick in some places, powdery under the action of a scalpel blade. In some areas it is located directly on CP4.
CP3	Red corrosion layer, lumpy and matte, thick, sometimes hard and sometimes powdery under the action of a scalpel blade.
Limitos	Interface of the limit of the original surface. Shiny, straight and black with manufacturing traces.
CP4	Dark grey with red or green reflection. Shiny, hard, straight, dense and with traces of engraving and possible inlays.

CP5	Isolated white corrosion products: waxy and very soft.
SV	Void in CP4 resulting in loss of the limitos.
M2	Yellow stratum with metallic sheen, dense and hardly scratched by scalpel blade.

Fig. 6: Preliminary stratigraphy 1, corresponding to the front face of the aegis. S = soil, D = deposit, M = metal, CP = corrosion products, SV = structural void,

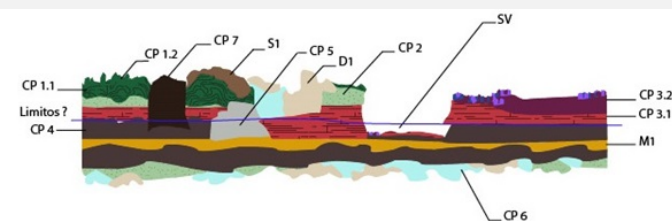
Captions	Colour, aspect, hardness and cohesion
S1	Brown, matte, can be scratched with scalpel blade but remains cohesive.
D1	White shiny deposit, powdery when shaved with scalpel.
CP1.1	Dark green corrosion layer, lumpy and matte, thick, hardly scratched by a scalpel blade, cohesive and compact.
CP1.2	Minor stratum of CP1.1. Dark green crystals appearing on the surface of the artefact. Easily scratched by a scalpel blade.
CP2	Light green corrosion layer, matte and thick in some places, powdery under the action of a scalpel blade. Sometimes located directly on CP4.
CP3.1	Red corrosion layer, lumpy and matte, thick, sometimes hard and sometimes powdery under the action of a scalpel blade.
CP3.2	Minor stratum of CP3.1. Purple with blue-purple crystals, hard and cohesive.
Limitos	Interface of the limit of the original surface. Shiny, straight, black, manufacturing traces.
CP4	Dark grey with red or green reflection. Shiny, hard, straight, dense and with traces of engraving and possible inlays.

CP5	Isolated white stratum: waxy and very soft.
CP6	Light blue stratum, chalky. Isolated on the exterior surface and extends on the interior surface.
CP7	Isolated black stratum, very hard, straight and shiny.
SV:	Void in CP4, resulting in loss of the limitos. Presence of CP1.2 crystals inside the void.
Structural Void	
M1	Yellow stratum with metallic sheen, dense and hardly scratched by scalpel blade.

Fig. 7: Preliminary stratigraphy 2, corresponding to the back face of the aegis and interior (below part). S = soil, D = deposit, M = metal, CP = corrosion products, SV = structural void,

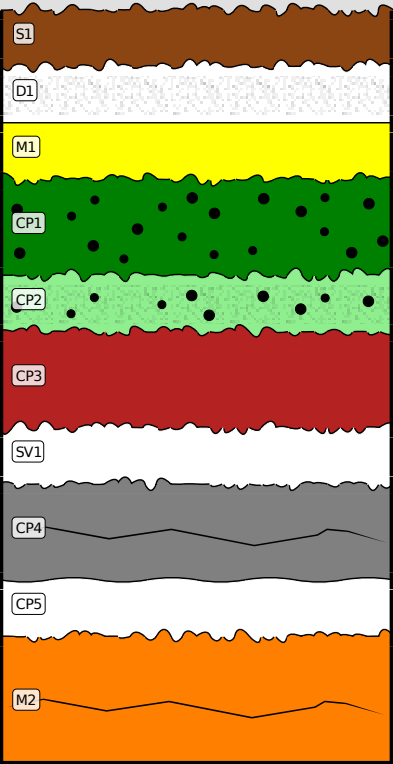
Fig.9: Schematic representation combining stratigraphies 1 and 2 using the MiCorr application. The characteristics of the strata are only accessible by clicking on the drawing that redirects you to the search tool by stratigraphy representation, Credit He-Arc CR, L.Pedersen.

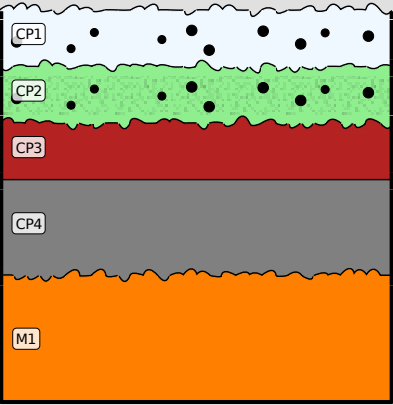
Fig.10: Schematic representation of stratigraphy 3 using the MiCorr application. CP1 is CP6 in Fig. 8. The characteristics of the strata are only accessible by clicking on the drawing that redirects you to the search tool by stratigraphy representation, Credit He-Arc CR, L. Pedersen.

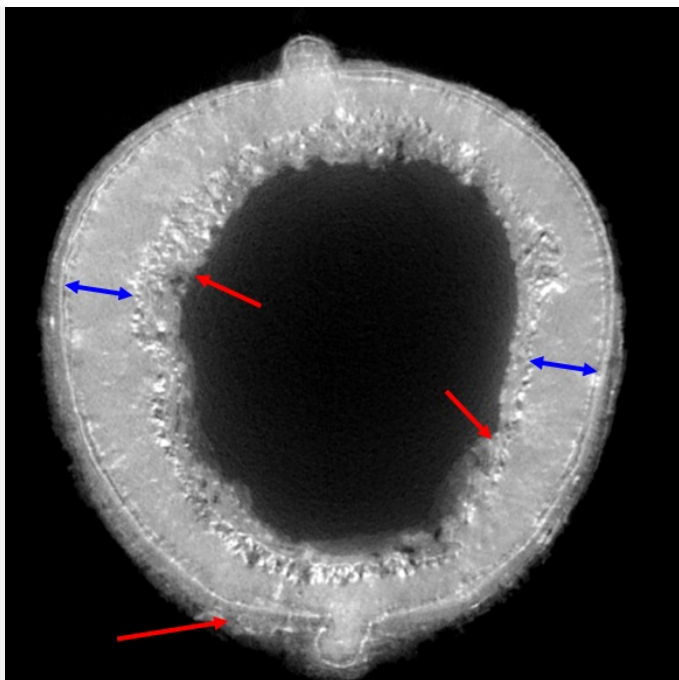
As indicated by the X-ray tomography, the metal of the aegis seems to be well preserved (Figs. 11-12). The metal (M2 in Fig.9 and M1 in Fig. 10) was analysed on the broken edge of the bottom of the artefact where despite a highly corroded surface, the metal seems to be the best preserved. The XRF analyses revealed that the metal is a leaded bronze with remains of gold leaf on the surface (Table 1, Au was detected in the measurement spots 4,5 and 6) (Scott 2002; Gouda 2012; Mohammed 2012).

Fig. 11: X-ray tomography by cross section of the crown showing a dense and non-porous metal core (blue arrows). The corrosion products however are porous (red arrows). The

external limitos is visible as a fine line preserved under corrosion layers,

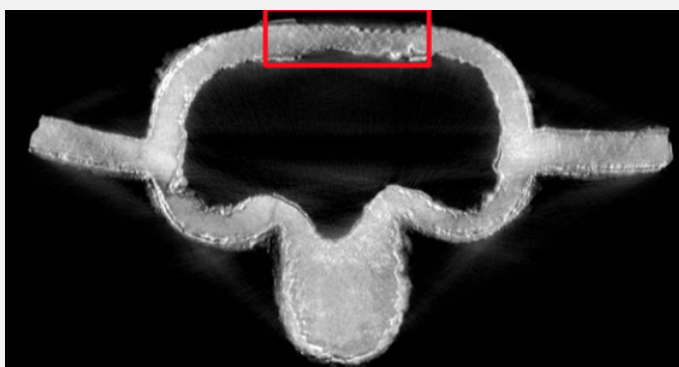
Fig. 12: X-ray tomography by cross section of the lower part showing that there are losses of the original surface (red square),

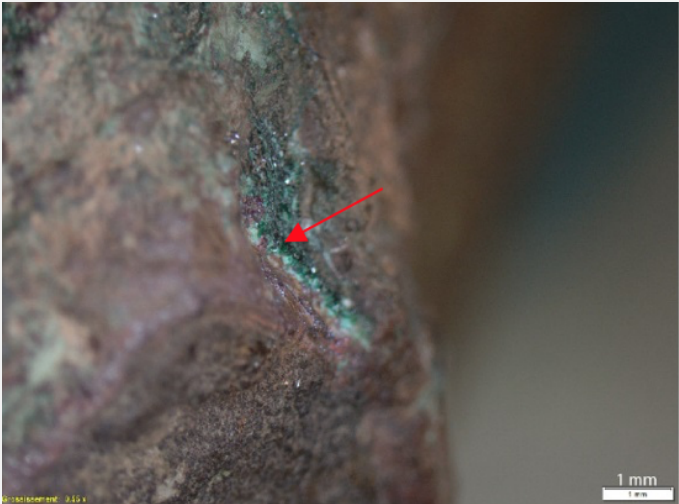
Fig. 13: Observation of the dark green corrosion product,

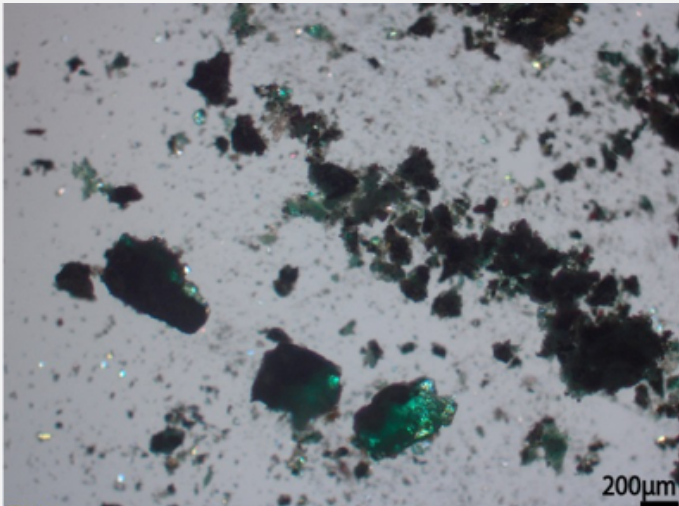
Fig. 14: Dark green corrosion product identified as paratacamite, atacamite $\text{Cu}_2\text{Cl}(\text{OH})_3$ by XRD. Microscopic examination under polarized light,

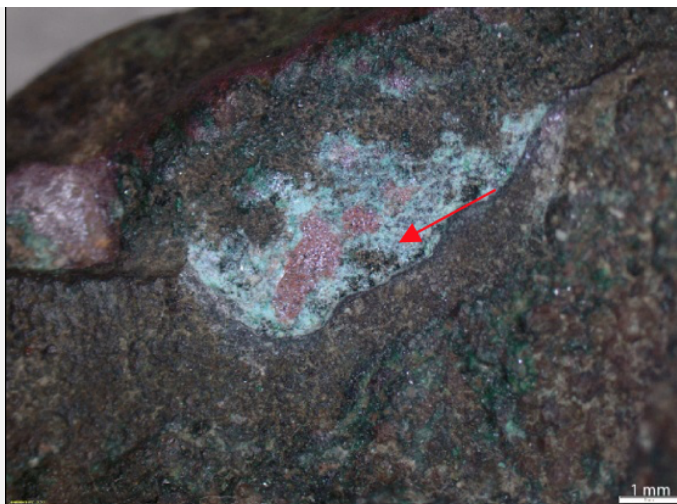
Fig. 15: Observation of the light green corrosion product,

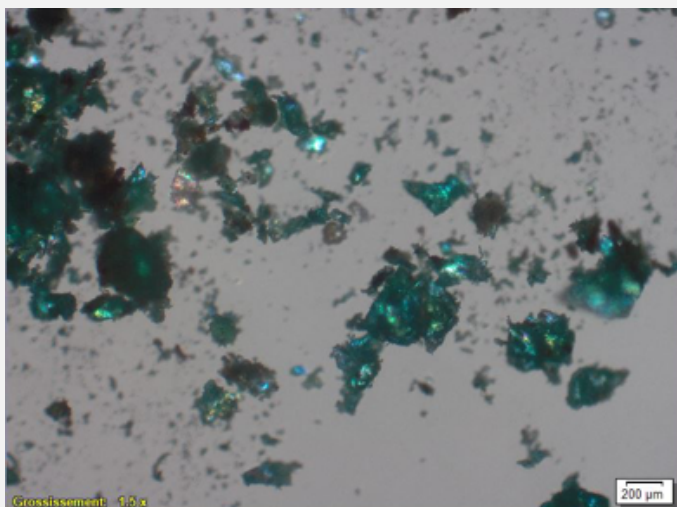
Fig. 16: Light green corrosion product identified as paratacamite, atacamite ($\text{Cu}_2\text{Cl}(\text{OH})_3$) by XRD. Microscopic examination under polarized light,

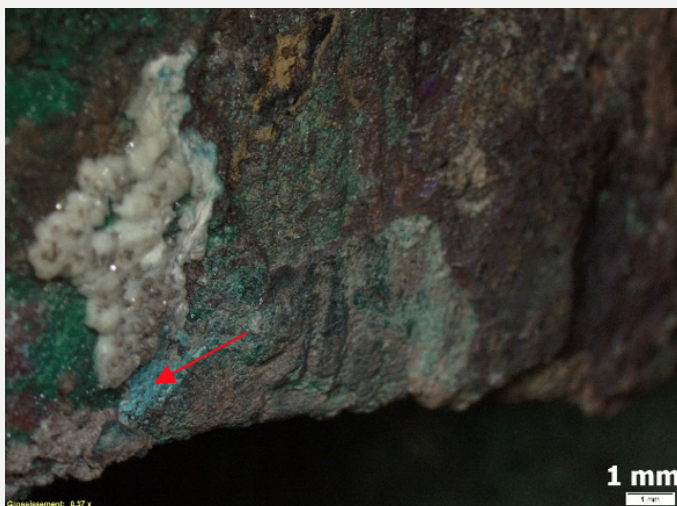
Fig. 17: Observation of the light blue corrosion product,

Fig. 18: Light blue corrosion product identified as chalconatronite $\text{Na}_2\text{Cu}(\text{CO}_3)_2 \cdot 3\text{H}_2\text{O}$ by XRD. Microscopic examination under polarized light,

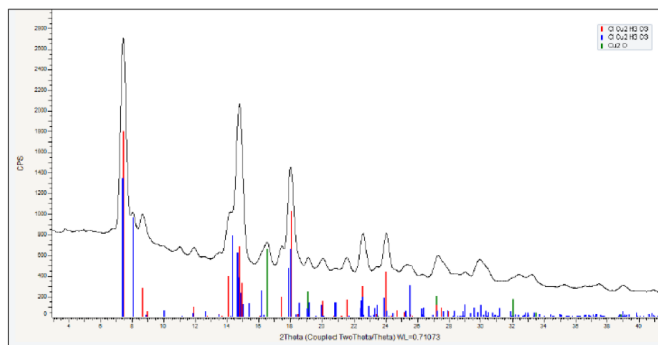
Fig. 22: XRD spectrum of the sample from the light green corrosion product showing the presence of atacamite and paratacamite ($\text{Cu}_2\text{Cl}(\text{OH})_3$) as major compound and cuprite (Cu_2O) as minor compound,

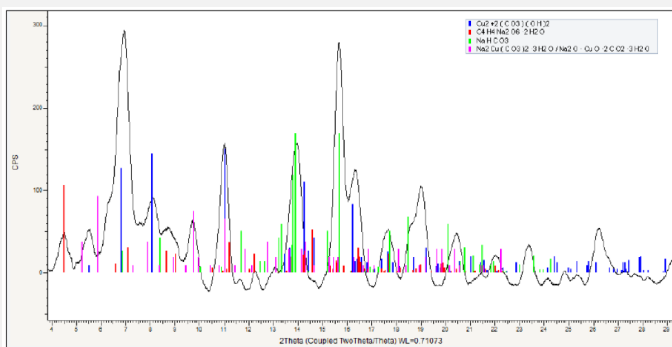
Fig. 23: XRD spectrum of the sample from the light blue corrosion product showing the presence of chalconatronite ($\text{Na}_2\text{Cu}(\text{CO}_3)_2 \cdot 3\text{H}_2\text{O}$). The other compounds are analysis supposition, but are not relevant,

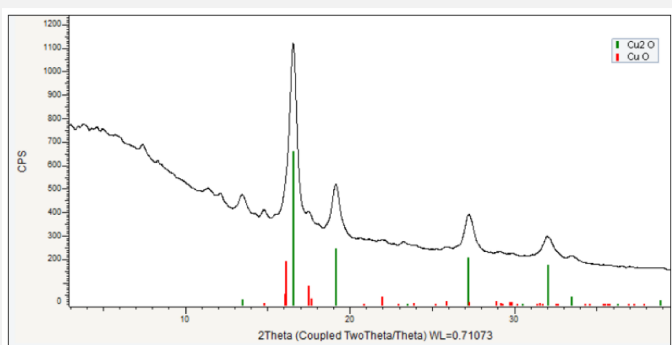
Fig. 24: XRD spectrum of the sample from the dark red corrosion product showing the presence of cuprite (Cu_2O) as major compound and tenorite (CuO) as minor compound,
