SHINGLE OF A ROOF – CU ALLOY – MODERN TIMES – SWITZERLAND

Artefact name	Shingle of a roof
Authors	Marianne. Senn (EMPA, Dübendorf, Zurich, Switzerland) & Christian. Degryny (HE-Arc CR, Neuchâtel, Neuchâtel, Switzerland)
Url	/artefacts/506/

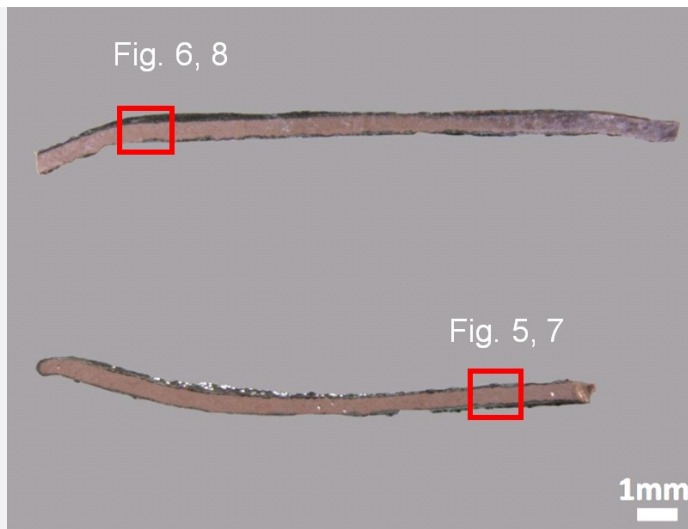
Fig. 3: Micrograph of the cross-sections of the sample taken from the shingle showing the location of Figs. 5 to 8,

Description of sample	Two samples were taken (Fig. 2). The polished samples show a well-preserved metal surface with a thin corrosion crust (Fig. 3). T = 0.5mm.
Alloy	Cu Alloy
Technology	Rolled (probably hot rolling) and annealed
Lab number of sample	MAH-98-257
Sample location	Empa (Marianne Senn)
Responsible institution	Conservation Department of the Musées d'art et d'histoire, Genève, Geneva
Date and aim of sampling	2009, integration of sample to the MIFAC-Métal project

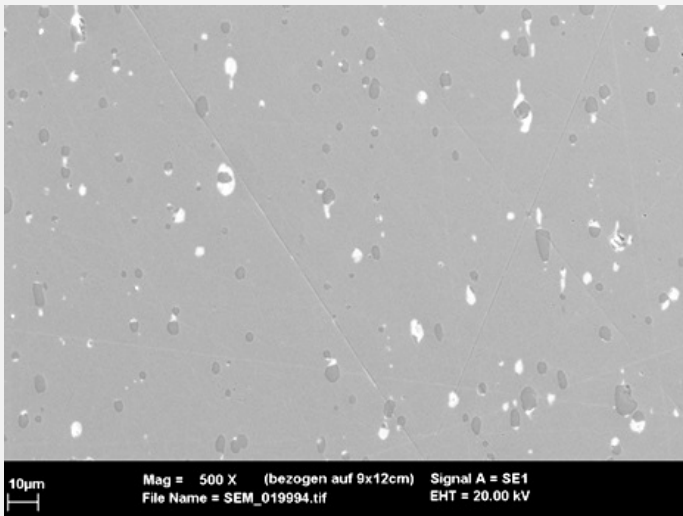
The remaining metal is a copper alloy (Table 1). The evenly distributed inclusions observed under SEM, SE-mode, are either light-grey or white (Fig. 5). The oval shape of the light-grey inclusions is due to deformation, probably by hot rolling (a common technique in the 18th century). Under polarised light they look red (Fig. 7) and their analysis reveals a composition similar to cuprite/Cu₂O (Table 2). The white inclusions are rich in Pb and are remnants of the refining process (Table 2). The etched copper shows a structure of polygonal and twinned grains (Fig. 6). The grain size is variable. The average hardness of the metal is about HV1 70.

Fig. 5: SEM image, SE-mode, of the metal sample from Fig. 3 (detail). Light-grey and white inclusions are distributed evenly,

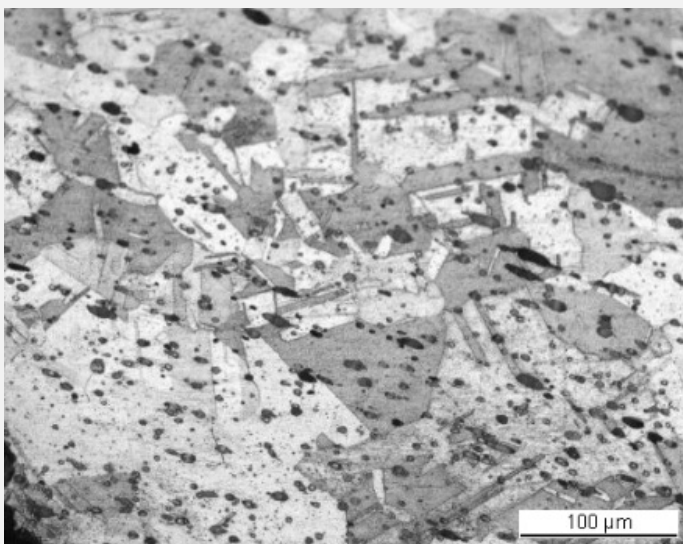
Fig. 6: Micrograph of the metal sample from Fig. 3 (detail), etched, bright field. The metal shows a structure of polygonal and twinned grains. Cuprite inclusions appear as dark spots,

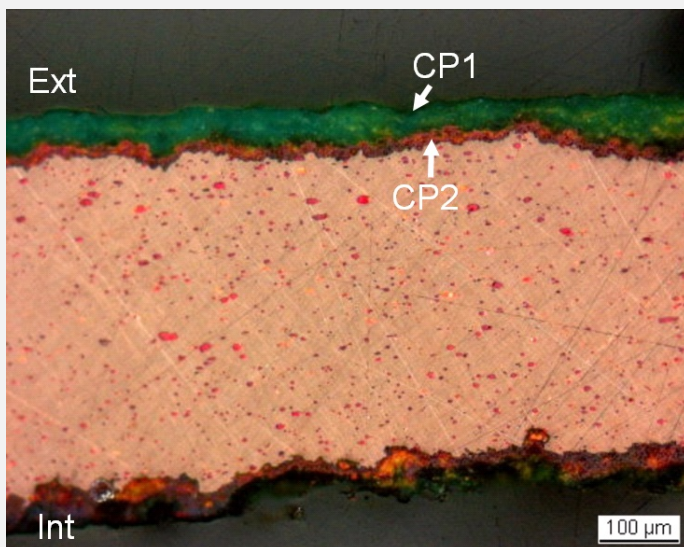
The corrosion crusts of the external and internal sides are distinctively different (Fig. 7). On the internal side an irregular red-orange corrosion layer has developed, and pitting corrosion has occurred. The more uniform corrosion layers on the external side are composed of a red-orange layer, followed by a thicker green outer layer. In some areas, dark-red corrosion products can be observed between the green and red-orange sub-layers. The same dark-red sub-layer can be seen in areas on the internal side covering the red-orange corrosion products. The red-orange corrosion layer on both sides (CP2) has a chemical composition similar to cuprite/ Cu_2O , while the green layer on the external side (CP1) contains Cu, S and O and is enriched on its upper surface with Si (Table 3 and Fig. 8). XRD analysis of the corrosion products on the external side of another shingle fragment from the same roof identified brochantite/ $\text{Cu}_4\text{SO}_4(\text{OH})_6$ and cuprite as corrosion products (Rapport d'analyse no. MAH 98-257). These results are confirmed by Raman spectroscopy of the external side of this sample where the same compounds were clearly identified (Figs. 9 and 10).

Fig. 7: Micrograph of the metal sample from Fig. 3 and corresponding to the stratigraphy of Fig. 4, polarised light. External side: the regular corrosion crust with outer green, inner red-orange corrosion products and intermediate dark-red corrosion products. Internal side: the irregular corrosion crust with inner red-orange and outer dark-red corrosion products.

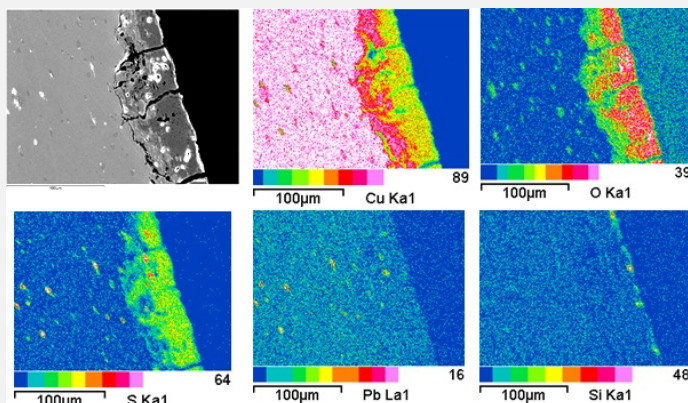
Fig. 8: SEM image, SE-mode, and elemental chemical distribution of the selected area of Fig. 3 (rotated image, detail). Method of examination: SEM/EDS, Laboratory of Analytical Chemistry, Empa,

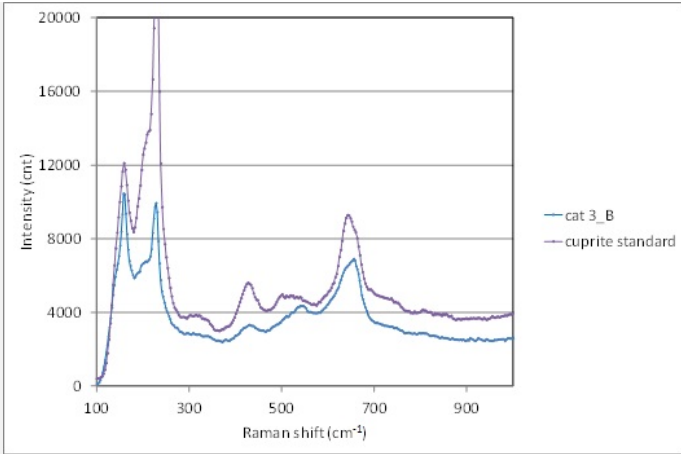
Fig. 9: Raman spectrum of the red-orange inner corrosion layer (CP2) of the external side (cat3_B) compared to a cuprite standard spectrum. Settings: laser wavelength 532nm, acquisition time 100s, one accumulation, filter D2 (0.75-0.8 mW), hole 500, slit 80, grating 600. Method of analysis: Raman spectroscopy, Lab Swiss National Museum, Affoltern a. Albis ZH,

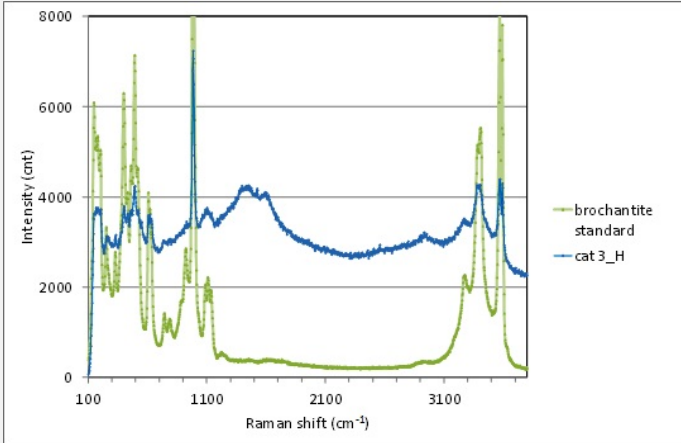
Fig. 10: Raman spectrum of the green outer corrosion layer (CP1) of the external side (cat3_H) compared to a brochantite standard spectrum. Settings: laser wavelength 532nm, acquisition time 100s, one accumulation, filter D2 (0.75-0.8 mW), hole 500, slit 80, grating 600. The peak indicated with an arrow on the cat3_H spectrum is due to fluorescence. Method of analysis: Raman spectroscopy, Lab Swiss National Museum, Affoltern a. Albis ZH,

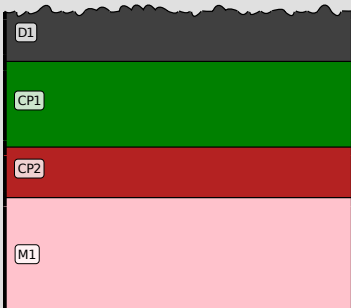
Fig. 4: Stratigraphic representation of the sample taken from the shingle in cross-section using the MiCorr application. The characteristics of the strata are only accessible by clicking on the drawing that redirects you to the search tool by stratigraphy representation. This representation can be compared to Fig. 7, Credit HE-Arc CR.
