SHINGLE OF A ROOF – CU ALLOY – MODERN TIMES – SWITZERLAND

Artefact name	Shingle of a roof
Authors	Marianne. Senn (EMPA, Dübendorf, Zurich, Switzerland) & Christian. Degriany (HE-Arc CR, Neuchâtel, Neuchâtel, Switzerland)
Url	/artefacts/506/

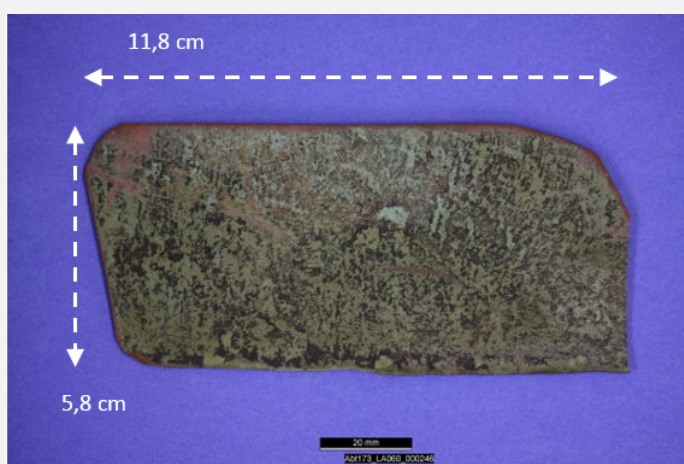
Fig. 1: Shingle of a roof, internal side,

Description of the artefact	Shingle, slightly curved, the internal side is covered with heterogeneously distributed green and black corrosion products (Fig. 1). The external side shows a regular dark green corrosion crust. Dimensions: L = 11.8cm; W = 5.8cm.
Type of artefact	Architectural element
Origin	Roof of the Abbey of St Gallen, Sankt Gallen, Saint Gallen, Switzerland
Recovering date	None
Chronology category	Modern Times
chronology tpq	<input type="text" value="1780"/> A.D. ▼
chronology taq	<input type="text" value=""/> ---- ▼
Chronology comment	1780
Burial conditions / environment	Outdoor atmosphere
Artefact location	Conservation Department of the Musées d'art et d'histoire, Genève, Geneva
Owner	Abbey of St Gallen, Sankt Gallen, Saint Gallen

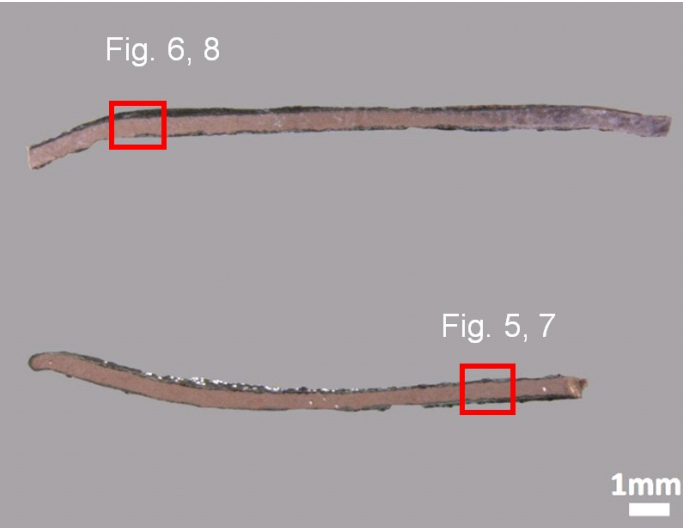
Fig. 3: Micrograph of the cross-sections of the sample taken from the shingle showing the location of Figs. 5 to 8,

Description of sample	Two samples were taken (Fig. 2). The polished samples show a well-preserved metal surface with a thin corrosion crust (Fig. 3). T = 0.5mm.
Alloy	Cu Alloy
Technology	Rolled (probably hot rolling) and annealed
Lab number of sample	MAH-98-257
Sample location	Empa (Marianne Senn)
Responsible institution	Conservation Department of the Musées d'art et d'histoire, Genève, Geneva
Date and aim of sampling	2009, integration of sample to the MIFAC-Métal project

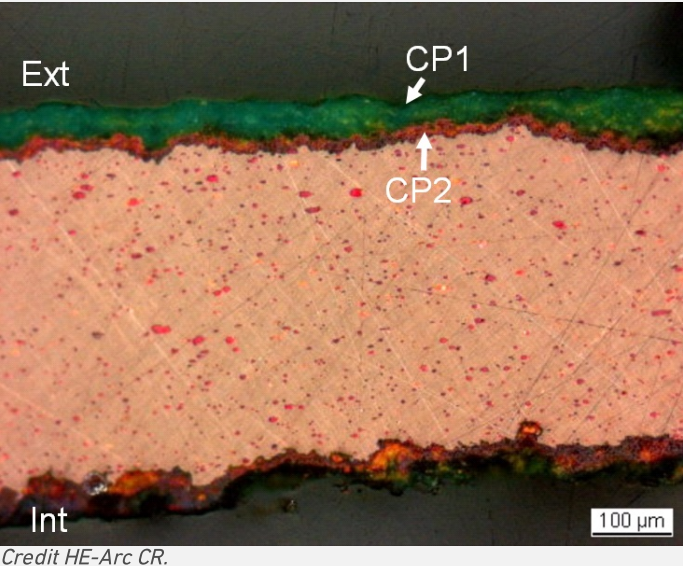
The corrosion crusts of the external and internal sides are distinctively different (Fig. 7). On the internal side an irregular red-orange corrosion layer has developed, and pitting corrosion has occurred. The more uniform corrosion layers on the external side are composed of a red-orange layer, followed by a thicker green outer layer. In some areas, dark-red corrosion products can be observed between the green and red-orange sub-layers. The same dark-red sub-layer can be seen in areas on the internal side covering the red-orange corrosion products. The red-orange corrosion layer on both sides (CP2) has a chemical composition similar to cuprite/ Cu_2O , while the green layer on the external side (CP1) contains Cu, S and O and is enriched on its upper surface with Si (Table 3 and Fig. 8). XRD analysis of the corrosion products on the external side of another shingle fragment from the same roof identified brochantite/ $\text{Cu}_4\text{SO}_4(\text{OH})_6$ and cuprite as corrosion products (Rapport d'analyse no. MAH 98-257). These results are confirmed by Raman spectroscopy of the external side of this sample where the same compounds were clearly identified (Figs. 9 and 10).

Fig. 7: Micrograph of the metal sample from Fig. 3 and corresponding to the stratigraphy of Fig. 4, polarised light. External side: the regular corrosion crust with outer green, inner red-orange corrosion products and intermediate dark-red corrosion products. Internal side: the irregular corrosion crust with inner red-orange and outer dark-red corrosion products,

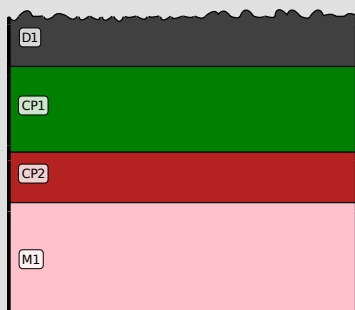
Fig. 4: Stratigraphic representation of the sample taken from the shingle in cross-section using the MiCorr application. The characteristics of the strata are only accessible by clicking on the drawing that redirects you to the search tool by stratigraphy representation. This representation can be compared to Fig. 7, Credit HE-Arc CR.
