SHINGLE OF A ROOF – CU ALLOY – MODERN TIMES – SWITZERLAND

Artefact name	Shingle of a roof
Authors	Marianne. Senn (EMPA, Dübendorf, Zurich, Switzerland) & Christian. Degriany (HE-Arc CR, Neuchâtel, Neuchâtel, Switzerland)
Url	/artefacts/506/

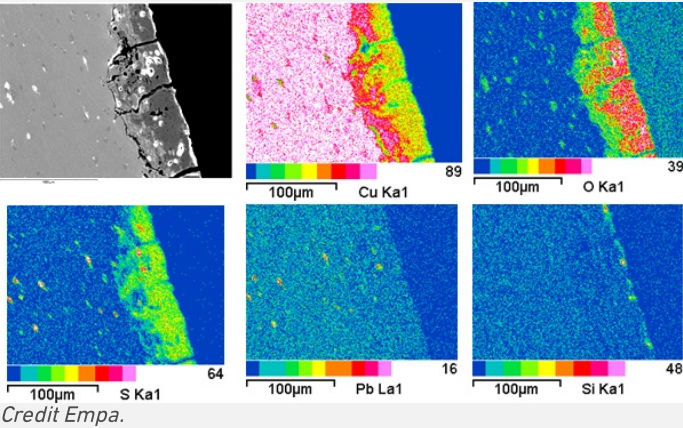
Fig. 8: SEM image, SE-mode, and elemental chemical distribution of the selected area of Fig. 3 (rotated image, detail). Method of examination: SEM/EDS, Laboratory of Analytical Chemistry, Empa,

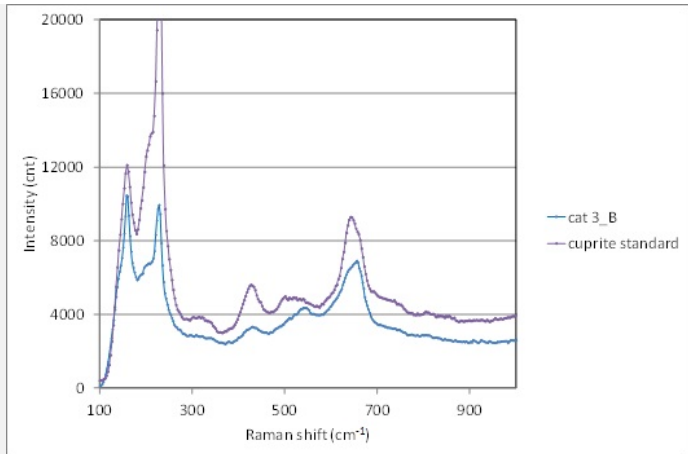
Fig. 9: Raman spectrum of the red-orange inner corrosion layer (CP2) of the external side (cat3_B) compared to a cuprite standard spectrum. Settings: laser wavelength 532nm, acquisition time 100s, one accumulation, filter D2 (0.75-0.8 mW), hole 500, slit 80, grating 600. Method of analysis: Raman spectroscopy, Lab Swiss National Museum, Affoltern a. Albis ZH,

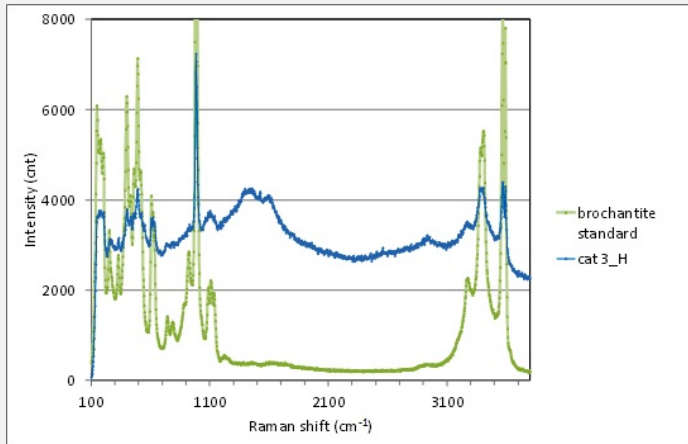
Fig. 10: Raman spectrum of the green outer corrosion layer (CP1) of the external side (cat3_H) compared to a brochantite standard spectrum. Settings: laser wavelength 532nm, acquisition time 100s, one accumulation, filter D2 (0.75-0.8 mW), hole 500, slit 80, grating 600. The peak indicated with an arrow on the cat3_H spectrum is due to fluorescence. Method of analysis: Raman spectroscopy, Lab Swiss National Museum, Affoltern a. Albis ZH,

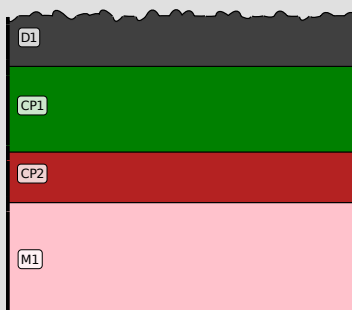
Fig. 4: Stratigraphic representation of the sample taken from the shingle in cross-section using the MiCorr application. The characteristics of the strata are only accessible by clicking on the drawing that redirects you to the search tool by stratigraphy representation. This representation can be compared to Fig. 7, Credit HE-Arc CR.
