# ARMATURE FROM A CLOCK MOVEMENT MIH IV-212 – ZN AL SN CU ALLOY – MODERN TIMES

Artefact name	Armature from a clock movement MIH IV-212
Authors	Marianne. Senn (EMPA, Dübendorf, Zurich, Switzerland) & Christian. Degriigny (HE-Arc CR, Neuchâtel, Neuchâtel, Switzerland)
Url	/artefacts/509/

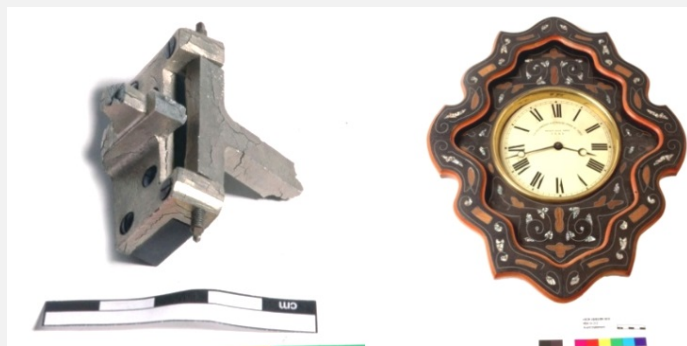
Fig. 1: Broken armature (left) from the clock movement of a wooden wall clock (right) (after Seematter 2009),

Description of the artefact	Armature from the clock movement of a wooden wall clock with electric movement broken in two elements (Fig. 1 and Fig. 2).
Type of artefact	Horological object
Origin	Wooden wall clock
Recovering date	1902-1904
Chronology category	Modern Times
chronology tpq	1902 A.D. ▼
chronology taq	1904 A.D. ▼
Chronology comment	
Burial conditions / environment	Indoor atmosphere
Artefact location	International museum of horology (IMH), La Chaux-de-Fonds, Neuchâtel
Owner	International museum of horology (IMH), La Chaux-de-Fonds, Neuchâtel
Inv. number	MIH IV-212
Recorded conservation data	Not conserved

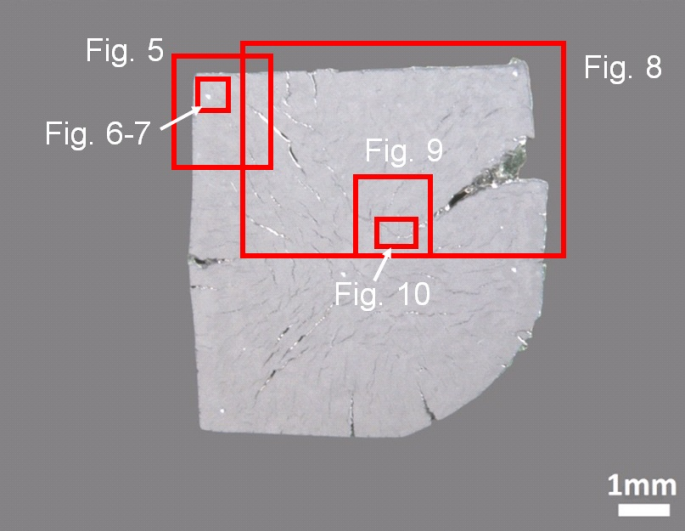
Fig. 3: Micrograph of the cross-section of the fragment sampled from the armature showing the location of Figs. 5 to 10,

Description of sample	This sample is the complete cross-section from an element of the armature (Fig. 2). The metal has huge cracks radiating from the centre to the outside which have deformed the armature (Fig. 3). The metal is covered with a Ni coating.
Alloy	Zn Al Sn Cu Alloy
Technology	As-cast
Lab number of sample	MIH-VI-212
Sample location	HE-Arc CR, Neuchâtel, Neuchâtel
Responsible institution	International museum of horology (IMH), La Chaux-de-Fonds, Neuchâtel
Date and aim of sampling	2009, metal analysis
