ARMATURE FROM A CLOCK MOVEMENT MIH IV-212 - ZN AL SN CU ALLOY - MODERN TIMES

Artefact name Armature from a clock movement MIH IV-212

Authors Marianne. Senn (EMPA, Dübendorf, Zurich, Switzerland) & Christian. Degryny (HE-Arc CR, Neuchâtel, Neuchâtel, Switzerland)

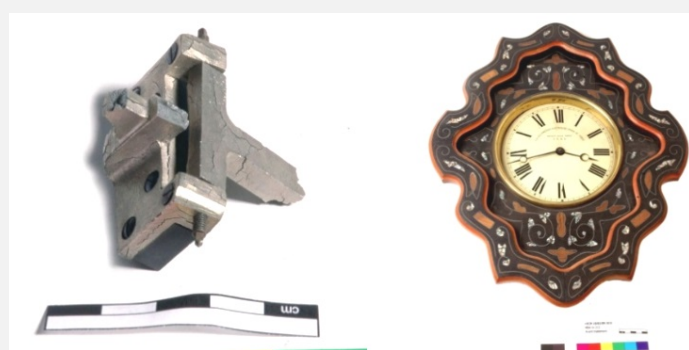
Fig. 1: Broken armature (left) from the clock movement of a wooden wall clock (right) (after Seematter 2009),

Description of the artefact	Armature from the clock movement of a wooden wall clock with electric movement broken in two elements (Fig. 1 and Fig. 2).
Type of artefact	Horological object
Origin	Wooden wall clock
Recovering date	1902-1904
Chronology category	Modern Times
chronology tpq	<input type="text" value="1902"/> A.D. ▾
chronology taq	<input type="text" value="1904"/> A.D. ▾
Chronology comment	
Burial conditions / environment	Indoor atmosphere
Artefact location	International museum of horology (IMH), La Chaux-de-Fonds, Neuchâtel
Owner	International museum of horology (IMH), La Chaux-de-Fonds, Neuchâtel

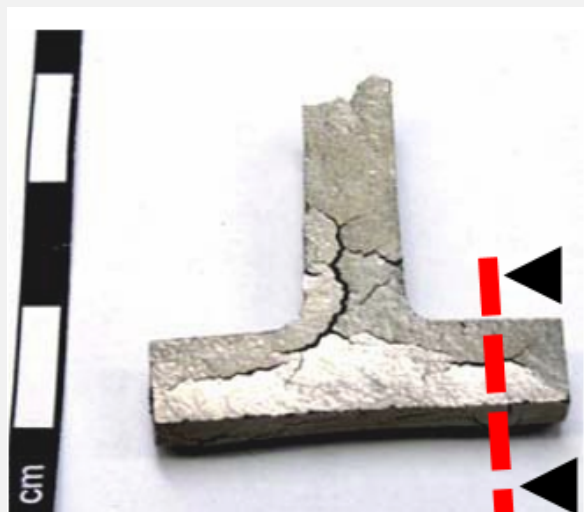
Fig. 2: Location of sampling area on the second element of the armature,

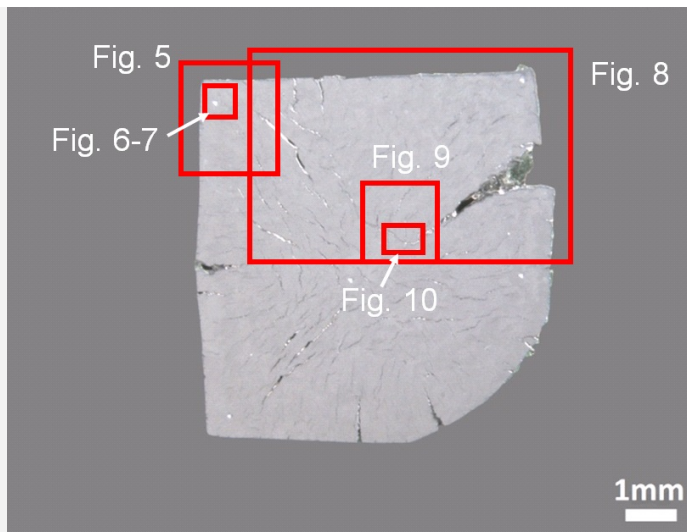
Fig. 3: Micrograph of the cross-section of the fragment sampled from the armature showing the location of Figs. 5 to 10,

Description of sample	This sample is the complete cross-section from an element of the armature (Fig. 2). The metal has huge cracks radiating from the centre to the outside which have deformed the armature (Fig. 3). The metal is covered with a Ni coating.
Alloy	Zn Al Sn Cu Alloy
Technology	As-cast
Lab number of sample	MIH-VI-212
Sample location	HE-Arc CR, Neuchâtel, Neuchâtel
Responsible institution	International museum of horology (IMH), La Chaux-de-Fonds, Neuchâtel
Date and aim of sampling	2009, metal analysis

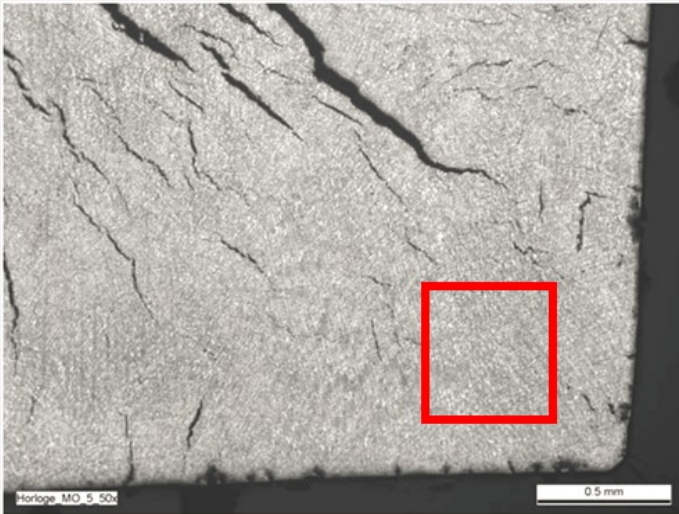
The metal is a Zn-Al-Sn-Cu alloy (Table 1) with an average hardness of HV1 105. A fine dendritic structure is observed (Fig. 5) which consists of clearly separated Zn, Al-Cu and Sn-rich phases (Figs. 6 and 7). Pb is associated with Sn but also forms tiny nodules.

Fig. 5: Micrograph of the metal sample from Fig. 3 (inverted picture, rotated by 270°, detail), unetched, bright field. A dendritic structure is visible. The micrograph of Fig. 6 is marked by a square,

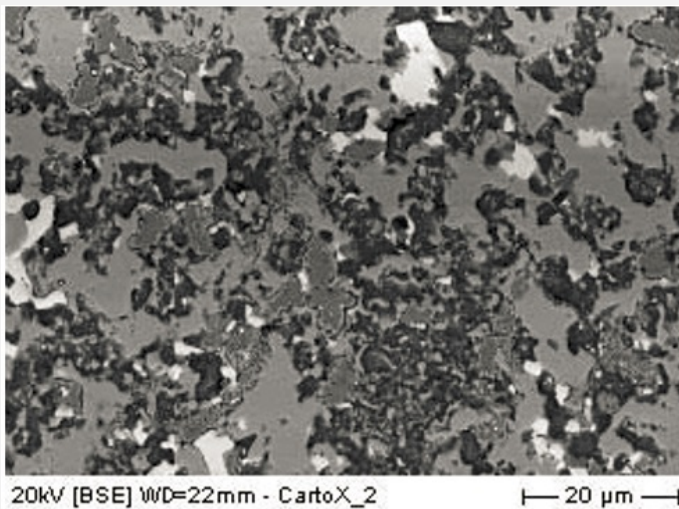
Fig. 6: SEM image, BSE-mode, detail from Fig. 5 (detail), unetched, bright field. Three phases appear: in light-grey the Zn-rich phase, in dark-grey the Al and Cu-rich phase and in white the Sn-rich phase,

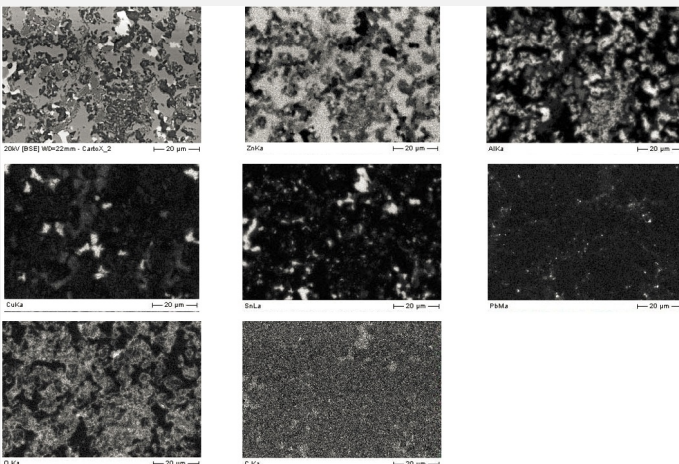
Fig. 7: SEM image, BSE-mode, and elemental chemical distribution of the selected area from Fig. 6. Method of examination: SEM/EDS, Lab of Electronic Microscopy and microanalysis, IMA (Néode), HEI Arc,

The Zn-rich phase is heavily oxidised internally (Fig. 7). The corrosion has developed throughout the entire metal body, generating cracks (Figs. 8 and 9). The cracks are Zn, O and C-rich (Fig. 10) and could be composed of zinc carbonate.

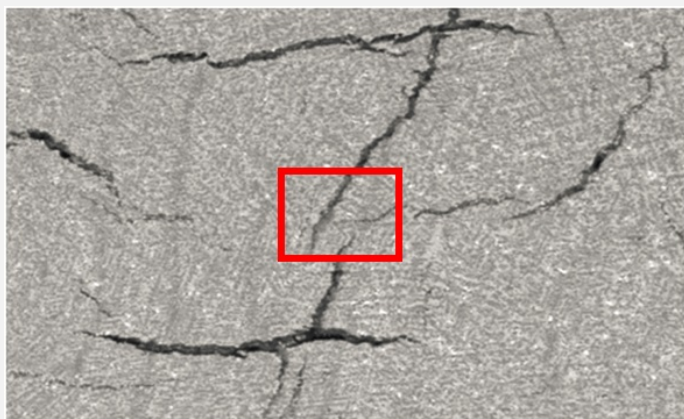
Fig. 9: Micrograph of the metal sample, detail from Fig. 8 (reversed and rotated by 90°), unetched, bright field. A dendritic structure is visible. The area selected for elementary mapping (Fig. 10) is marked by a rectangle,

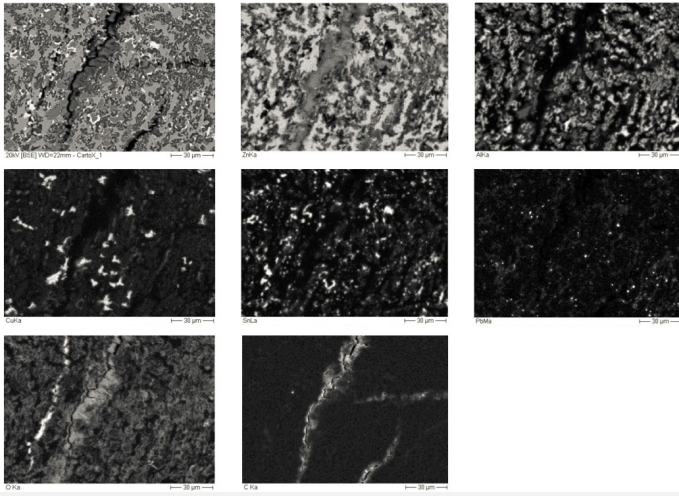
Fig. 10: SEM image, BSE-mode, and elemental chemical distribution of the selected area from Fig. 9 (detail). Method of examination: SEM/EDX, Lab of Electronic Microscopy and microanalysis, IMA (Néode), HEI Arc,

Corrosion form Internal cracking
 Corrosion type zinc pest
