# AIRCRAFT FRONT FASTENING PLATE VHS-497 (2) - AL CU SN ZN SI ALLOY - MODERN TIMES

**Artefact name** Aircraft front fastening plate VHS-497 (2)

**Authors** Marianne. Senn (EMPA, Dübendorf, Zurich, Switzerland) & Christian. Degriigny (HE-Arc CR, Neuchâtel, Neuchâtel, Switzerland)

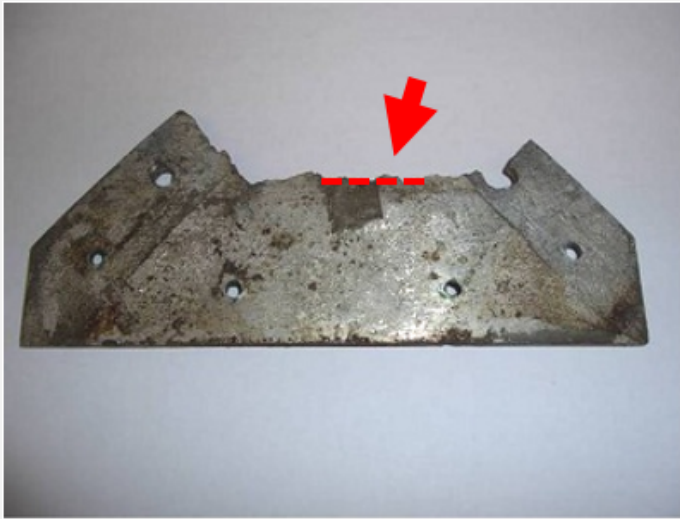
Fig. 2: Location of sampling area.

The top part has been cut during sampling (Fig. 2). The more regular right side is the plate surface and the irregular side is the broken edge (Fig. 3). Dimensions: L = 4mm ; W = 4mm.

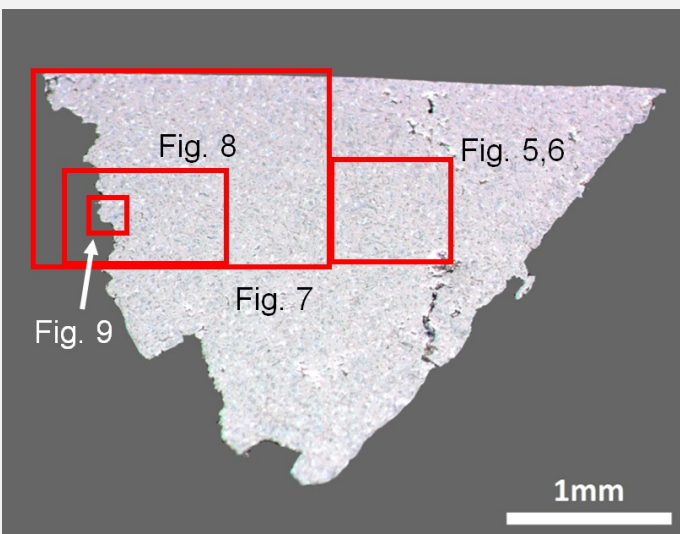
Fig. 3: Micrograph of the cross-section of the sample taken from the front fastening plate showing the location of Figs. 5 to 9,

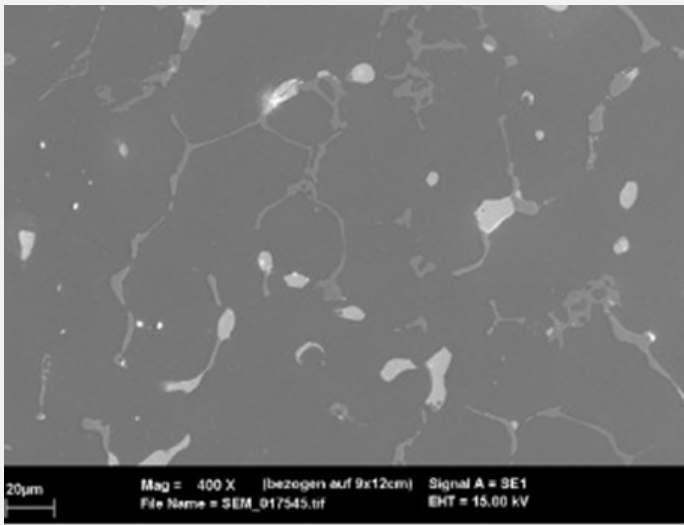
Fig. 6: SEM image of the metal sample from Fig. 3 (detail), SE-mode, unetched. We observe in dark-grey the metal matrix, in medium-grey the intermetallic compound  $Al_2Cu$  as well as Al,Fe,Si & Cu phase clusters and in light-grey the Sn inclusions,

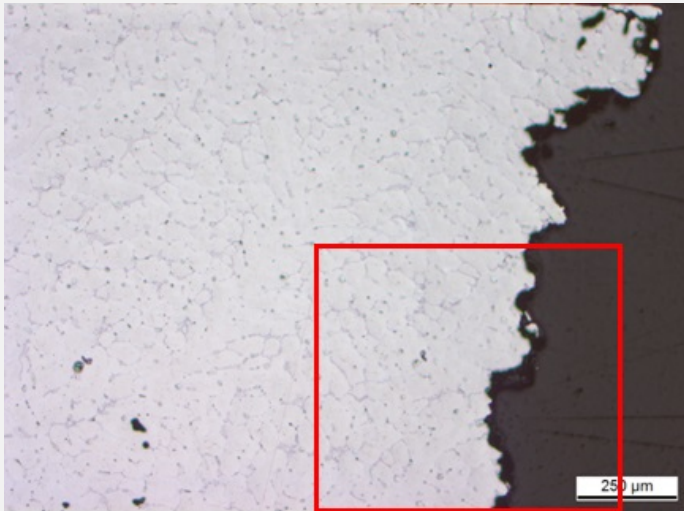
No corrosion layer can be seen on the metal surface (Figs. 3 and 7). Under polarized light small white and brown particles are visible on the broken edge (D1, Fig. 8). Their analysis reveals the presence of silica particles surrounded by dirt (Table 2 and Fig. 9). The metal surface is covered by a thin oxygen bearing skin (CP1, Fig. 9).

Fig. 7: Micrograph showing the metal - "corrosion products" interface from Fig. 3 (reversed picture, detail), unetched, bright field. We observe in white the metal matrix, in dark-grey Al, Fe, Si & Cu phase and light-grey Al<sub>2</sub>Cu intermetallic compounds. The micrograph of Fig. 8 is marked by a rectangle,

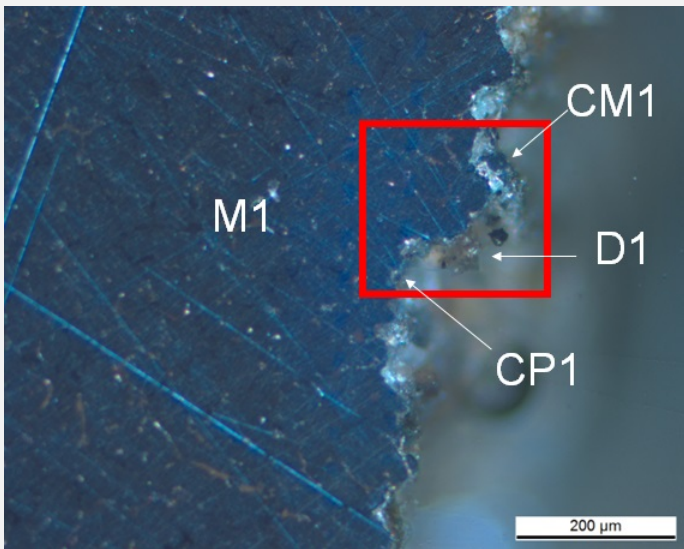
Fig. 8: Micrograph from Fig. 7 (detail) and corresponding to the stratigraphy of Fig. 4, unetched, polarised light. We observe in grey the metal matrix and blue-brown the adherent material. The area selected for elemental chemical distribution (Fig. 9) is marked by a rectangle,
