AIRCRAFT FRONT FASTENING PLATE VHS-497 (2) – AL CU SN ZN SI ALLOY – MODERN TIMES

Artefact name	Aircraft front fastening plate VHS-497 (2)
Authors	Marianne. Senn (EMPA, Dübendorf, Zurich, Switzerland) & Christian. Degrigny (HE-Arc CR, Neuchâtel, Neuchâtel, Switzerland)
Url	/artefacts/510/

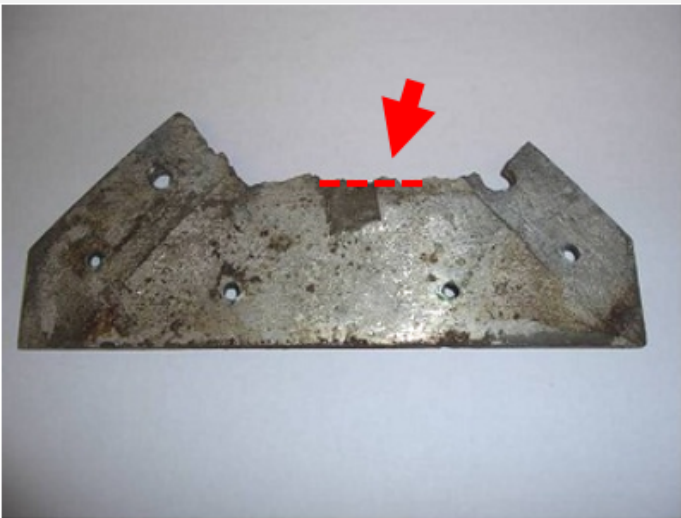
Fig. 2: Location of sampling area,

The top part has been cut during sampling (Fig. 2). The more regular right side is the plate surface and the irregular side is the broken edge (Fig. 3). Dimensions: L = 4mm ; W = 4mm.

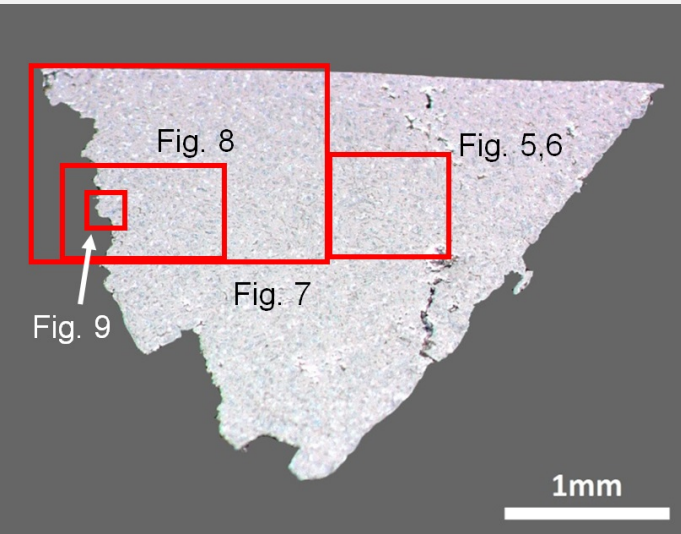
Fig. 3: Micrograph of the cross-section of the sample taken from the front fastening plate showing the location of Figs. 5 to 9,

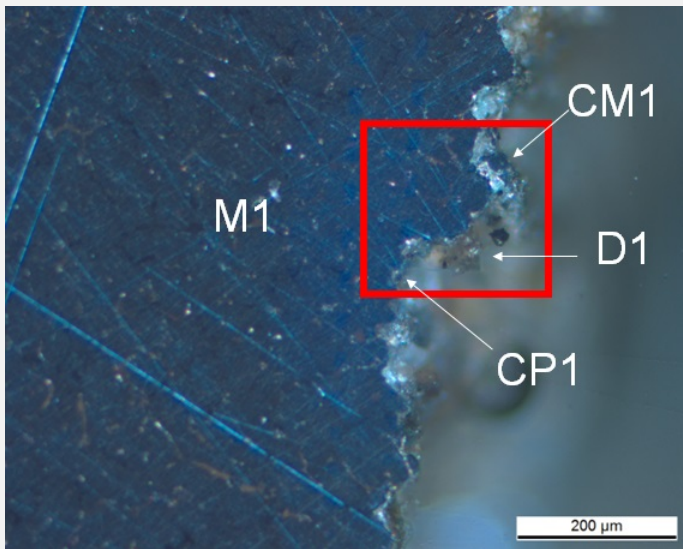
No corrosion layer can be seen on the metal surface (Figs. 3 and 7). Under polarized light small white and brown particles are visible on the broken edge (D1, Fig. 8). Their analysis reveals the presence of silica particles surrounded by dirt (Table 2 and Fig. 9). The metal surface is covered by a thin oxygen bearing skin (CP1, Fig. 9).

Fig. 8: Micrograph from Fig. 7 (detail) and corresponding to the stratigraphy of Fig. 4, unetched, polarised light. We observe in grey the metal matrix and blue-brown the adherent material. The area selected for elemental chemical distribution (Fig. 9) is marked by a rectangle,

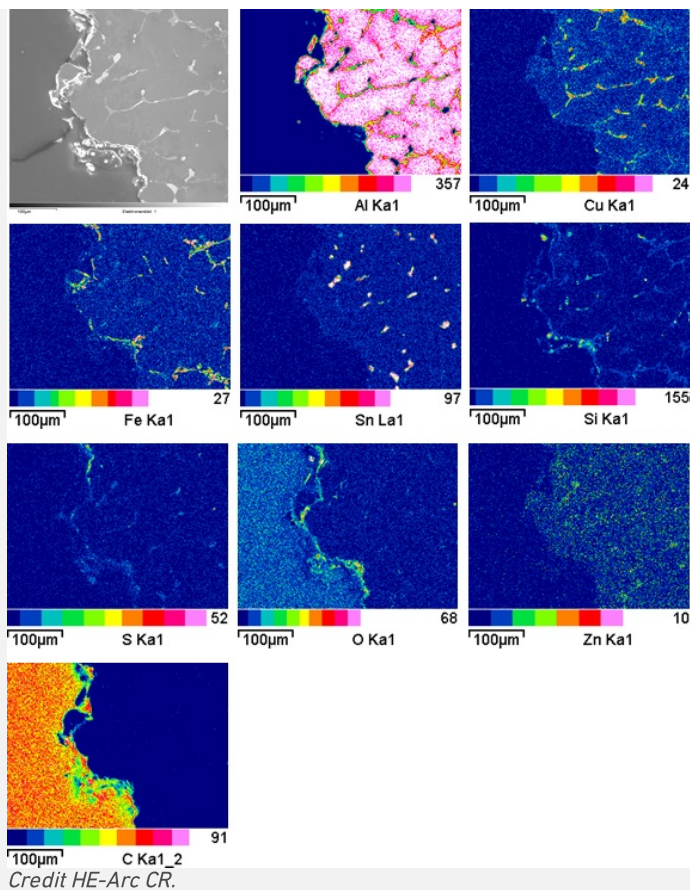
Fig. 9: SEM image, BSE-mode, and elemental chemical distribution of the selected area from Fig. 8 (reversed picture, detail). Method of examination: SEM/EDS, Laboratory of Analytical Chemistry, Empa,

Although not common at the beginning of the 20th, this Al-Cu-Sn-Zn-Si cast alloy was used on the Dufaux IV plane. No corrosion layer has been found on the metal surface except adherent silica-rich particles and the thin oxidised skin typical of Al alloys. The presence of these materials can be explained by the regular maintenance of the metal, probably using silicon carbide abrasive paper.
