AIRCRAFT FRONT FASTENING PLATE VHS-497 (2) - AL CU SN ZN SI ALLOY - MODERN TIMES

Artefact name Aircraft front fastening plate VHS-497 (2)

Authors Marianne. Senn (EMPA, Dübendorf, Zurich, Switzerland) & Christian. Degryny (HE-Arc CR, Neuchâtel, Neuchâtel, Switzerland)

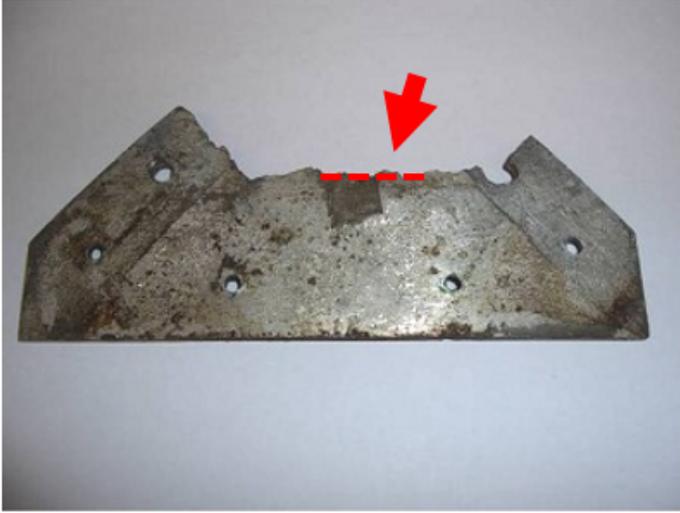
Fig. 2: Location of sampling area,

Description of sample	The top part has been cut during sampling (Fig. 2). The more regular right side is the plate surface and the irregular side is the broken edge (Fig. 3). Dimensions: L = 4mm ; W = 4mm.
Alloy	Al Cu Sn Zn Si Alloy
Technology	As-cast
Lab number of sample	DUF-4
Sample location	Empa (Marianne Senn)
Responsible institution	Swiss Museum of Transport, Luzern, Lucerne
Date and aim of sampling	September 2007, metallography and alloy composition

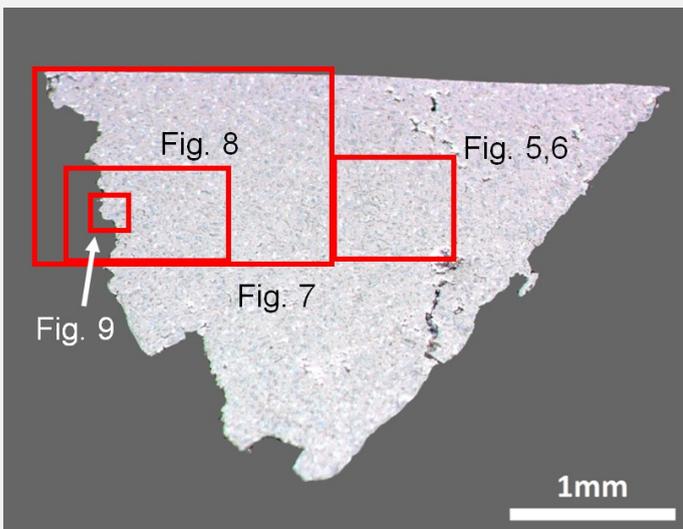
Fig. 3: Micrograph of the cross-section of the sample taken from the front fastening plate showing the location of Figs. 5 to 9,

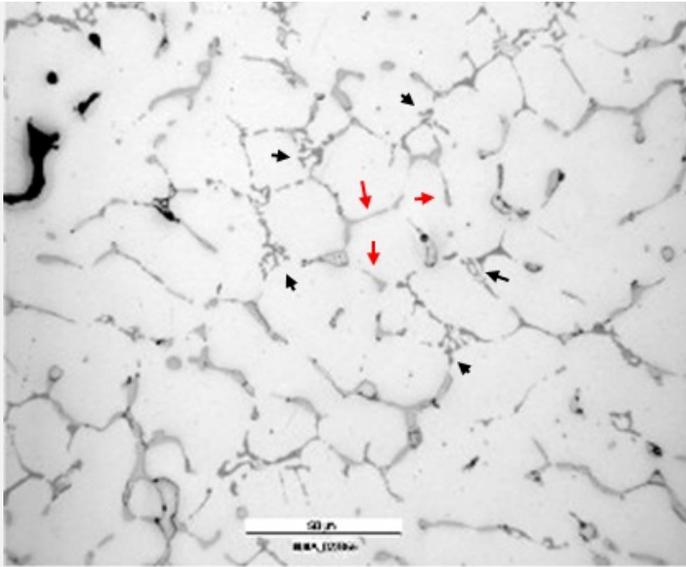
The metal is an aluminium alloy containing Cu, Sn, Zn and Si (Table 1). The unetched metal shows an as-cast structure consisting of the aluminium matrix with Sn (not soluble in Al) inclusions (Figs. 5 and 6), intermetallic compounds such as Al₂Cu (Fig. 5, red arrows) and clusters of Al,Fe,Cu & Si phases (Fig. 5, black arrows). There are porosities in the metal (Figs. 3 and 5). The average hardness of the metal is HV1 80.

Table 1: Chemical composition (mass %) of the metal and inclusions (from Fig. 5). Method of analysis: SEM/EDS, Laboratory of Analytical Chemistry, Empa.

Fig. 5: Micrograph of the metal sample from Fig. 3 (detail), unetched, bright field. The cast structure is revealed by light grey intermetallic compounds (Al₂Cu, red arrows), dark-grey Al,Fe,Si & Cu phase clusters (black arrows) and Sn inclusions (nodules). On the top left some pores can be seen,

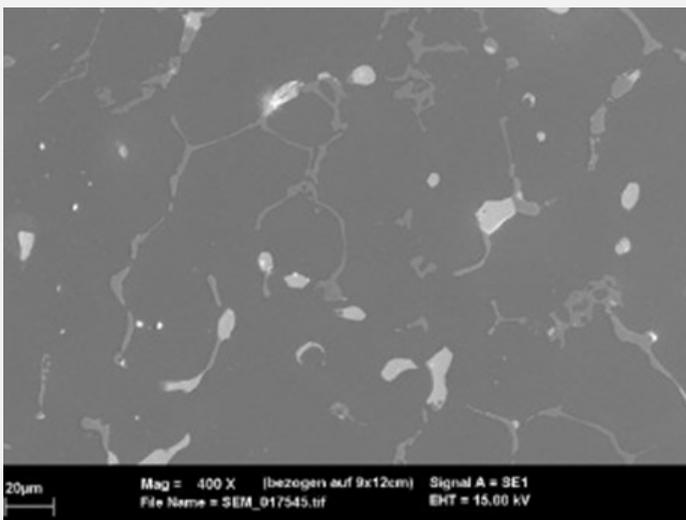
Fig. 6: SEM image of the metal sample from Fig. 3 (detail), SE-mode, unetched. We observe in dark-grey the metal matrix, in medium-grey the intermetallic compound Al₂Cu as well as Al,Fe,Si & Cu phase clusters and in light-grey the Sn inclusions,

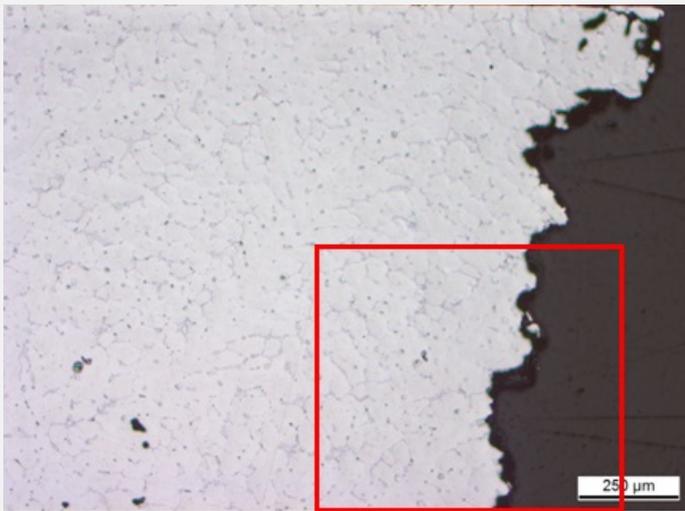
No corrosion layer can be seen on the metal surface (Figs. 3 and 7). Under polarized light small white and brown particles are visible on the broken edge (D1, Fig. 8). Their analysis reveals the presence of silica particles surrounded by dirt (Table 2 and Fig. 9). The metal surface is covered by a thin oxygen bearing skin (CP1, Fig. 9).

Fig. 7: Micrograph showing the metal - "corrosion products" interface from Fig. 3 (reversed picture, detail), unetched, bright field. We observe in white the metal matrix, in dark-grey Al, Fe, Si & Cu phase and light-grey Al₂Cu intermetallic compounds. The micrograph of Fig. 8 is marked by a rectangle,

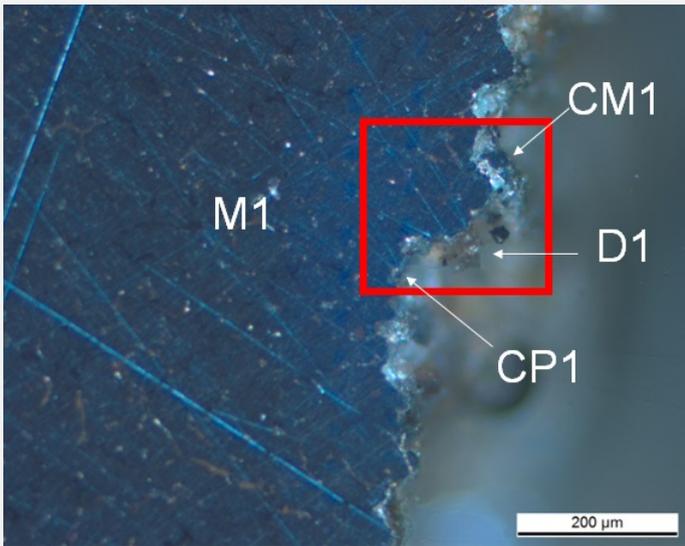
Fig. 8: Micrograph from Fig. 7 (detail) and corresponding to the stratigraphy of Fig. 4, unetched, polarised light. We observe in grey the metal matrix and blue-brown the adherent material. The area selected for elemental chemical distribution (Fig. 9) is marked by a rectangle,

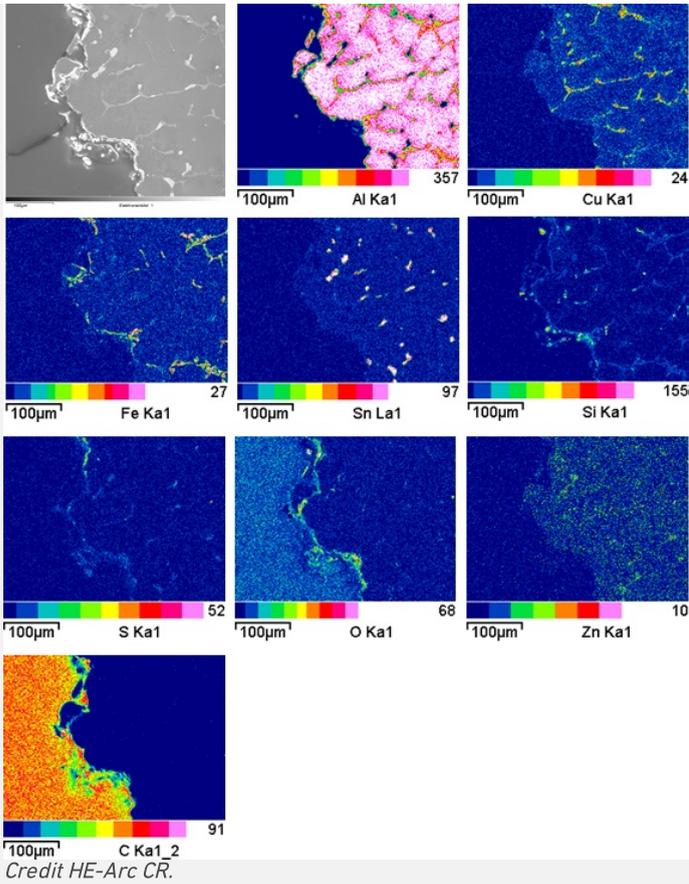
Fig. 9: SEM image, BSE-mode, and elemental chemical distribution of the selected area from Fig. 8 (reversed picture, detail). Method of examination: SEM/EDS, Laboratory of Analytical Chemistry, Empa,

Although not common at the beginning of the 20th, this Al-Cu-Sn-Zn-Si cast alloy was used on the Dufaux IV plane. No corrosion layer has been found on the metal surface except adherent silica-rich particles and the thin oxidised skin typical of Al alloys. The presence of these materials can be explained by the regular maintenance of the metal, probably using silicon carbide abrasive paper.
