# AIRCRAFT FRONT FASTENING PLATE VHS-497 (2) – AL CU SN ZN SI ALLOY – MODERN TIMES

| Artefact name | Aircraft front fastening plate VHS-497 (2) |
| Authors | Marianne. Senn (EMPA, Dübendorf, Zurich, Switzerland) & Christian. Degrigny (HE-Arc CR, Neuchâtel, Neuchâtel, Switzerland) |

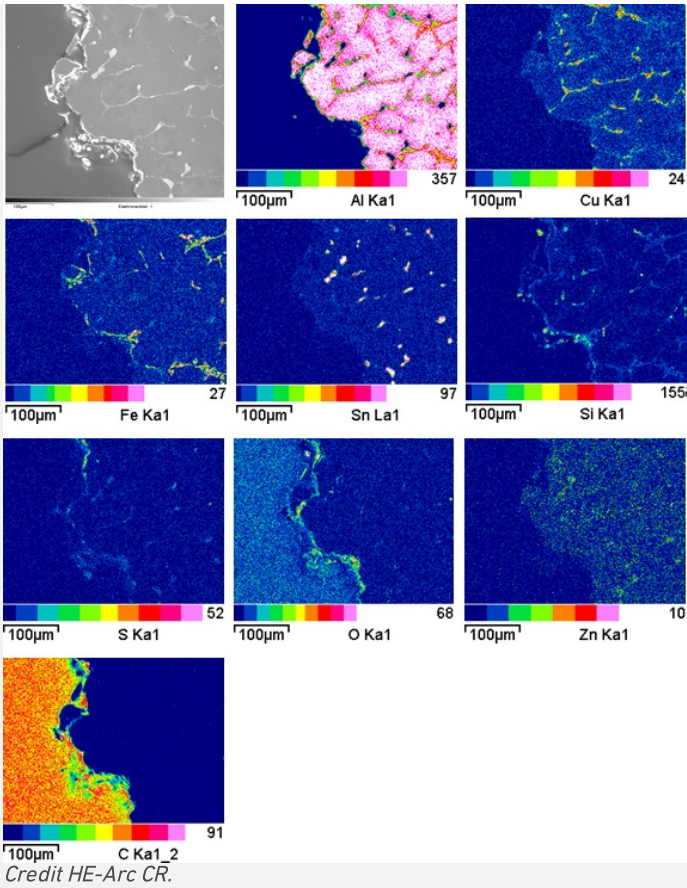
No corrosion layer can be seen on the metal surface (Figs. 3 and 7). Under polarized light small white and brown particles are visible on the broken edge (D1, Fig. 8). Their analysis reveals the presence of silica particles surrounded by dirt (Table 2 and Fig. 9). The metal surface is covered by a thin oxygen bearing skin (CP1, Fig. 9).

Fig. 9: SEM image, BSE-mode, and elemental chemical distribution of the selected area from Fig. 8 (reversed picture, detail). Method of examination: SEM/EDS, Laboratory of Analytical Chemistry, Empa,

Although not common at the beginning of the 20<sup>th</sup>, this Al-Cu-Sn-Zn-Si cast alloy was used on the Dufaux IV plane. No corrosion layer has been found on the metal surface except adherent silica-rich particles and the thin oxidised skin typical of Al alloys. The presence of these materials can be explained by the regular maintenance of the metal, probably using silicon carbide abrasive paper.
