AIRCRAFT REAR FASTENING PLATE VHS-497 - AL ALLOY - MODERN TIMES

Artefact name Aircraft rear fastening plate VHS-497

Authors Marianne. Senn (EMPA, Dübendorf, Zurich, Switzerland) & Christian. Degriigny (HE-Arc CR, Neuchâtel, Neuchâtel, Switzerland)

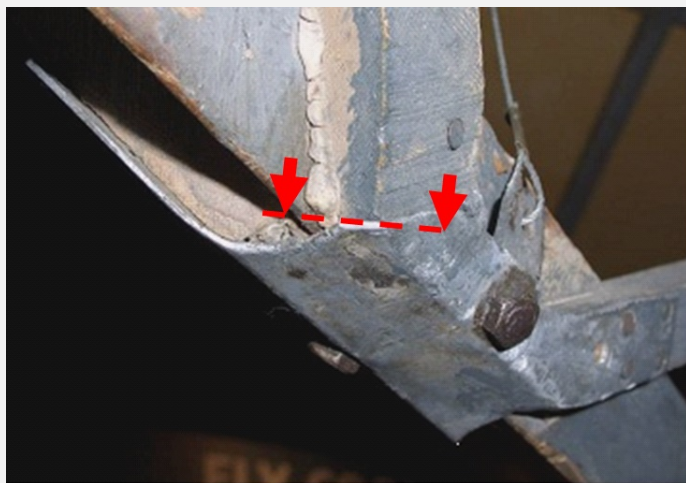
Fig. 2: Location of sampling area,

Sample cut from the corner of the fastening plate (Fig. 2). Dimensions: L = 4mm ; W = 1.2mm.

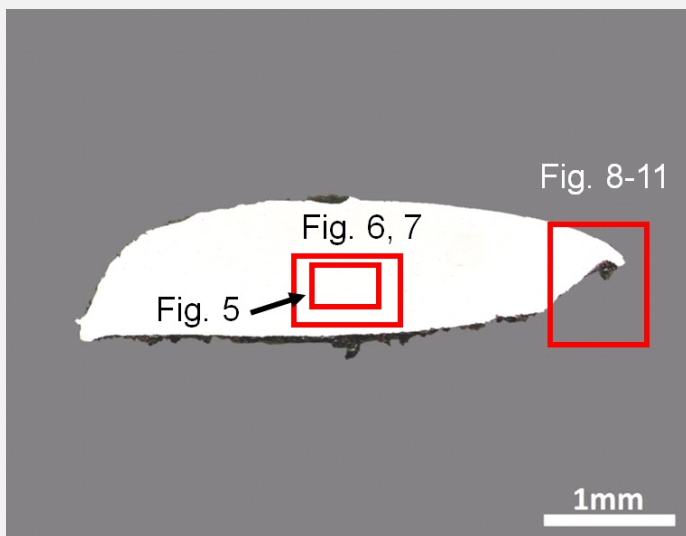
Fig. 3: Micrograph of the cross-section of the sample taken from the back fastening plate showing the location of Figs. 5 to 11,

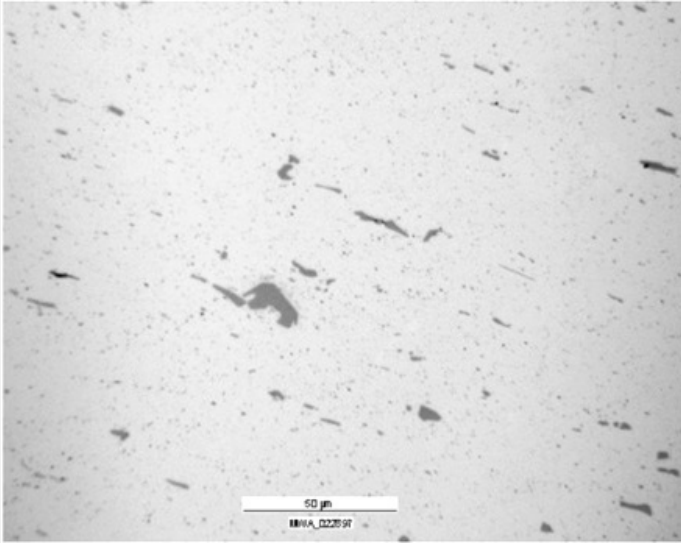
The metal is a relatively pure aluminium alloy with numerous inclusions (Table 1). From the chemical composition of the inclusions they can be interpreted as alpha-AlFeSi intermetallic compounds. In bright field we observe elongated inclusions indicating that the metal was rolled (Fig. 5). The alloy composition is similar to an unalloyed primary aluminium (Al content between 99 and 99.8 mass%). The O content reflects the immediate oxidation of the metal and is not part of the alloy. After etching the organisation of inclusions in rows is more easily seen (Fig. 6). The SEM image shows large grains formed after annealing (Fig. 7). The average hardness of the metal is HV1 40.

Fig. 5: Micrograph of the metal sample from Fig. 3 (detail), unetched, bright field. The metal matrix is in white, the elongated inclusions in grey,

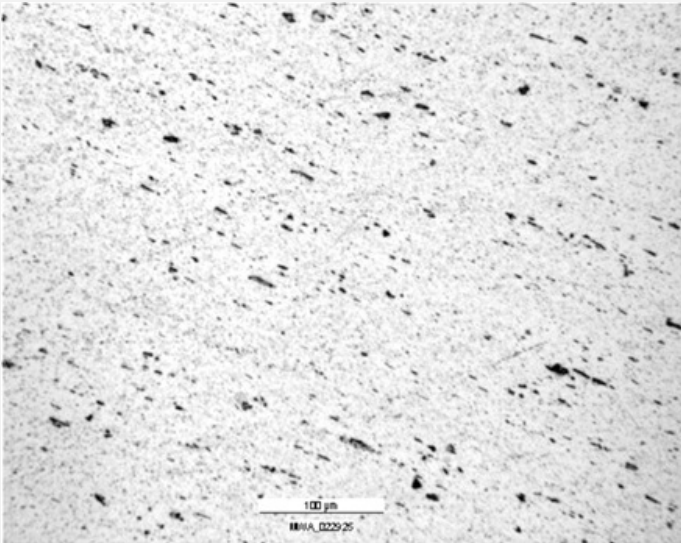
Fig. 6: Micrograph of the metal sample from Fig. 3 (detail), etched, bright field. The metal matrix is in white, the elongated inclusions in dark-grey and black,

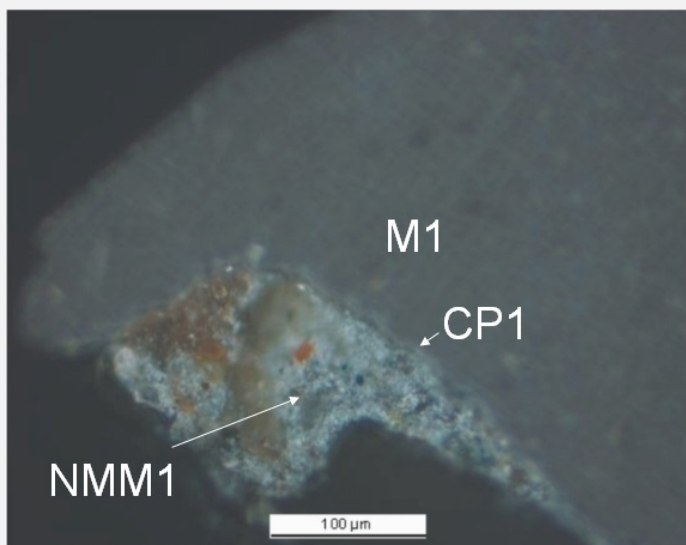
The metal is covered by a very thin corrosion layer (CP1). In addition to this, locally thicker adhering materials can be observed (NMM1, appearing as dark-grey area in Fig. 8). Under polarized light, they appear blue-brown (Fig. 9). Analysis by SEM-EDS indicates that the metal is, as expected, covered by a very thin Al and O-rich layer whereas the particles in the adherent material contain C, O, Si, Ca, Fe, Zn, S and even Ti (Figs. 10 and 11). The location of the adherent material and the presence of both Zn and Ti suggest that it is a residue of a paint coating.

Fig. 9: Micrograph (same as Fig. 8) and corresponding to the stratigraphy of Fig. 4, unetched, polarised light. We observe in grey the metal matrix and blue-brown the adhering material,

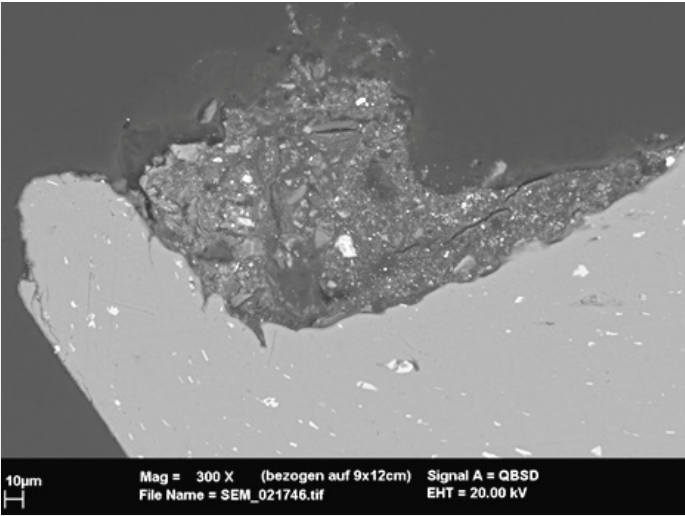
Fig. 10: SEM image (same as Fig. 8, inverted picture, detail), BSE-mode, unetched,
