AIRCRAFT REAR FASTENING PLATE VHS-497 – AL ALLOY – MODERN TIMES

Artefact name	Aircraft rear fastening plate VHS-497
Authors	Marianne. Senn (EMPA, Dübendorf, Zurich, Switzerland) & Christian. Degrieny (HE-Arc CR, Neuchâtel, Neuchâtel, Switzerland)
Url	/artefacts/511/

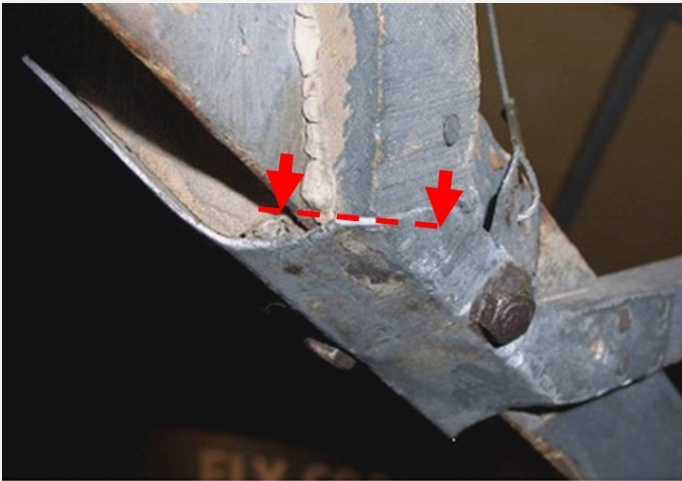
Fig. 2: Location of sampling area,

Sample cut from the corner of the fastening plate (Fig. 2). Dimensions: L = 4mm ; W = 1.2mm.

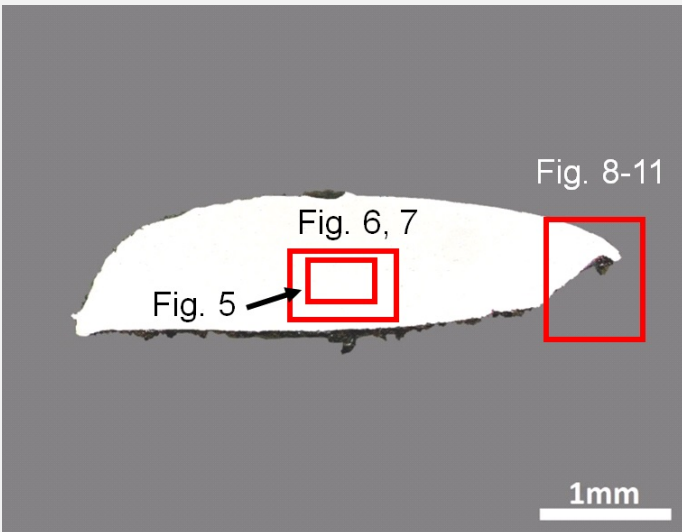
Fig. 3: Micrograph of the cross-section of the sample taken from the back fastening plate showing the location of Figs. 5 to 11,

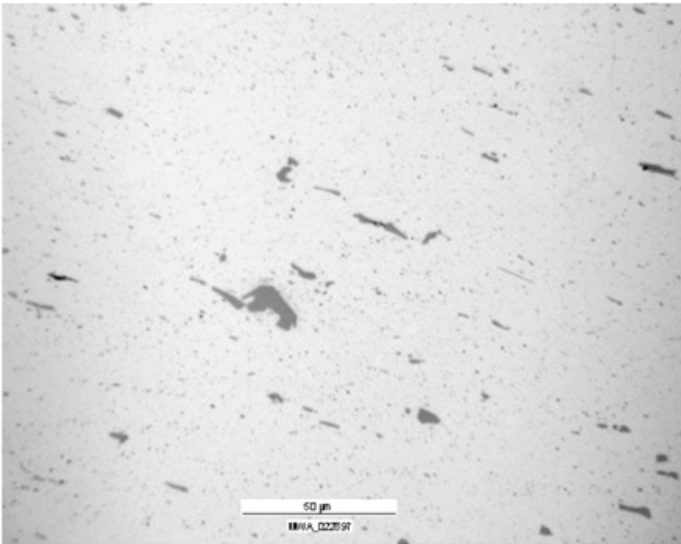
The metal is a relatively pure aluminium alloy with numerous inclusions (Table 1). From the chemical composition of the inclusions they can be interpreted as alpha-AlFeSi intermetallic compounds. In bright field we observe elongated inclusions indicating that the metal was rolled (Fig. 5). The alloy composition is similar to an unalloyed primary aluminium (Al content between 99 and 99.8 mass%). The O content reflects the immediate oxidation of the metal and is not part of the alloy. After etching the organisation of inclusions in rows is more easily seen (Fig. 6). The SEM image shows large grains formed after annealing (Fig. 7). The average hardness of the metal is HV1 40.

Fig. 5: Micrograph of the metal sample from Fig. 3 (detail), unetched, bright field. The metal matrix is in white, the elongated inclusions in grey.
