AIRCRAFT REAR FASTENING PLATE VHS-497 – AL ALLOY – MODERN TIMES

Artefact name Aircraft rear fastening plate VHS-497

Authors Marianne. Senn (EMPA, Dübendorf, Zurich, Switzerland) & Christian. Degrieny (HE-Arc CR, Neuchâtel, Neuchâtel, Switzerland)

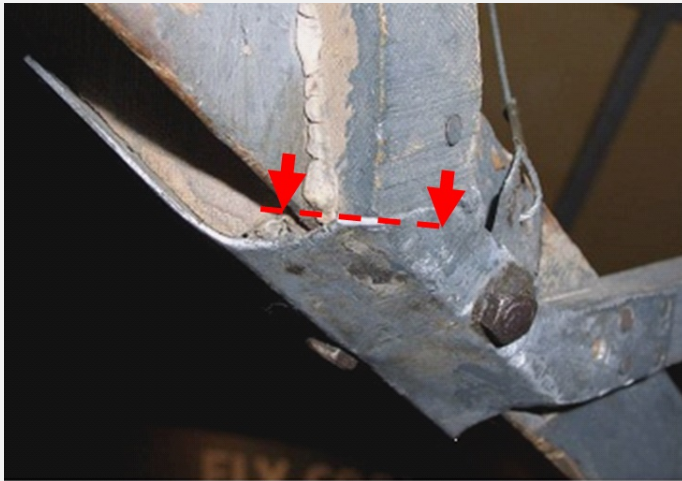
Fig. 2: Location of sampling area.

Sample cut from the corner of the fastening plate (Fig. 2). Dimensions: L = 4mm ; W = 1.2mm.

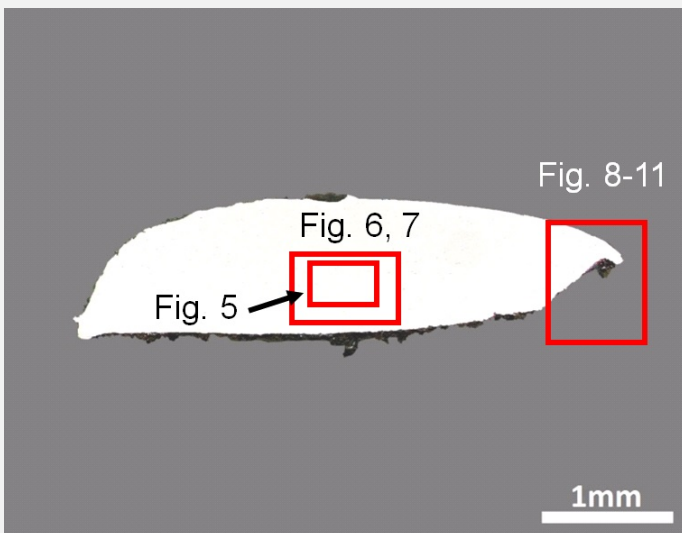
Fig. 3: Micrograph of the cross-section of the sample taken from the back fastening plate showing the location of Figs. 5 to 11,
