AIRCRAFT REAR FASTENING PLATE VHS-497 – AL ALLOY – MODERN TIMES

Artefact name Aircraft rear fastening plate VHS-497

Authors Marianne. Senn (EMPA, Dübendorf, Zurich, Switzerland) & Christian. Degrieny (HE-Arc CR, Neuchâtel, Neuchâtel, Switzerland)

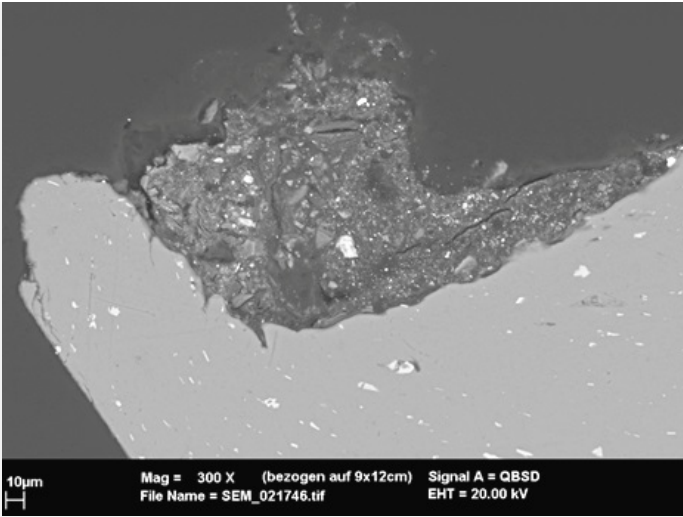
Fig. 10: SEM image (same as Fig. 8, inverted picture, detail), BSE-mode, unetched,

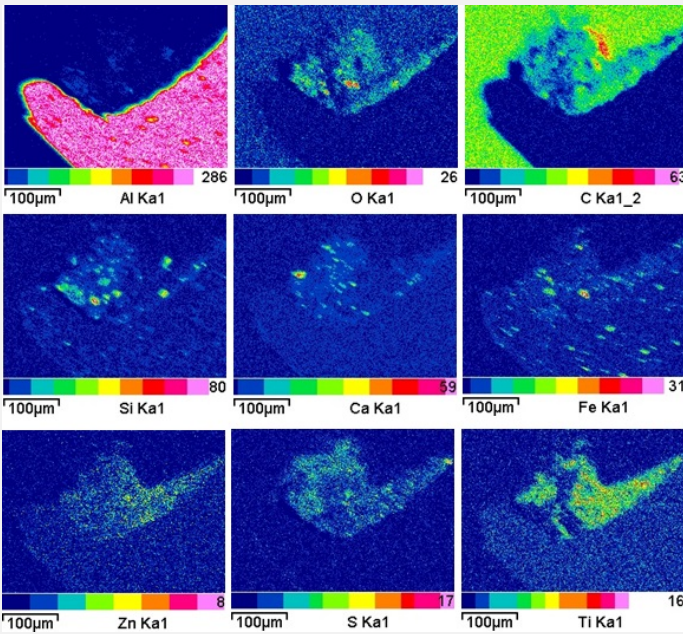
Fig. 11: Elemental chemical distribution of the selected area from Fig. 10. Method of examination: SEM/EDS, Laboratory of Analytical Chemistry, Empa,
