TANG FRAGMENT OF A KNIFE HR-6246 - TIN BRONZE - LATE BRONZE AGE - SWITZERLAND

Artefact name	Tang fragment of a knife HR-6246
Authors	Marianne. Senn (EMPA, Dübendorf, Zurich, Switzerland) & Christian. Degrigny (HE-Arc CR, Neuchâtel, Neuchâtel, Switzerland)
Url	/artefacts/516/

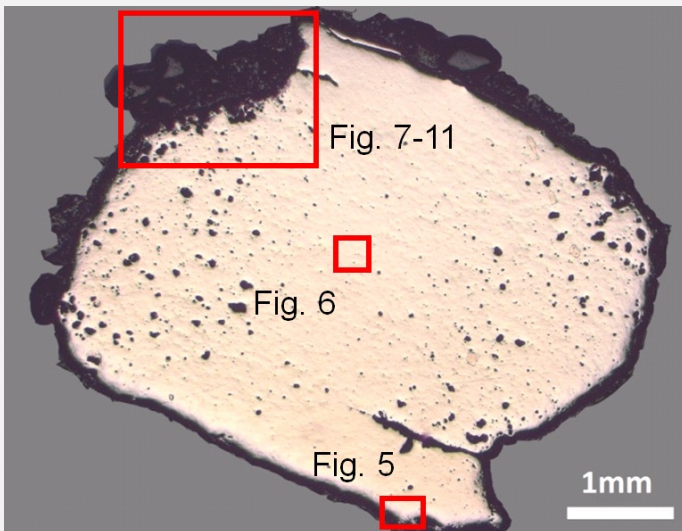
Fig. 3: Micrograph of the cross-section of the sample taken from the tang fragment showing the location of Figs. 5 to 11,

The cross-section corresponds to a lateral cut (Fig. 2). The surface is covered with a thick corrosion crust (Fig. 3).

The remaining metal is a tin bronze (Table 1) with high porosity and large cracks both on the left and right edges of the sample (Fig. 3). The metal contains small, elongated copper sulphide (Table 2) and Pb inclusions that are oriented parallel to the cracks. Near the metal surface, slip lines are outlined by the development of intergranular corrosion (Fig. 5). The etched metal shows small, elongated grains with slip lines (Fig. 6). Annealing is visible in areas near the surface. The average hardness of the metal is HV1 145, but significant variations are observed, depending on where the measurements are taken.

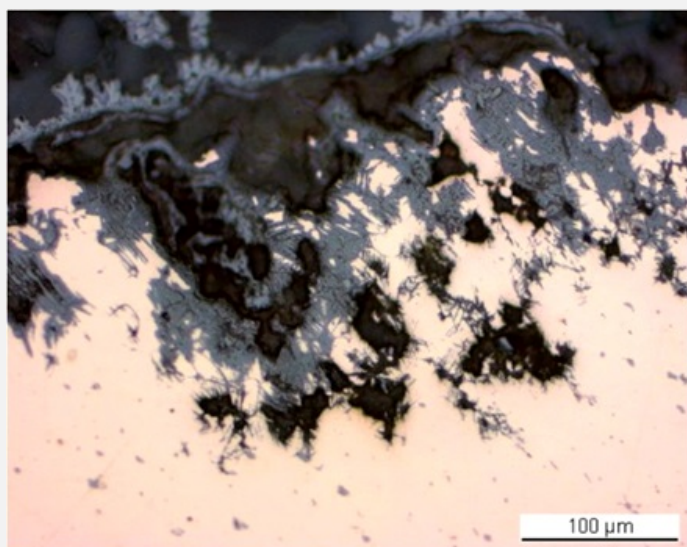
Fig. 5: Micrograph of the metal sample from Fig. 3 (inverted and reversed picture, detail), unetched, bright field. Corrosion products are in dark-grey whereas the metal is in pink. Slip lines are outlined by the development of intergranular corrosion,

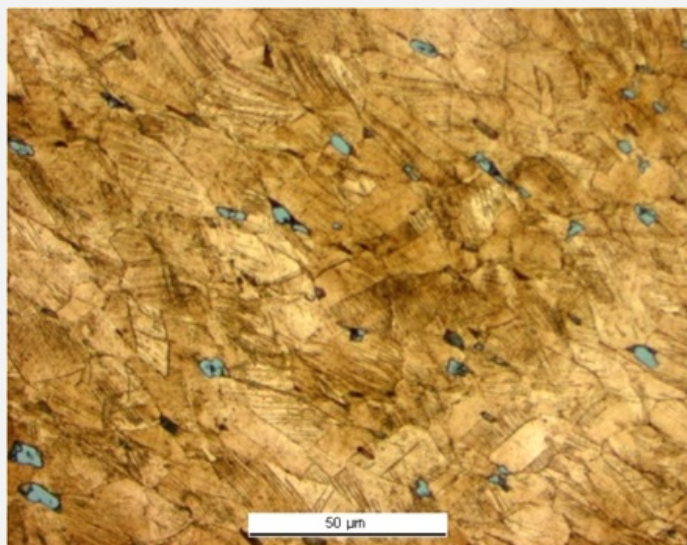
Fig. 6: Micrograph of the metal sample from Fig. 3 (detail), etched, bright field. We observe elongated grains with slip lines as well as grey copper sulphide inclusions,

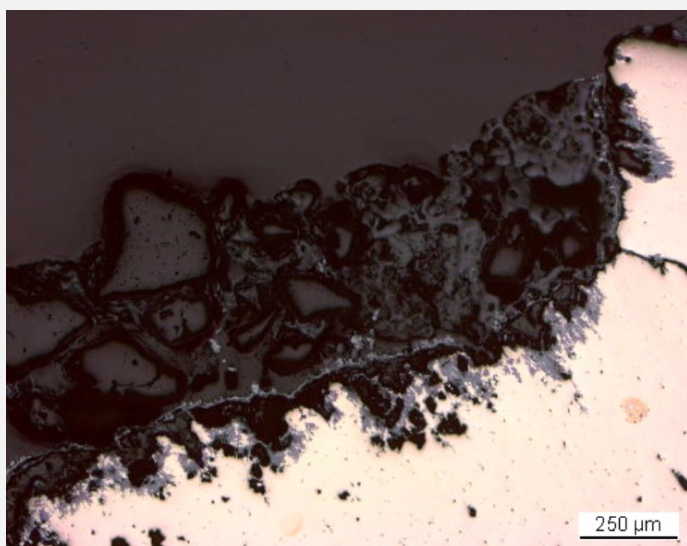
The corrosion crust has a thickness between 0.1mm and 0.7mm (Fig. 3). In bright field (Fig. 7), one can observe that the metal has been replaced by light-grey corrosion products. Adjacent to the metal is a thick, heterogeneous, dark-grey layer with a band of light-grey corrosion products. In polarised light (Fig. 8), all corrosion products which were previously light-grey appear brown-orange, the dark-grey layer turquoise. The elemental chemical distribution of the SEM images (Figs. 9 and 10) reveals that the inner corrosion products are Sn-rich whereas the adjacent band is Cu and S-rich (Fig. 11). The outer layer contains large inclusions (quartz and others, Si, Al and Na, see Figs. 10-11) and is most probably composed of malachite/ $\text{Cu}_2(\text{CO}_3)(\text{OH})_2$ (only Cu and O are detected – Fig. 11). S is distributed throughout this layer. XRD analyses indicated the presence of posnjakite/ $\text{Cu}_4\text{SO}_4(\text{OH})_6\text{H}_2\text{O}$, chalcocite/ Cu_2S and djurleite/ $\text{Cu}_{1.93}\text{S}$ (Schweizer 1994).

Fig. 7: Micrograph of the metal sample from Fig. 3 (detail), unetched, bright field. The inner light-grey corrosion products extend into the metal surface (in pink) and appear as a line within the dark-grey corrosion layer,

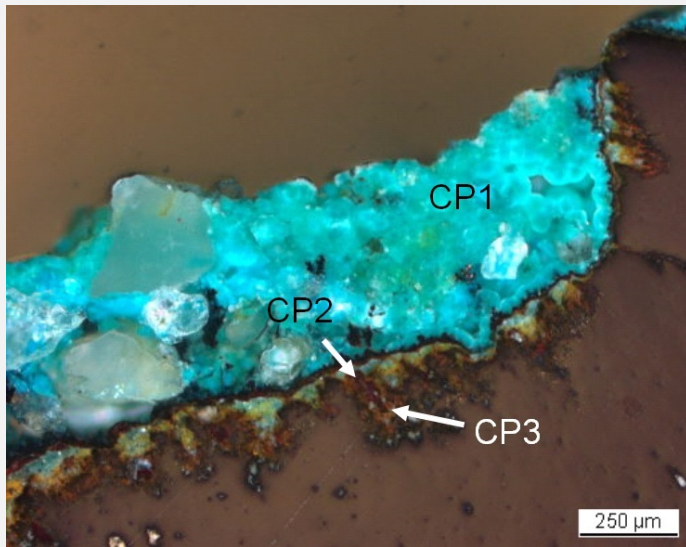
Fig. 8: Micrograph similar to Fig. 7 and corresponding to the stratigraphy of Fig. 4, polarized light. One can see that large mineral features are incorporated only in the corrosion layers above the brown-orange corrosion band,

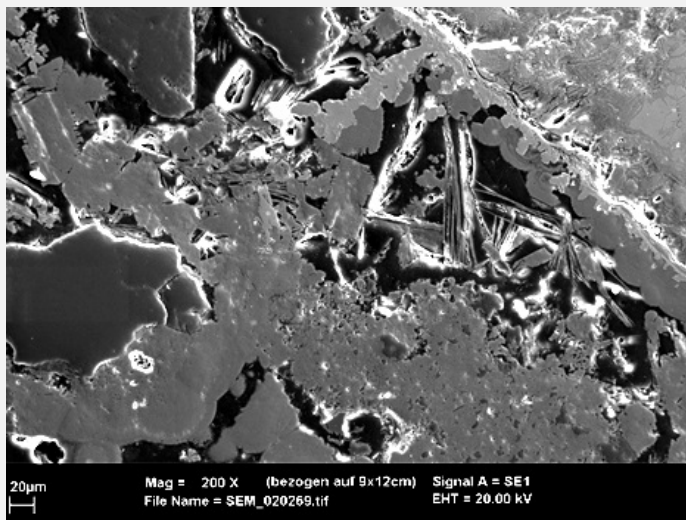
Fig. 9: SEM image (detail of Fig. 7), SE-mode. From bottom to top right: the thick, porous outer corrosion layer, the light-grey band and the remaining metal,

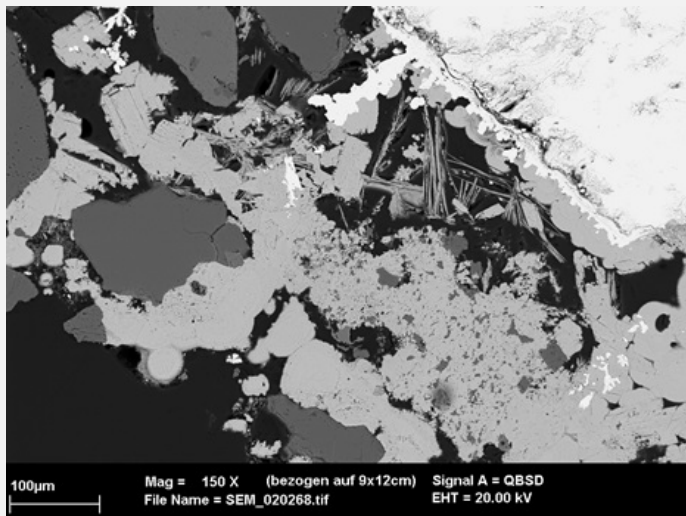
Fig. 10: SEM image, similar to Fig. 9, BSE-mode,

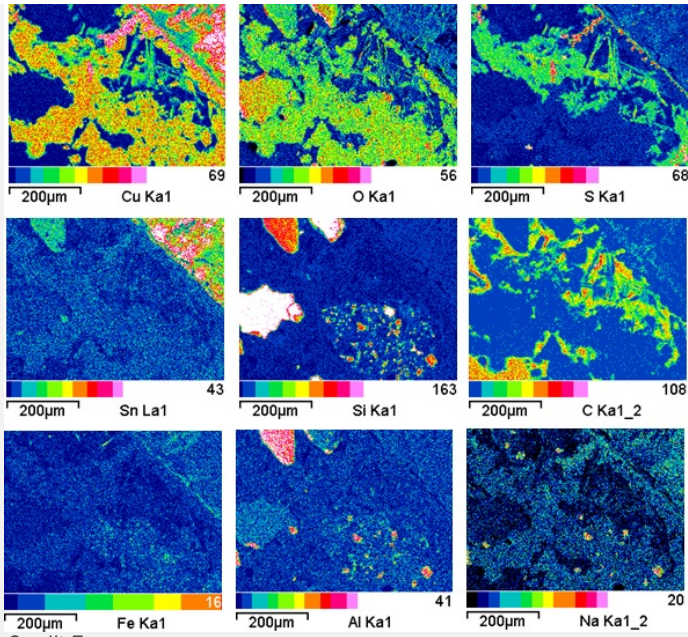
Fig. 11: EDS elemental chemical distribution of the SEM image of Fig. 9. Method of examination: SEM/EDS, Laboratory of Analytical Chemistry, Empa,

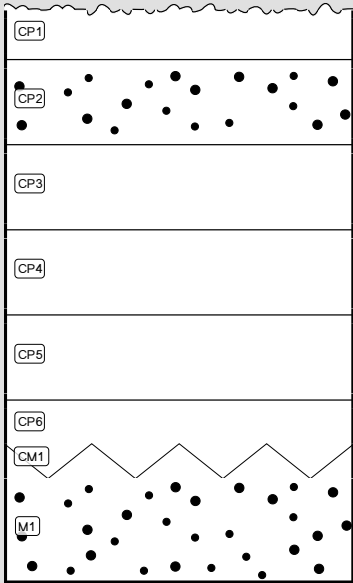
Fig. 4: Stratigraphic representation of the sample taken from the tang fragment in cross-section using the MiCorr application. The characteristics of the strata are only accessible by clicking on the drawing that redirects you to the search tool by stratigraphy representation. This representation can be compared to Fig. 8, Credit HE-Arc CR.
