COFFEE FILTER – AL ALLOY – MODERN TIMES – FRANCE

Artefact name Coffee filter

Authors Christian. Degriigny (HE-Arc CR, Neuchâtel, Neuchâtel, Switzerland)

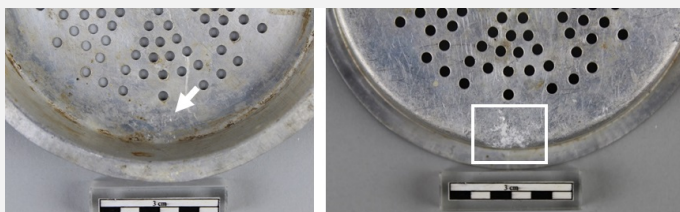
Fig. 2: Detail of the front and back sides of the coffee filter showing the location of Fig. 3,

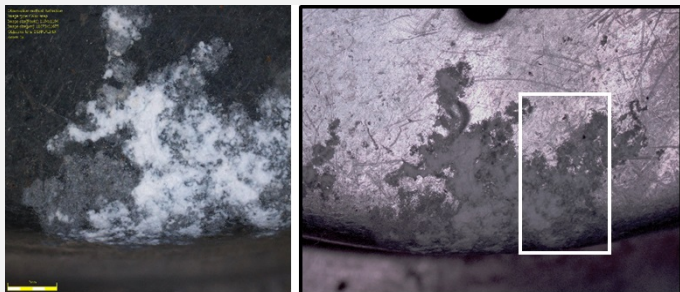
Fig. 3: Detail of the back side of the coffee filter showing the location of the sampling area,

| Description of sample | Sample cut from the back side of the coffee filter (Fig. 3). |

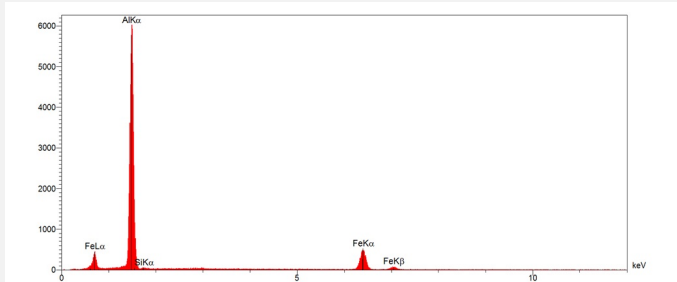
Fig. 7: EDS spectrum of the elongated inclusions of Fig. 6,
