COFFEE FILTER – AL ALLOY – MODERN TIMES – FRANCE

Artefact name Coffee filter

Authors Christian. Degriigny (HE-Arc CR, Neuchâtel, Neuchâtel, Switzerland)

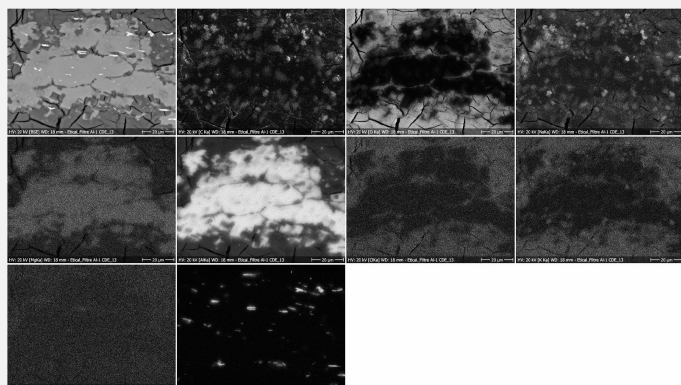
Fig. 11: SEM image, BSE-mode, and elemental chemical distribution of the selected area of Fig. 9. Method of examination: SEM-EDS, Lab of Electronic Microscopy and Microanalysis, IMA (Néode), HEI Arc,
