# COFFEE FILTER – AL ALLOY – MODERN TIMES – FRANCE

**Artefact name** Coffee filter

**Authors** Christian. Degriigny (HE-Arc CR, Neuchâtel, Neuchâtel, Switzerland)

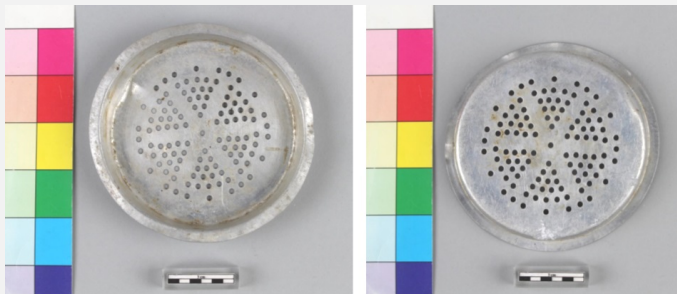
Fig. 1: Front and back sides of a coffee filter,

<b>Description of the artefact</b>	Coffee filter with traces of use (deposits, deformation) and presence of local filiform corrosion (Fig. 1). Dimensions: ø.ext. = 10cm.
<b>Type of artefact</b>	Household implement
<b>Origin</b>	Château de Germolles, Mellecey, Bourgogne, France
<b>Recovering date</b>	Unknown
<b>Chronology category</b>	Modern Times
<b>chronology tpq</b>	<input type="text" value="1960"/> A.D. ∨
<b>chronology taq</b>	<input type="text" value="2000"/> A.D. ∨
<b>Chronology comment</b>	20th century
<b>Burial conditions / environment</b>	Outdoor atmosphere
<b>Artefact location</b>	Château de Germolles, Mellecey, Bourgogne
<b>Owner</b>	Château de Germolles, Mellecey, Bourgogne

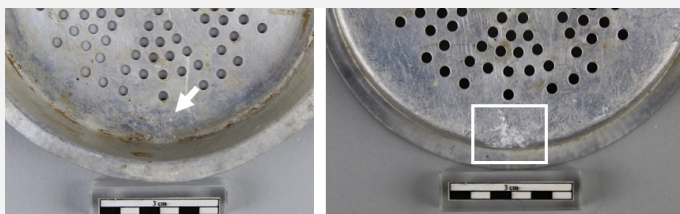
Fig. 2: Detail of the front and back sides of the coffee filter showing the location of Fig. 3,

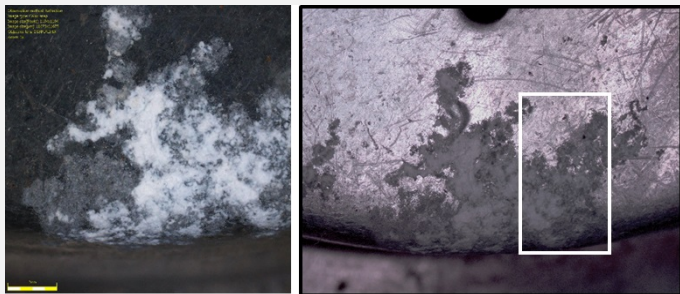
Fig. 3: Detail of the back side of the coffee filter showing the location of the sampling area,

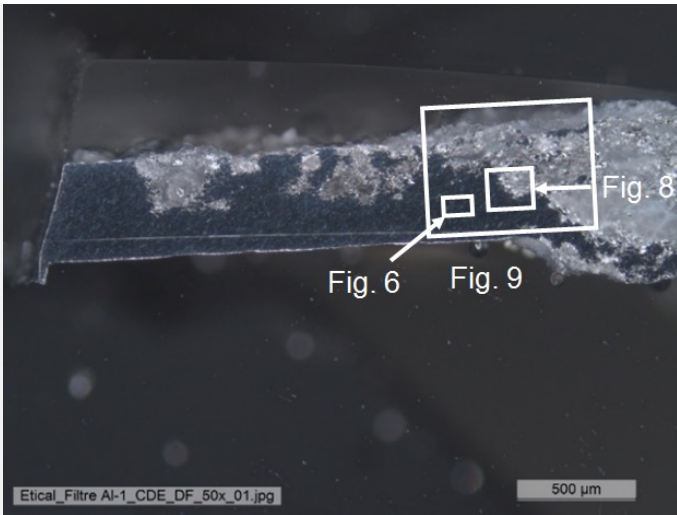
Fig. 4: Micrograph of the cross-section of the fragment sampled from the coffee filter showing the location of Figs. 6, 8 and 9, dark field,

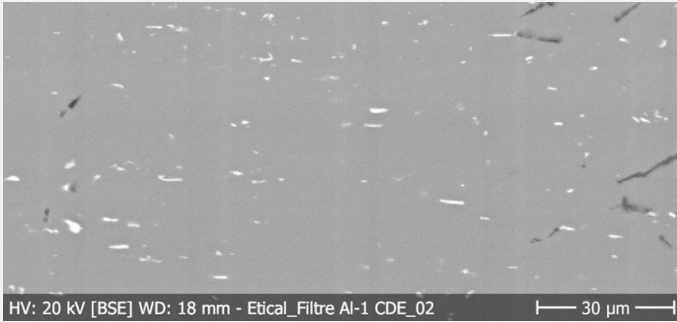
The metal is a relatively pure aluminium alloy with numerous elongated inclusions (Fig. 6). From their chemical composition they can be interpreted as Al<sub>3</sub>Fe intermetallic compounds (Fig. 7). Inter- and transgranular corrosion has

Fig. 6: SEM image of the metal sample from Fig. 4 (detail), BSE-mode. We observe the presence of numerous elongated inclusions,

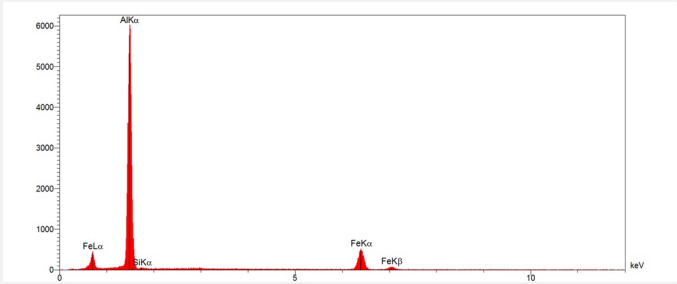
Fig. 7: EDS spectrum of the elongated inclusions of Fig. 6,

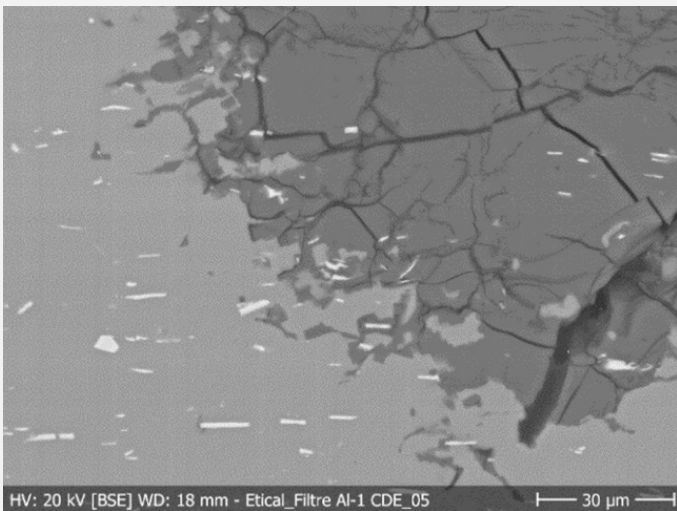
developed so extensively that some grains (not elongated) are outlined (Fig. 8).

Fig. 8: SEM image of the metal sample from Fig. 4 (detail), BSE-mode. Extensive inter- and transgranular corrosion has developed within the metal,

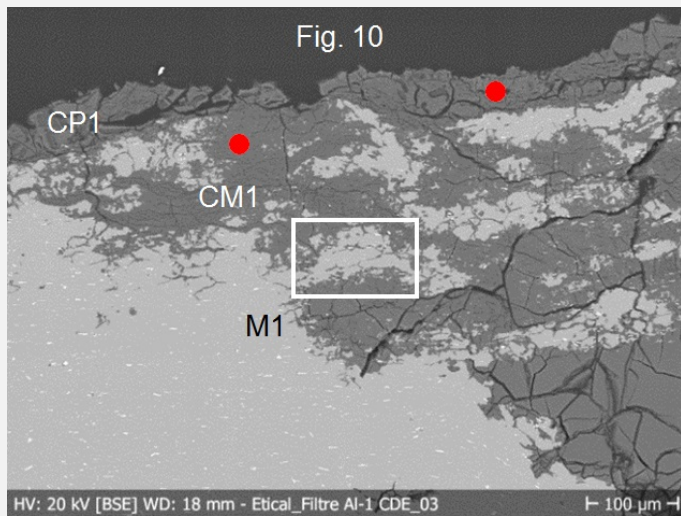
The average thickness of the corrosion layer (CP1) is about 50 micrometers, but may be thinner or thicker depending on the area. Intergranular corrosion developed locally to extend through the entire thickness of the metal. EDS-SEM

analysis indicates that the metal is, as expected, covered by a layer rich in Al and O containing chlorides (red spots on Fig. 9) and surprisingly Na (Figs. 10 and 11). Chlorides do not seem to form active corrosion. A new examination carried out after 4 months (Fig. 12) shows new forms of alteration with a local enrichment of Na, C and O ( $\text{Na}_2\text{CO}_3$ ?).

Fig. 9: SEM picture (detail of Fig. 4 with location (red spots) of EDS analyses of Fig. 10), BSE-mode. From bottom to top left: the metal (M1) in light grey, the corroded metal (CM1) and CP1. The area selected for elemental chemical distributions (Figs. 11 and 12) is marked by a rectangle,

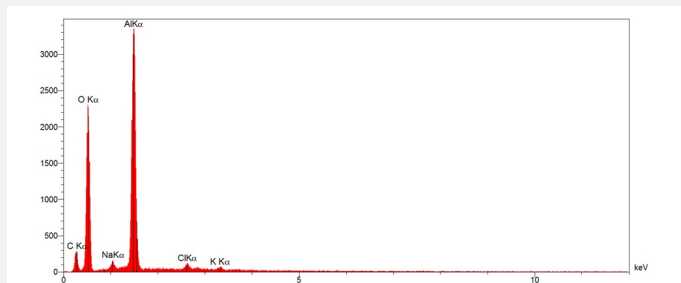
Fig. 10: EDS spectrum of red spots in Fig. 9,

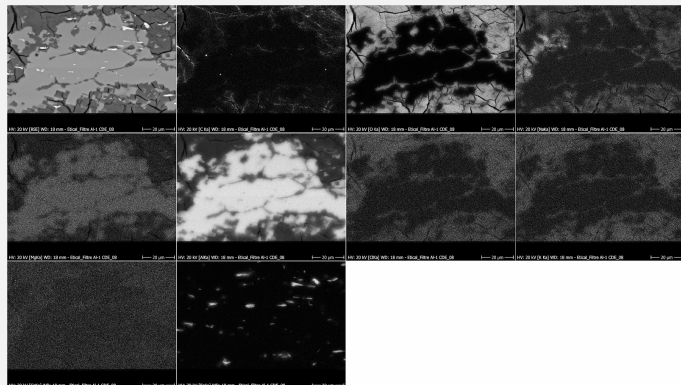
Fig. 11: SEM image, BSE-mode, and elemental chemical distribution of the selected area of Fig. 9. Method of examination: SEM-EDS, Lab of Electronic Microscopy and Microanalysis, IMA (Néode), HEI Arc,

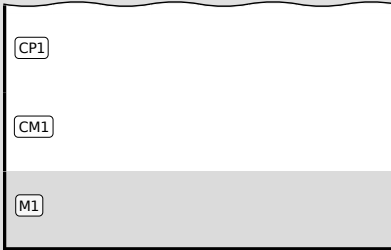
Fig. 5: Stratigraphic representation of the fragment sampled from the coffee filter in cross-section using the MiCorr application. The characteristics of the strata are only accessible by clicking on the drawing that redirects you to the search tool by stratigraphy representation. This representation can be compared to Fig. 9, Credit HE-Arc CR, C.Degrigny.
