TOWEL BAR – AL ALLOY – MODERN TIMES – FRANCE

Artefact name	Towel bar
Authors	Christian. Degriigny (HE-Arc CR, Neuchâtel, Neuchâtel, Switzerland)
Url	/artefacts/521/

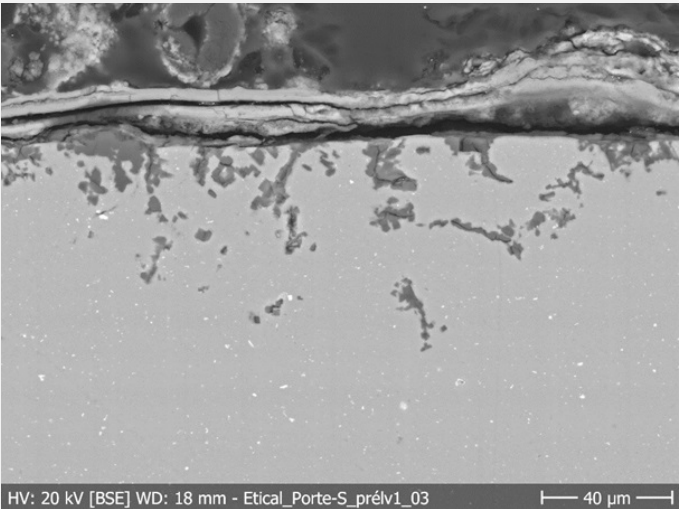
The metal is a relatively pure aluminium alloy with numerous inclusions (Fig. 5). From their chemical composition they can be interpreted as Al₃Fe intermetallic compounds (Fig. 6). Pitting corrosion as well as a start of intergranular corrosion developing locally under the deposits, outlining some of the grains (Fig. 5).

Fig. 5: SEM image of the metal sample from Fig. 3 (detail), BSE-mode. We observe the presence of numerous inclusions,

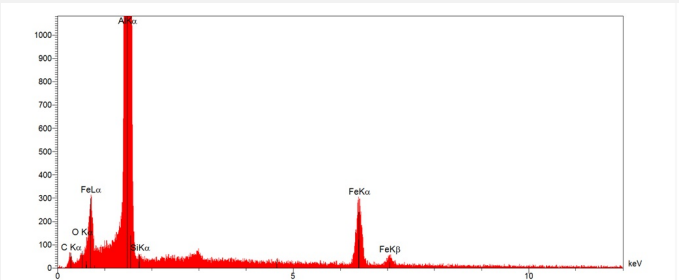
Fig. 6: EDS spectrum of the inclusions of Fig. 5,

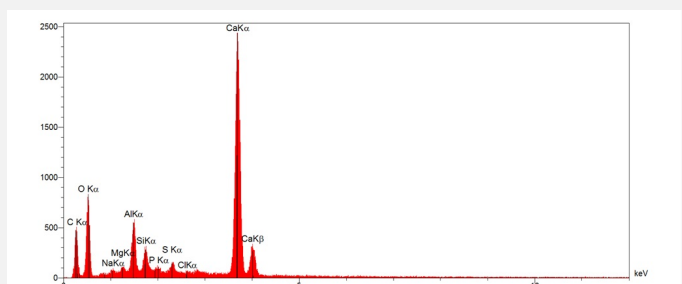
Fig. 8: EDS spectrum of area 1 of Fig. 7,

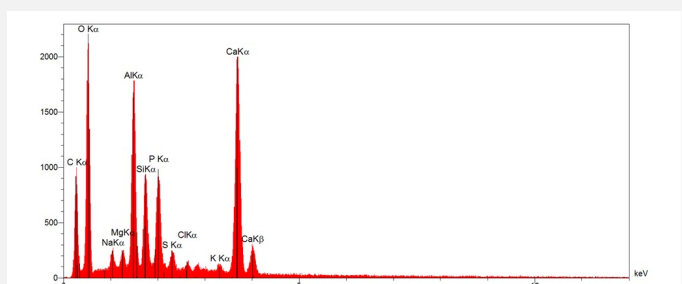
Fig. 9: EDS spectrum of area 2 of Fig. 7,

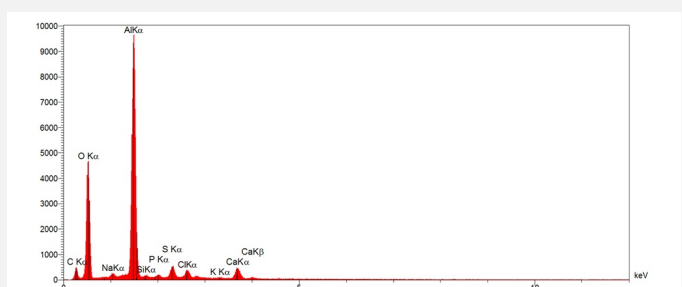
Fig. 10: EDS spectrum of area 3 of Fig. 7,

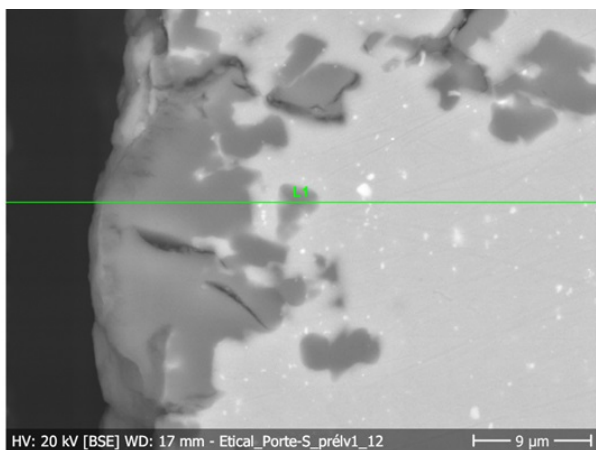
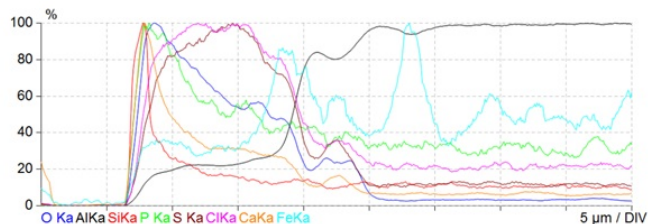
Fig. 11: EDS Linescan from CM1 to M1,

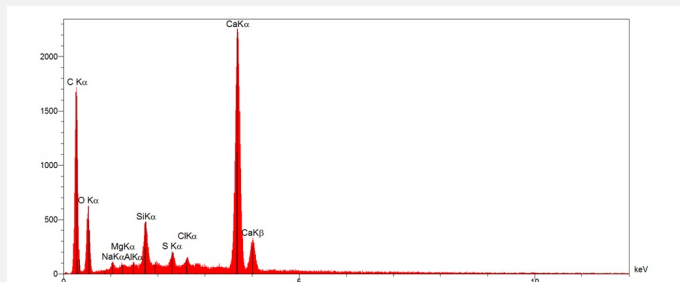
Fig. 12: EDS spectrum of area 4 of Fig. 7,

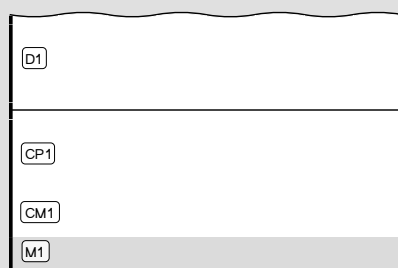
Fig. 4: Stratigraphic representation of the fragment sampled from the towel bar in cross-section using the MiCorr application. The characteristics of the strata are only accessible by clicking on the drawing that redirects you to the search tool by stratigraphy representation. This representation can be compared to Fig. 7, Credit HE-Arc CR, C.Degrigny.
