TOWEL BAR – AL ALLOY – MODERN TIMES – FRANCE

Artefact name	Towel bar
Authors	Christian. Degriigny (HE-Arc CR, Neuchâtel, Neuchâtel, Switzerland)
Url	/artefacts/521/

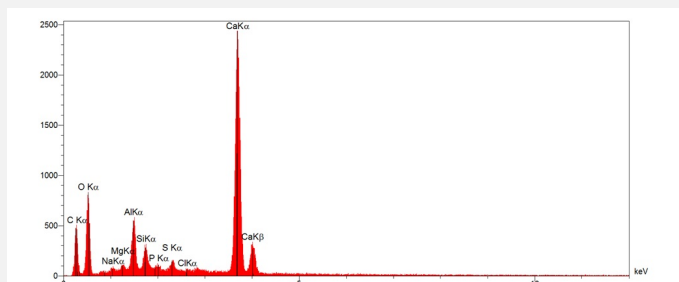
Fig. 8: EDS spectrum of area 1 of Fig. 7,

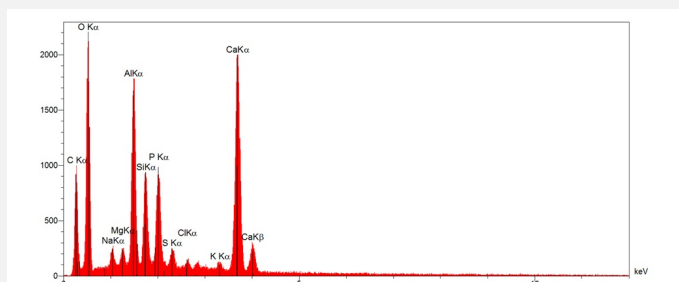
Fig. 9: EDS spectrum of area 2 of Fig. 7,

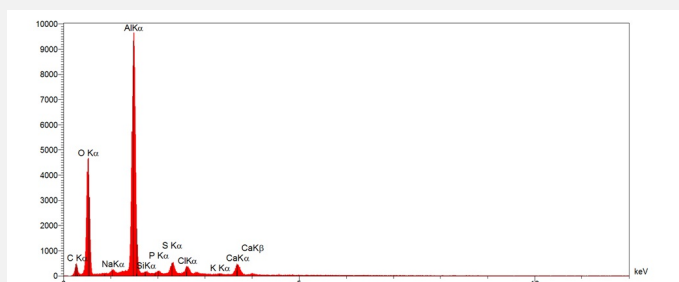
Fig. 10: EDS spectrum of area 3 of Fig. 7,

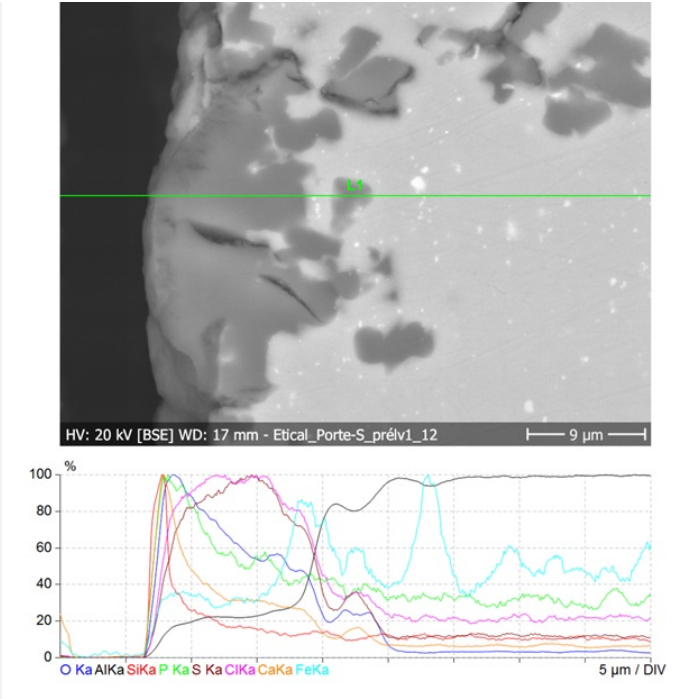
Fig. 11: EDS Linescan from CM1 to M1,

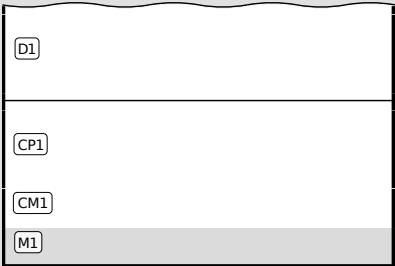
Fig. 4: Stratigraphic representation of the fragment sampled from the towel bar in cross-section using the MiCorr application. The characteristics of the strata are only accessible by clicking on the drawing that redirects you to the search tool by stratigraphy representation. This representation can be compared to Fig. 7, Credit HE-Arc CR, C.Degrigny.
