TOWEL BAR – AL ALLOY – MODERN TIMES – FRANCE

Artefact name Towel bar

Authors Christian. Degriigny (HE-Arc CR, Neuchâtel, Neuchâtel, Switzerland)

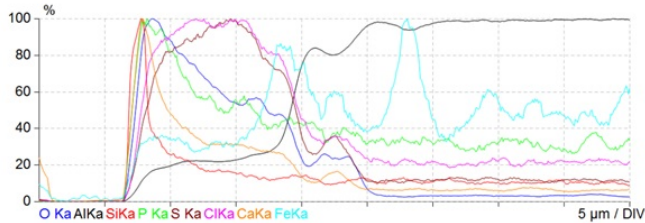
Fig. 11: EDS Linescan from CM1 to M1,

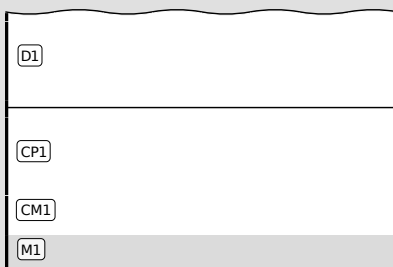
Fig. 4: Stratigraphic representation of the fragment sampled from the towel bar in cross-section using the MiCorr application. The characteristics of the strata are only accessible by clicking on the drawing that redirects you to the search tool by stratigraphy representation. This representation can be compared to Fig. 7, Credit HE-Arc CR, C.Degrigny.
