# SHOE NAIL 2637 1370.B. – HYPOEUTECTOID STEEL – ROMAN TIMES – SWITZERLAND

<b>Artefact name</b>	Shoe nail 2637 1370.B.
<b>Authors</b>	Christian. Degriigny (HE-Arc CR, Neuchâtel, Neuchâtel, Switzerland) & Valentin. Boissonnas (HE-Arc CR, Neuchâtel, Neuchâtel, Switzerland) & Vincent Chappuis. (HE-Arc CR, Neuchâtel, Neuchâtel, Switzerland)
<b>Url</b>	/artefacts/523/

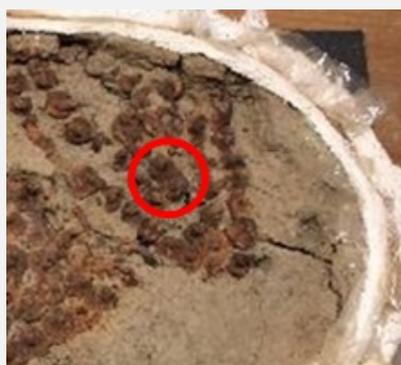
Fig. 2: Incomplete shoe from which the nail was sampled (in red circle),

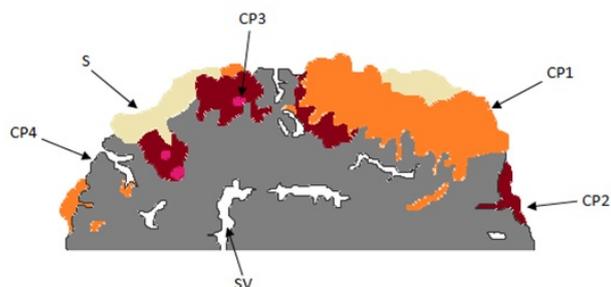
S = compact sand-clay soil.  
 CP1 = powdery soil, orange-coloured by corrosion products.  
 CP2 = dark-red corrosion crust, breaks into bits.  
 CP3 = vivid pink-red and globular corrosion products.  
 CP4 = dark grey to black and very hard corrosion products, results in an dark-orange powder when scratched.  
 SV = structural void near the center of the cross section, seems to draw a square shape.

Fig. 3: Preliminary stratigraphy of the corrosion layers based on the observation of a broken nail,

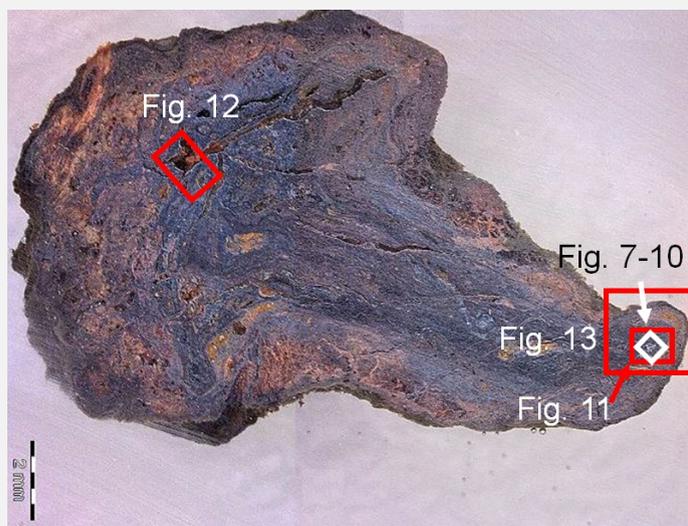
Fig. 4: Micrograph of the cross-section of the nail showing the location of figs. 7 to 13,

The metal is heavily corroded and the thickness of the corrosion crust is irregular, varying from 0.8 to 3.8mm, with an average of about 2mm. The corrosion has replaced most of the metal (Fig. 4). Between corrosion layers the limit of the original structure is visible. Some leather fibers seem to be preserved as pseudomorphic structures in voids of the metal core (POM1, Figs. 11 and 12). The carbon mapping (Fig.13) shows the presence of carbon in these areas. This can also be due to the penetration of the mounting resin in the cracks.

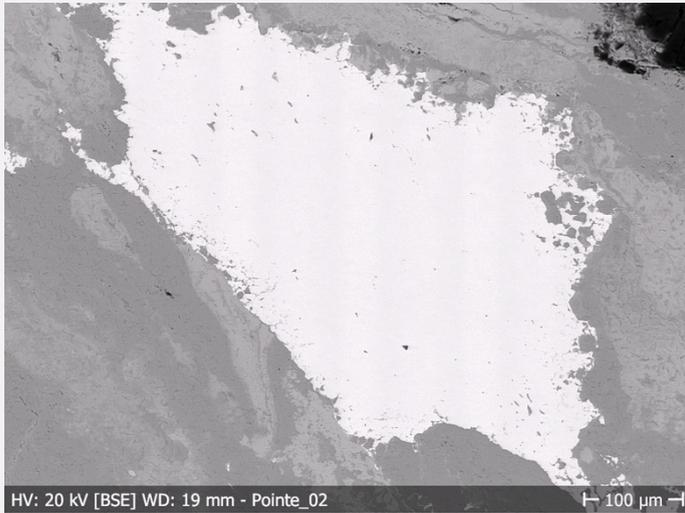
The remaining metal is an hypoeutectoid steel (Fig. 7 and 8), containing Fe, Si and O slags inclusions (possibly fayalite  $\text{FeO}, \text{SiO}_2$ ), and consisting of less than 1% of the total volume of the highly mineralized nail. After Nital etching, it shows intergranular corrosion on one of its sides (Figs. 9 and 10).

Fig. 7: SEM, BSE-mode picture of remaining metal,

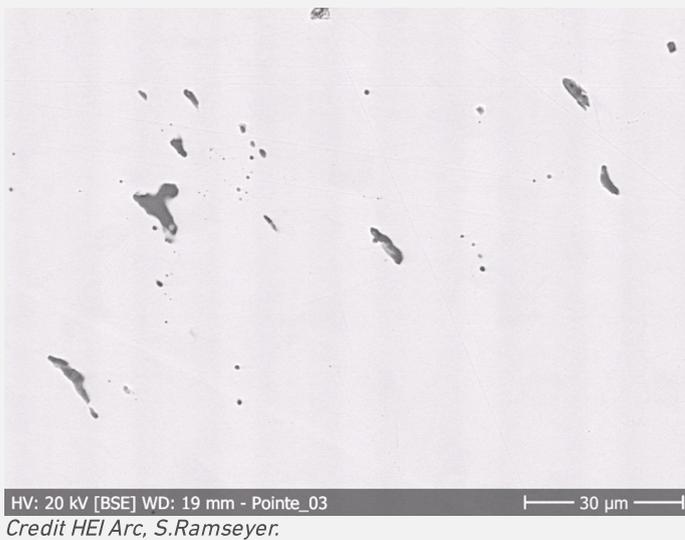
Fig. 8: SEM, BSE-mode picture of inclusions in remaining metal,

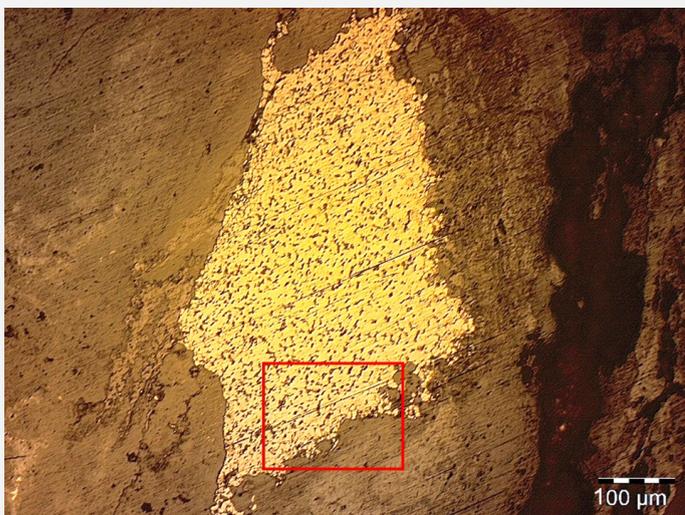
Fig. 9: Micrograph of the metal sample from Fig. 7 (detail, rotated 90°), Nital etched, bright field,

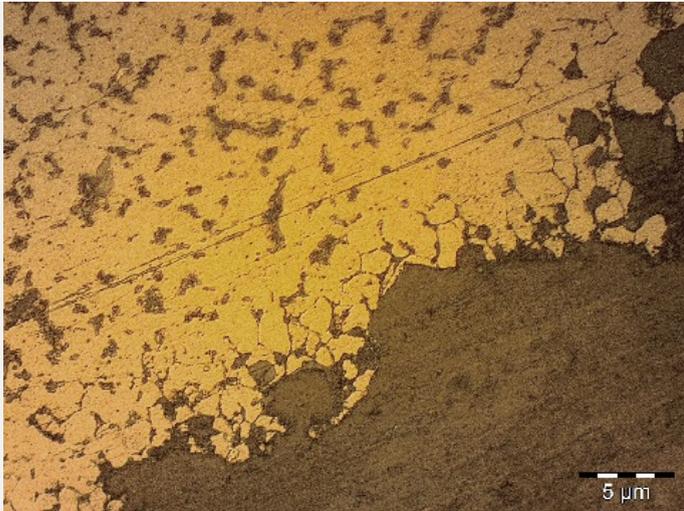
Fig. 10: Micrograph of the selected area of Fig. 9, Nital etched with no clear grain structure, bright field, Intergranular corrosion and grey phase (perlite?) are observed,

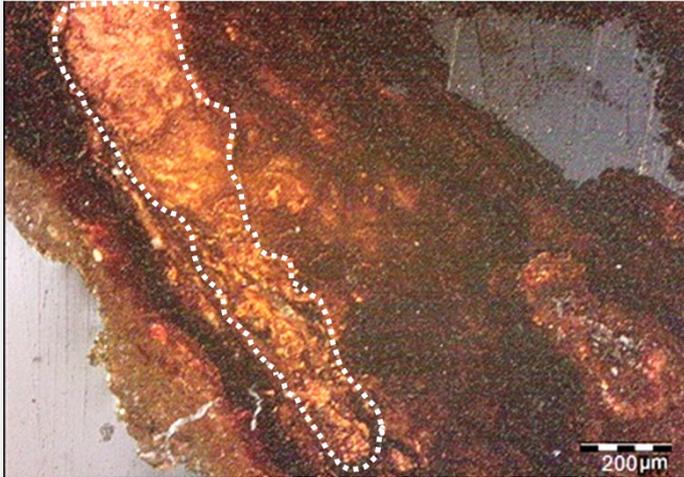
Fig. 11: Micrograph of the metal sample, bright field. The delimited zone shows what could be leather pseudomorphic fibers filling a void,

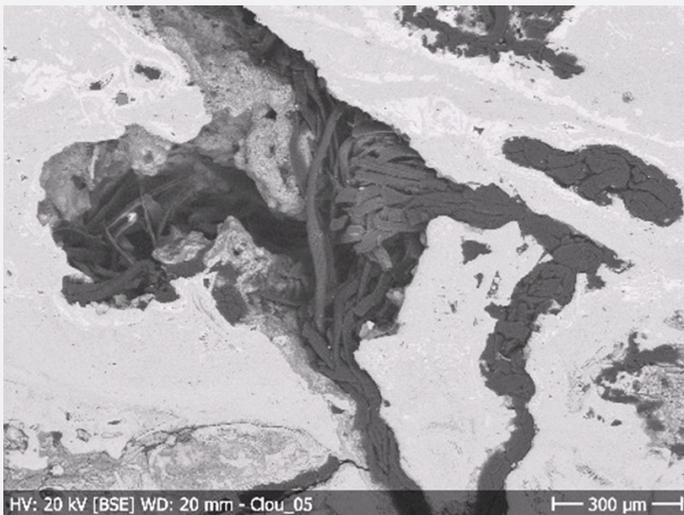
Fig. 12: Micrograph (SEM - BSE-mode) of another void filled with fibers in the head of the nail,

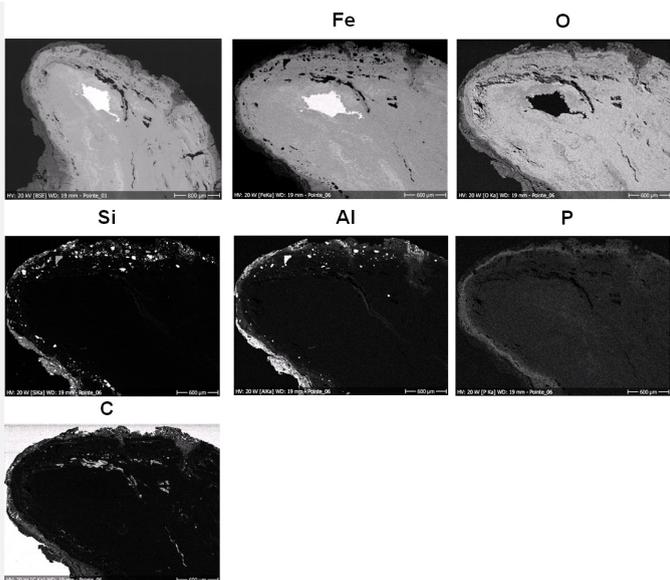
Si, Al, P and K can be considered external markers, helping to determine the limit of the original surface (Fig. 13 and Table 1). The outer layer of corrosion products (CP1-3) ranges from dark grey to orange in bright field and contains less O and Fe on its borders than the inner layer (CP4-5, Figs. 4 and 13, Table 1). The SEM pictures show a marbling appearance of the inner corrosion layer (CP5). Cl and S do not seem to be present in the sampled nail.

Fig. 13: Elemental chemical distribution of the selected area from Fig. 4 (90° counter-clockwise rotated). SEM-EDS,

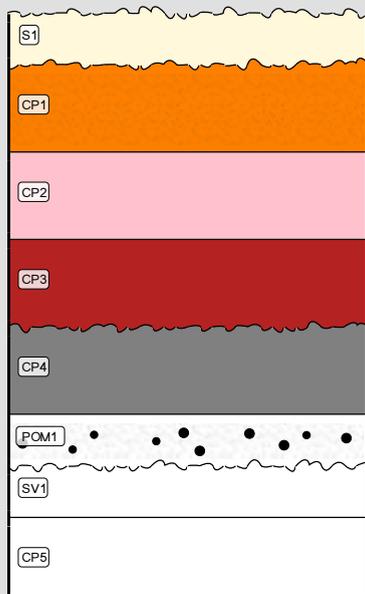
Fig. 5: Stratigraphic representation of the nail in cross-section using the MiCorr application. The characteristics of the strata are only accessible by clicking on the drawing that redirects you to the search tool by stratigraphy representation. This representation can be compared to Fig. 14, Credit HE-Arc CR, V.Chappuis.

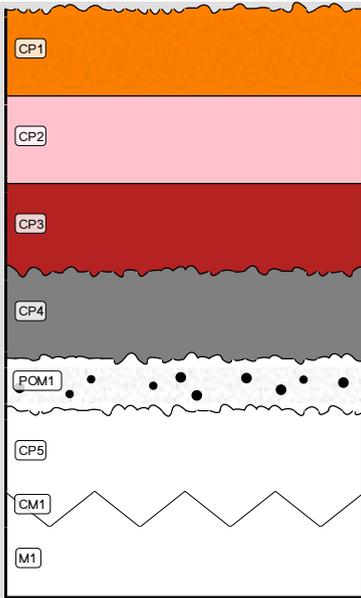
Fig. 6: Stratigraphic representation of the nail in cross-section using the MiCorr application. The characteristics of the strata are only accessible by clicking on the drawing that redirects you to the search tool by stratigraphy representation. This representation can be compared to Fig. 14, Credit HE-Arc CR, V.Chappuis.

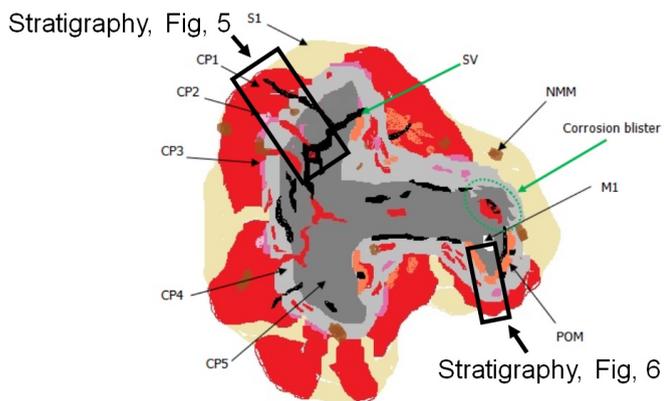
The schematic representation of corrosion layers of Fig. 3 integrating additional information based on the analyses carried out is given in Fig. 14. The following strata were identified:

Fig. 14: Improved stratigraphic representation of the nail from visual observations and analyses and visualization of the two stratigraphies of Figs. 5 and 6,
