SHOE NAIL 2637 1370.B. – HYPOEUTECTOID STEEL – ROMAN TIMES – SWITZERLAND

Artefact name Shoe nail 2637 1370.B.

Authors Christian. Degryny (HE-Arc CR, Neuchâtel, Neuchâtel, Switzerland) & Valentin. Boissonnas (HE-Arc CR, Neuchâtel, Neuchâtel, Switzerland) & Vincent Chappuis. (HE-Arc CR, Neuchâtel, Neuchâtel, Switzerland)

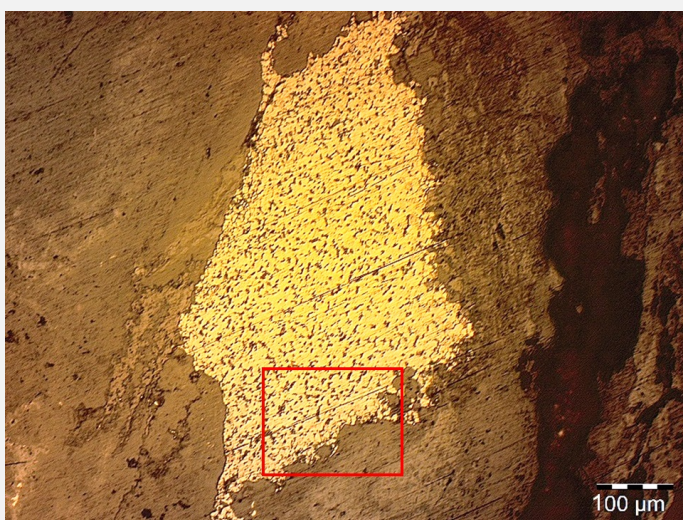
Fig. 9: Micrograph of the metal sample from Fig. 7 (detail, rotated 90°), Nital etched, bright field,

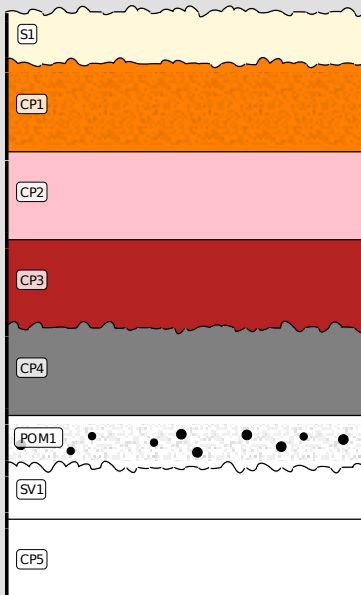
Fig. 5: Stratigraphic representation of the nail in cross-section using the MiCorr application. The characteristics of the strata are only accessible by clicking on the drawing that redirects you to the search tool by stratigraphy representation. This representation can be compared to Fig. 14, Credit HE-Arc CR, V.Chappuis.

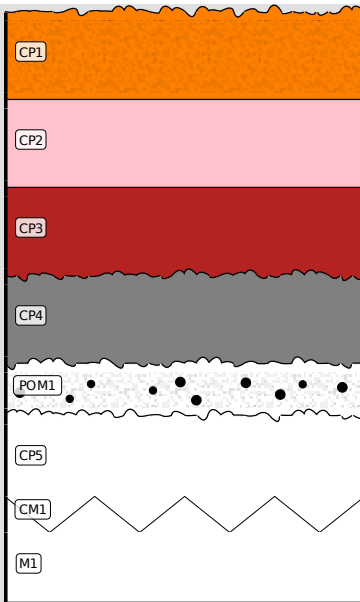
Fig. 6: Stratigraphic representation of the nail in cross-section using the MiCorr application. The characteristics of the strata are only accessible by clicking on the drawing that redirects you to the search tool by stratigraphy representation. This representation can be compared to Fig. 14, Credit HE-Arc CR, V.Chappuis.
