SHOE NAIL 2637 1370.B. - HYPOEUTECTOID STEEL - ROMAN TIMES -**SWITZERLAND**

Artefact name Shoe nail 2637 1370.B.

Christian. Degrigny (HE-Arc CR, Neuchâtel, Neuchâtel, Switzerland) & Valentin. Boissonnas (HE-Arc CR, Neuchâtel, Neuchâtel, Switzerland) & Vincent Chappuis. (HE-Arc CR, Neuchâtel, Neuchâtel, Switzerland)

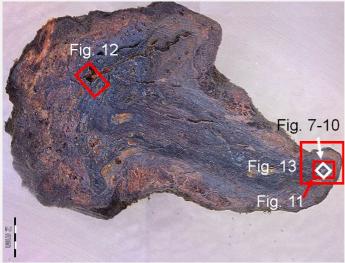
Fig. 4: Micrograph of the cross-section of the nail showing the location of figs. 7 to 13,

The metal is heavily corroded and the thickness of the corrosion crust is irregular, varying from 0.8 to 3.8mm, with an average of about 2mm. The corrosion has replaced most of the metal (Fig. 4). Between corrosion layers the limit of the original structure is visible. Some leather fibers seem to be preserved as pseudomorphic structures in voids of the metal core (POM1, Figs. 11 and 12). The carbon mapping (Fig.13) shows the presence of carbon in these areas. This can also be due to the penetration of the mounting resin in the cracks.

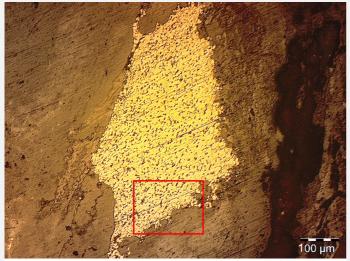
The remaining metal is an hypoeutectoid steel (Fig. 7 and 8), containing Fe, Si and O slags inclusions (possibly fayalite FeO,SiO2), and consisting of less than 1% of the total volume of the highly mineralized nail. After Nital etching, it shows intergranular corrosion on one of its sides (Figs. 9 and 10).

Fig. 7: SEM, BSE-mode picture of remaining metal,

Fig. 8: SEM, BSE-mode picture of inclusions in remaining metal,

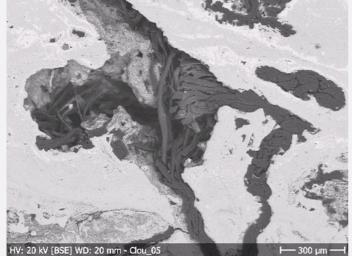
Fig. 11: Micrograph of the metal sample, bright field. The deliminated zone shows what could be leather pseudomorphic fibers filling a void,
