SACRIFICIAL ANODE VHS-8339 - ZN ALLOY - MODERN TIMES

Artefact name Sacrificial anode VHS-8339

Authors Marianne. Senn (EMPA, Dübendorf, Zurich, Switzerland) & Christian. Degriigny (HE-Arc CR, Neuchâtel, Neuchâtel, Switzerland)

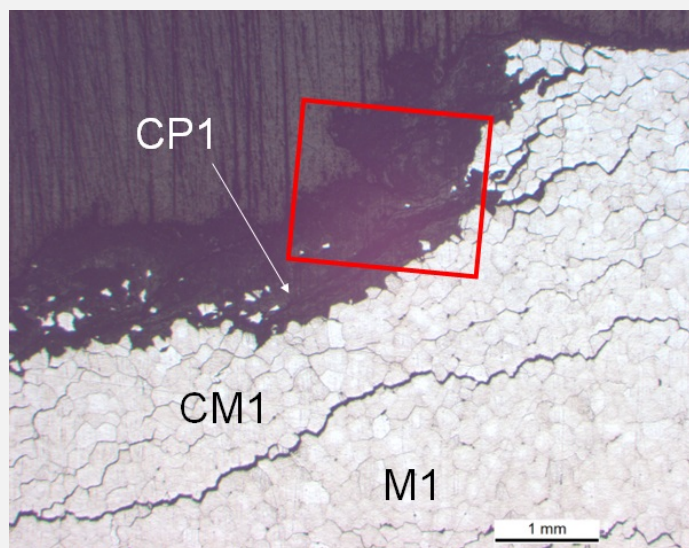
The remaining metal is an almost pure zinc alloy (Table 1). The oxygen content is not from the original alloy, but is due to secondary corrosion. The metal grains are visible without etching and present a polygonal structure (Figs. 5 and 6). The structure is recrystallised after annealing. The recrystallization of zinc alloys begins at room temperature.

Fig. 5: Micrograph of the metal sample from Fig. 3 (reversed picture, detail), unetched, bright field. Extensive intergranular corrosion is visible. The rectangle marks Fig. 7,

Extensive intergranular corrosion / cracking has developed in the metal structure (Figs. 5, 6). The metal is covered by a corrosion crust that is hardly visible in bright field and which contains remnant metal (Fig. 5). On most of the sample the corrosion crust is uniform. In areas we see cracks (Fig. 7) appearing as brown lines separating the corrosion crust (Fig. 8). In bright field the corrosion crust appears grey containing dark-grey zones (Fig. 7). Under polarized light, the corrosion crust appears white with darker parts including remnant metal (Fig. 8). It contains Zn and O as well as S along some cracks (Table 2 and Fig. 9).

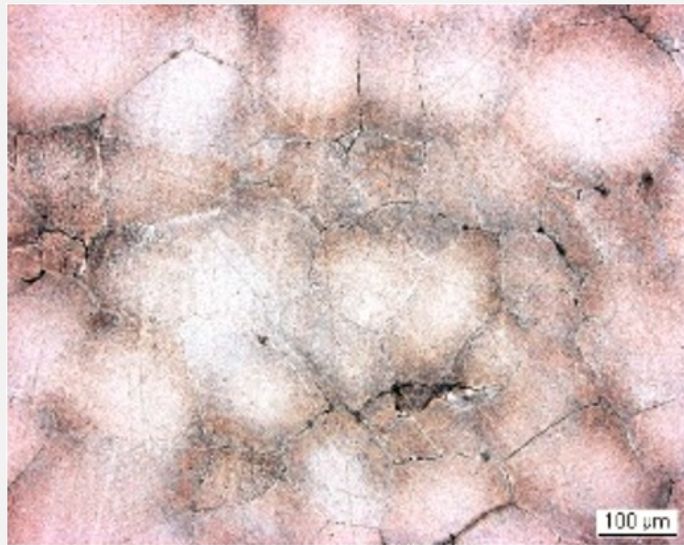
Fig. 6: Micrograph of the metal sample from Fig. 3 (detail), etched,

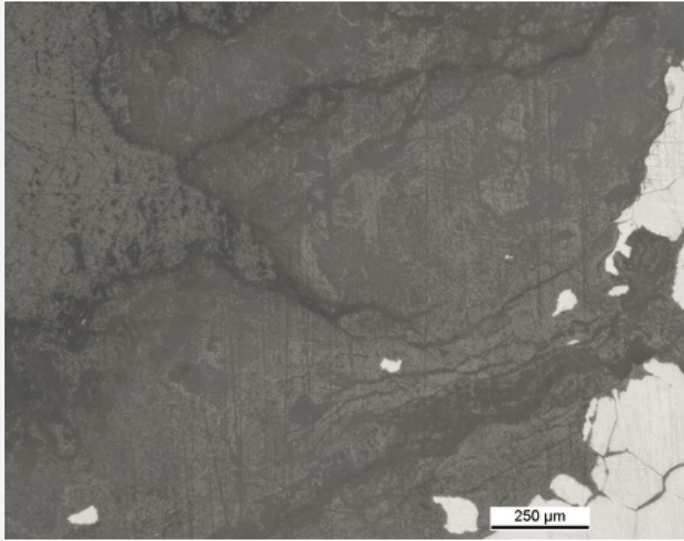
Table 2. Chemical composition (mass %) of the corrosion layer from Figs. 7 and 9. Method of analysis: SEM/EDS, Laboratory of Analytical Chemistry, Empa.

Fig. 7: Micrograph showing the metal - corrosion products interface from Fig. 5 (detail), unetched, bright field,

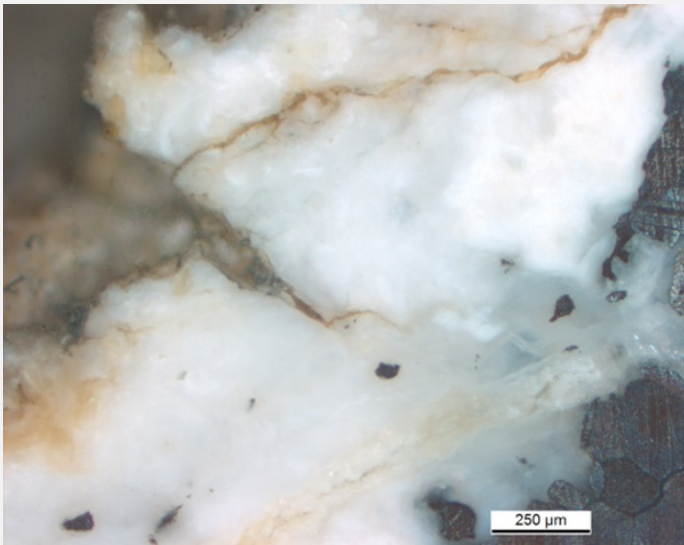
Fig. 8: Micrograph (same as Fig. 7) corresponding to the stratigraphy of Fig. 4, unetched, polarised light. We observe in dark-grey the metal, in white the corrosion crust separated by brown cracks including remnant metal,

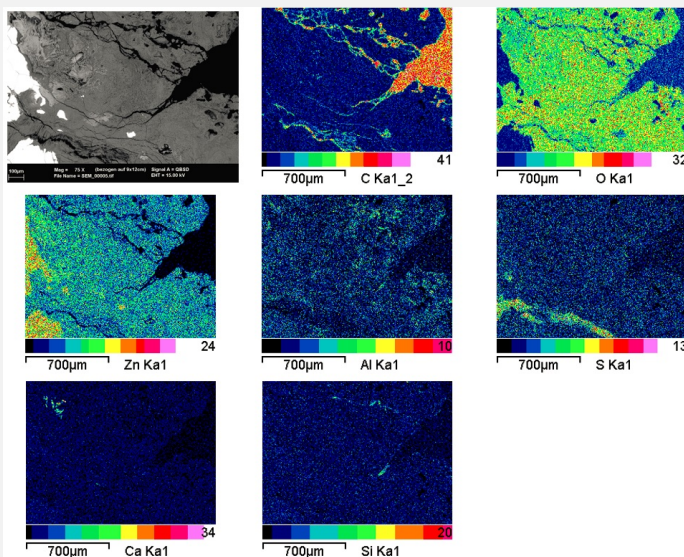
Fig. 9: SEM image, BSE-mode, and elemental chemical distribution of most of the area of Fig. 7 (reversed picture). Method of examination: SEM/EDS, Laboratory of Analytical Chemistry, Empa,
