SACRIFICIAL ANODE VHS-8339 – ZN ALLOY – MODERN TIMES

Artefact name	Sacrificial anode VHS-8339
Authors	Marianne. Senn (EMPA, Dübendorf, Zurich, Switzerland) & Christian. Degrieny (HE-Arc CR, Neuchâtel, Neuchâtel, Switzerland)
Url	/artefacts/525/

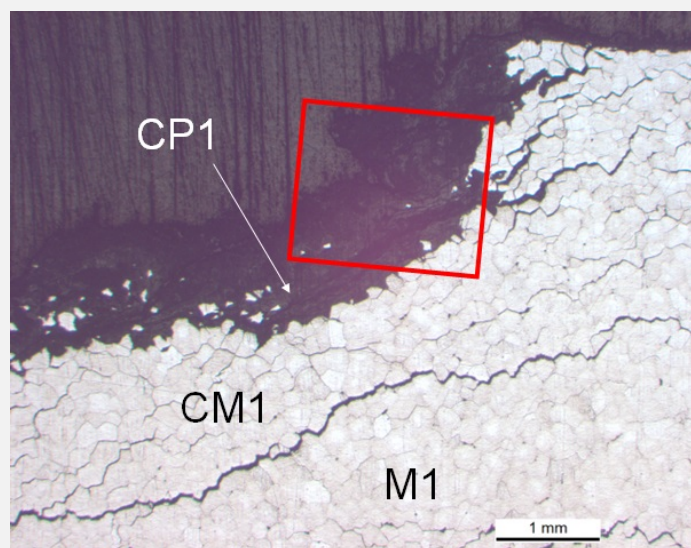
The remaining metal is an almost pure zinc alloy (Table 1). The oxygen content is not from the original alloy, but is due to secondary corrosion. The metal grains are visible without etching and present a polygonal structure (Figs. 5 and 6). The structure is recrystallised after annealing. The recrystallization of zinc alloys begins at room temperature.

Fig. 5: Micrograph of the metal sample from Fig. 3 (reversed picture, detail), unetched, bright field. Extensive intergranular corrosion is visible. The rectangle marks Fig. 7,

Extensive intergranular corrosion / cracking has developed in the metal structure (Figs. 5, 6). The metal is covered by a corrosion crust that is hardly visible in bright field and which contains remnant metal (Fig. 5). On most of the sample the corrosion crust is uniform. In areas we see cracks (Fig. 7) appearing as brown lines separating the corrosion crust (Fig. 8). In bright field the corrosion crust appears grey containing dark-grey zones (Fig. 7). Under polarized light, the corrosion crust appears white with darker parts including remnant metal (Fig. 8). It contains Zn and O as well as S along some cracks (Table 2 and Fig. 9).

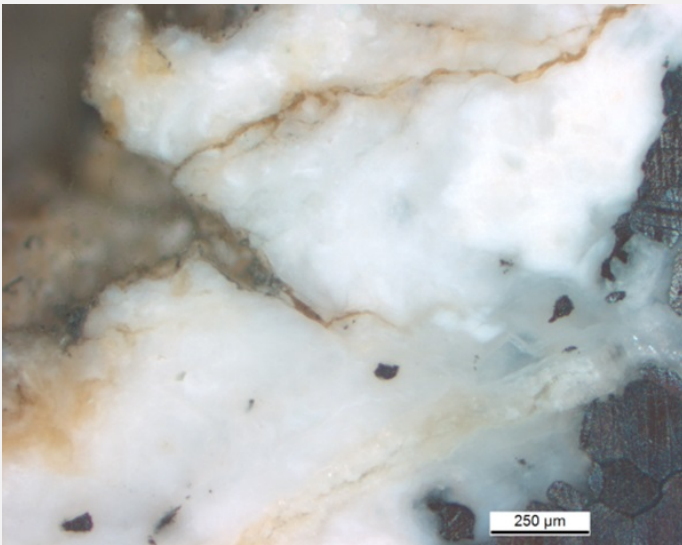
Fig. 8: Micrograph (same as Fig. 7) corresponding to the stratigraphy of Fig. 4, unetched, polarised light. We observe in dark-grey the metal, in white the corrosion crust separated by brown cracks including remnant metal,

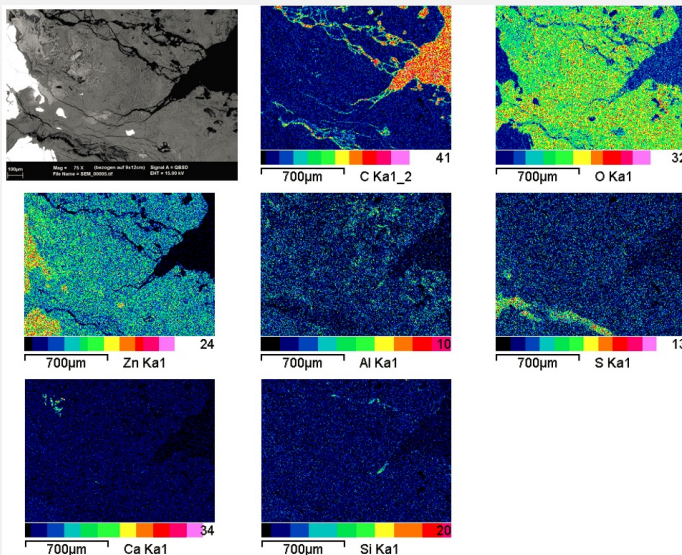
Table 2. Chemical composition (mass %) of the corrosion layer from Figs. 7 and 9. Method of analysis: SEM/EDS, Laboratory of Analytical Chemistry, Empa.

Fig. 9: SEM image, BSE-mode, and elemental chemical distribution of most of the area of Fig. 7 (reversed picture). Method of examination: SEM/EDS, Laboratory of Analytical Chemistry, Empa,
