SACRIFICIAL ANODE VHS-8339 - ZN ALLOY - MODERN TIMES

Artefact name Sacrificial anode VHS-8339

Authors Marianne. Senn (EMPA, Dübendorf, Zurich, Switzerland) & Christian. Degriigny (HE-Arc CR, Neuchâtel, Neuchâtel, Switzerland)

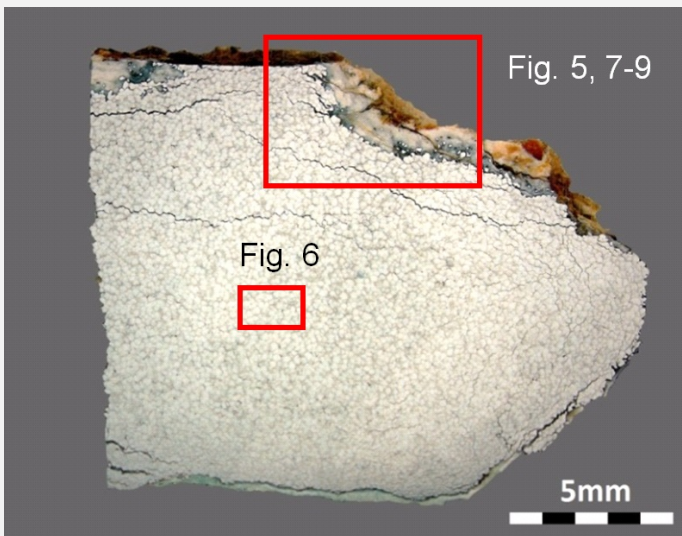
Fig. 3: Micrograph of the cross-section of the fragment sampled from the sacrificial anode showing the location of Figs. 5 to 9,

The sample (Fig. 3) shows a cross-section from the fragment of the sacrificial anode (Fig. 2). The thickness of the corrosion crust is variable. Dimensions: L = 17mm; W = 14mm.

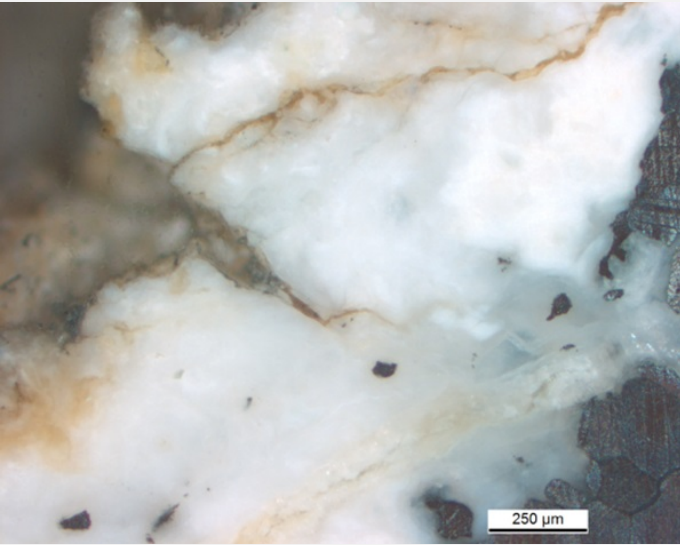
Fig. 8: Micrograph (same as Fig. 7) corresponding to the stratigraphy of Fig. 4, unetched, polarised light. We observe in dark-grey the metal, in white the corrosion crust separated by brown cracks including remnant metal,

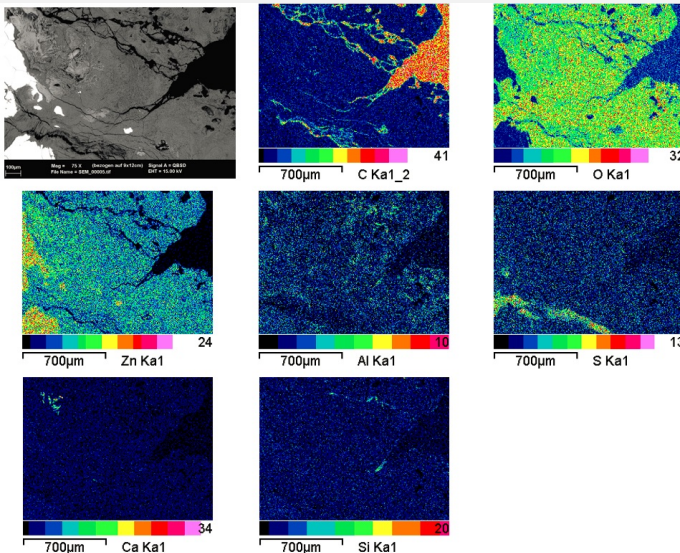
Elements	O	Al	Zn	Total
Light-grey corrosion part	23	<	77	98
Dark grey corrosion part	38	0.6	68	106

Fig. 9: SEM image, BSE-mode, and elemental chemical distribution of most of the area of Fig. 7 (reversed picture). Method of examination: SEM/EDS, Laboratory of Analytical Chemistry, Empa,
