SACRIFICIAL ANODE VHS-8339 - ZN ALLOY - MODERN TIMES

Artefact name Sacrificial anode VHS-8339

Authors Marianne. Senn (EMPA, Dübendorf, Zurich, Switzerland) & Christian. Degriigny (HE-Arc CR, Neuchâtel, Neuchâtel, Switzerland)

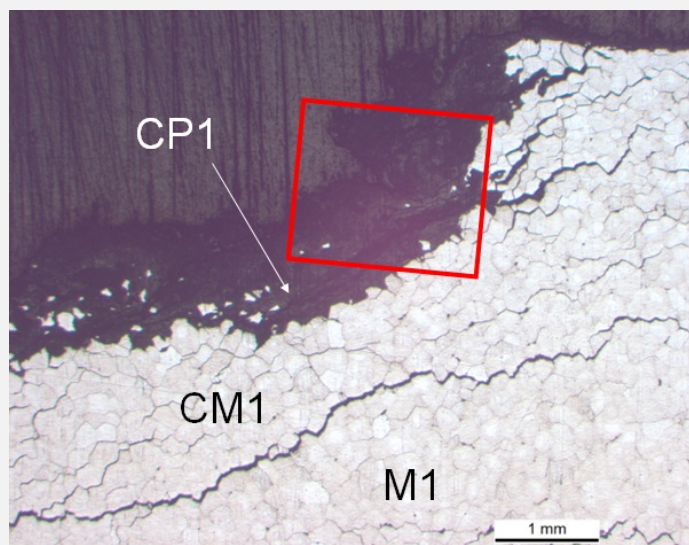
The remaining metal is an almost pure zinc alloy (Table 1). The oxygen content is not from the original alloy, but is due to secondary corrosion. The metal grains are visible without etching and present a polygonal structure (Figs. 5 and 6). The structure is recrystallised after annealing. The recrystallization of zinc alloys begins at room temperature.

Fig. 5: Micrograph of the metal sample from Fig. 3 (reversed picture, detail), unetched, bright field. Extensive intergranular corrosion is visible. The rectangle marks Fig. 7,

Extensive intergranular corrosion / cracking has developed in the metal structure (Figs. 5, 6). The metal is covered by a corrosion crust that is hardly visible in bright field and which contains remnant metal (Fig. 5). On most of the sample the corrosion crust is uniform. In areas we see cracks (Fig. 7) appearing as brown lines separating the corrosion crust (Fig. 8). In bright field the corrosion crust appears grey containing dark-grey zones (Fig. 7). Under polarized light, the corrosion crust appears white with darker parts including remnant metal (Fig. 8). It contains Zn and O as well as S along some cracks (Table 2 and Fig. 9).
