SACRIFICIAL ANODE VHS-8339 – ZN ALLOY – MODERN TIMES

Artefact name	Sacrificial anode VHS-8339
Authors	Marianne. Senn (EMPA, Dübendorf, Zurich, Switzerland) & Christian. Degriy (HE-Arc CR, Neuchâtel, Neuchâtel, Switzerland)
Url	/artefacts/525/

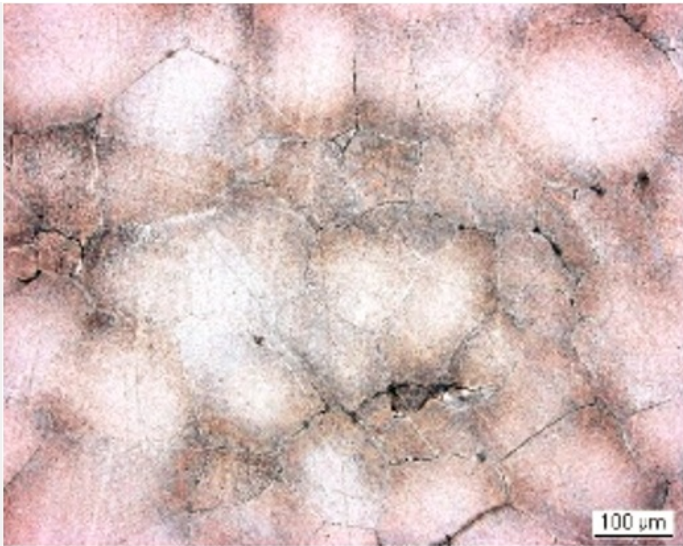
The remaining metal is an almost pure zinc alloy (Table 1). The oxygen content is not from the original alloy, but is due to secondary corrosion. The metal grains are visible without etching and present a polygonal structure (Figs. 5 and 6). The structure is recrystallised after annealing. The recrystallization of zinc alloys begins at room temperature.

Fig. 6: Micrograph of the metal sample from Fig. 3 (detail), etched,
