CIRCULAR DOOR KNOCKER STRIKING PLATE – CU ALLOY – MODERN TIMES – SWITZERLAND

Artefact name	Circular door knocker striking plate
Authors	Marianne. Senn (EMPA, Dübendorf, Zurich, Switzerland) & Christian. Degryny (HE-Arc CR, Neuchâtel, Neuchâtel, Switzerland)
Url	/artefacts/526/

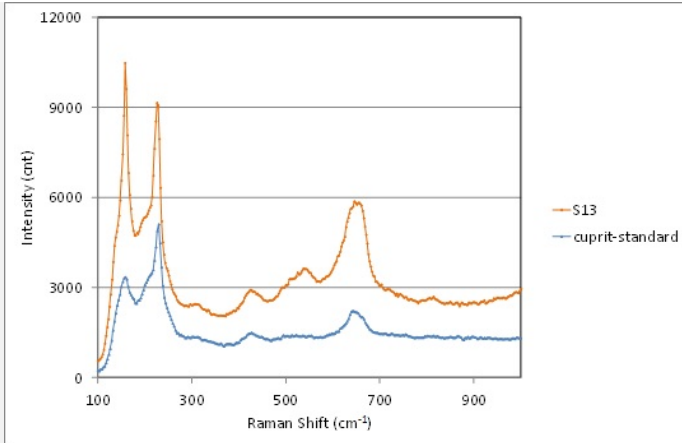
Fig. 7: Raman spectrum of a red inclusion (S13) of Fig. 5 compared to a cuprite standard spectrum. Settings: laser wavelength 532nm, acquisition time 100s, one accumulation, filter D2 (0.75-0.8mW), hole

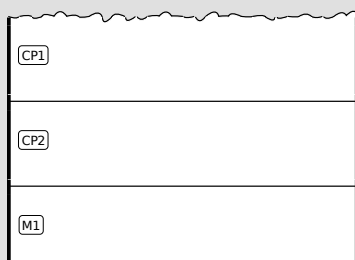
Fig. 4: Stratigraphic representation of the sample taken from the circular base in cross-section using the MiCorr application. The characteristics of the strata are only accessible by clicking on the drawing that redirects you to the search tool by stratigraphy representation. This representation can be compared to Fig. 8, Credit HE-Arc CR.
