CIRCULAR DOOR KNOCKER STRIKING PLATE – CU ALLOY – MODERN TIMES – SWITZERLAND

Artefact name	Circular door knocker striking plate
Authors	Marianne. Senn (EMPA, Dübendorf, Zurich, Switzerland) & Christian. Degrigny (HE-Arc CR, Neuchâtel, Neuchâtel, Switzerland)
Url	/artefacts/526/

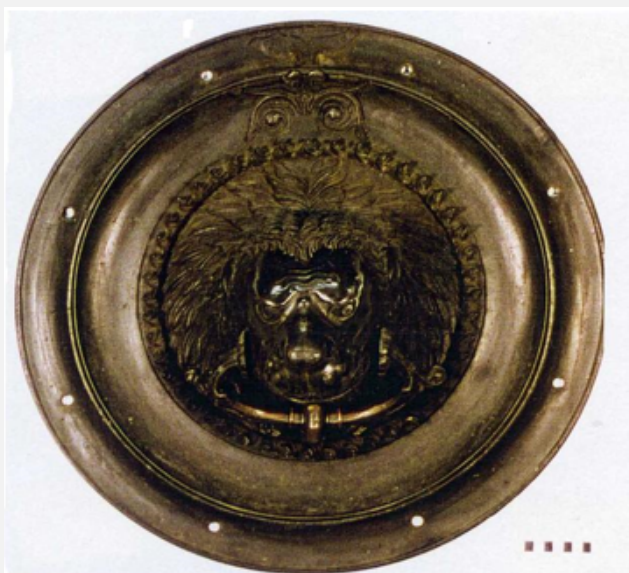
Fig. 1: Circular base from a door knocker (after Benoît, 1994),

Description of the artefact	Circular base no 2 (from a set of two) of a door knocker with a protruding lion head holding a hinge in his fangs, Ø.ext = 64cm. The circular base is covered by a gilded (?) decorative relief (Fig. 1, Benoit, 1994, 6).
Type of artefact	Architectural element
Origin	Door knocker of Lausanne cathedral, Lausanne, Vaud, Switzerland
Recovering date	None
Chronology category	Modern Times
chronology tpg	1601 A.D. ▼
chronology taq	1700 A.D. ▼
Chronology comment	17th Century AD
Burial conditions / environment	Outdoor atmosphere

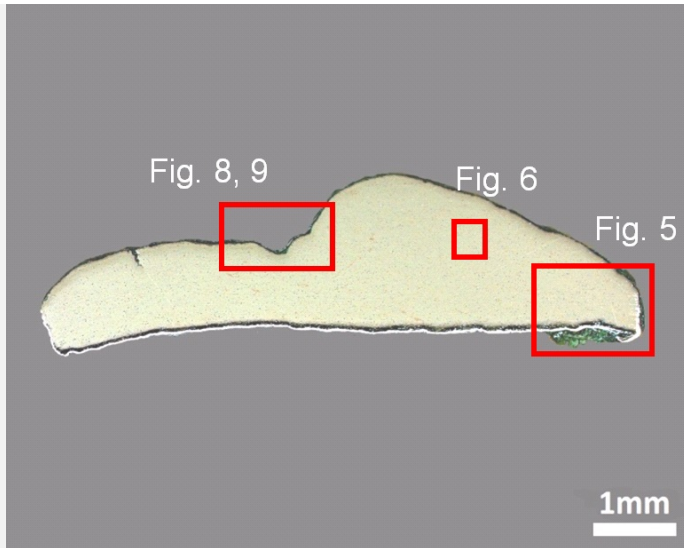
Fig. 3: Micrograph of the cross-section of the sample taken from the circular base showing the location of Figs. 5 to 6 and 8 to 9,

Description of sample	No information is given on where the sample has been taken. A supposed location is however illustrated in Fig. 2. The polished sample shows a well preserved metal surface with some cracks covered by a thin corrosion crust (Fig. 3).
Alloy	Cu Alloy
Technology	Rolled, annealed after cold working
Lab number of sample	MAH 94-156-001
Sample location	Musées d'art et d'histoire, Genève, Geneva
Responsible institution	Musées d'art et d'histoire, Genève, Geneva
Date and aim of sampling	1994, metallography and presence or not of a gilding treatment

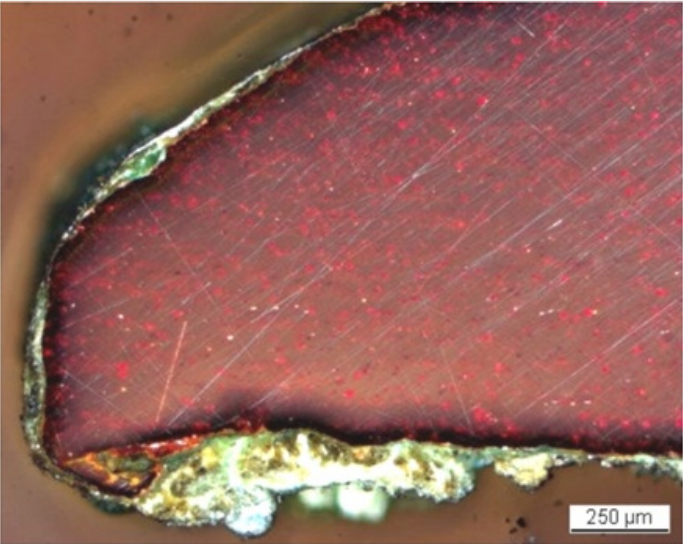
Fig. 5: Micrograph of the metal sample from Fig. 3 (reversed picture), unetched, polarised light. The red copper oxide inclusions form rows in the copper alloy matrix.,

The average thickness of the corrosion crust is about 90µm, but may be thinner or thicker depending on the area of origin (Fig. 5). Under polarized light, we observe a multilayer system with a dense and thin inner red corrosion layer (CP2, probably cuprite/Cu₂O) on the metal (Fig. 8) containing chlorides (Fig. 9 and Table 3). This is followed by bands of heterogeneous green corrosion products (CP1, possibly copper chloride / sulphate / carbonate). This outer corrosion layer is contaminated with atmospheric components (Si, Al, Cl, C and O and perhaps gypsum particles (CaSO₄)) (Fig. 9).

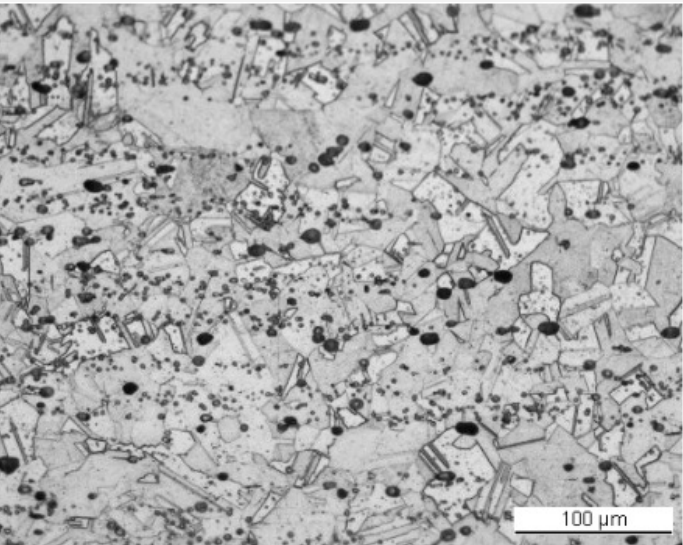
mode, Fig. 9). Due to the rolling process the copper oxide inclusions are parallel to the longitudinal orientation of the sample (Figs. 5 and 6). They were identified as cuprite by Raman spectroscopy (Fig. 7). The etched alloy shows a structure of polygonal grains with annealing twins (Fig. 6). The grain size is variable. The average hardness of the alloy is HV1 80, which is quite high compared to the average hardness of a pure annealed copper of around HV1 40-50 (Schumann 1991, 627).

Fig. 6: Micrograph of the metal sample from Fig. 3 (detail), etched, bright field. The metal shows a structure of polygonal and twinned grains. Copper oxide inclusions are visible as dark spots,

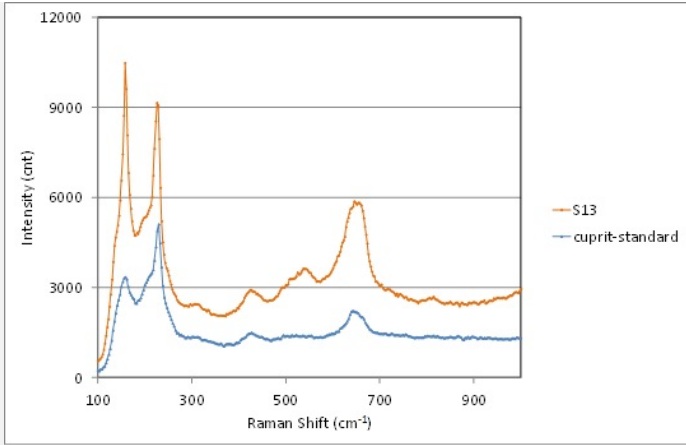
Fig. 7: Raman spectrum of a red inclusion (S13) of Fig. 5 compared to a cuprite standard spectrum. Settings: laser wavelength 532nm, acquisition time 100s, one accumulation, filter D2 (0.75-0.8mW), hole

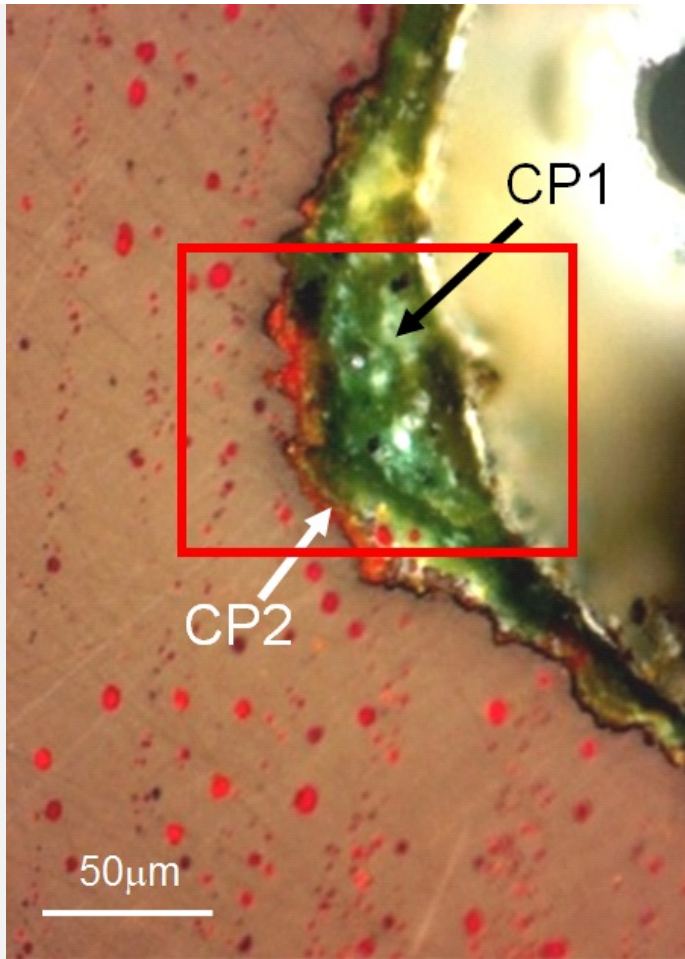
Fig. 8: Micrograph of the metal sample from Fig. 3 (rotated by 90°) and corresponding to the stratigraphy of Fig. 4, polarised light. Metal with red copper oxide inclusions. The black particles in the green corrosion layer are quartz inclusions. The area selected for elemental chemical distribution (Fig. 9) is marked by a red rectangle,

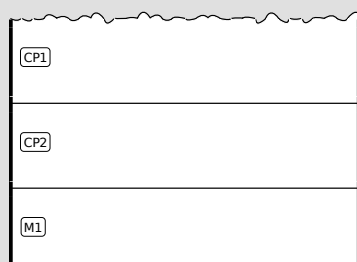
Fig. 4: Stratigraphic representation of the sample taken from the circular base in cross-section using the MiCorr application. The characteristics of the strata are only accessible by clicking on the drawing that redirects you to the search tool by stratigraphy representation. This representation can be compared to Fig. 8, Credit HE-Arc CR.
