# CIRCULAR DOOR KNOCKER STRIKING PLATE – CU ALLOY – MODERN TIMES – SWITZERLAND

Artefact name	Circular door knocker striking plate
Authors	Marianne. Senn (EMPA, Dübendorf, Zurich, Switzerland) & Christian. Degriigny (HE-Arc CR, Neuchâtel, Neuchâtel, Switzerland)
Url	/artefacts/526/

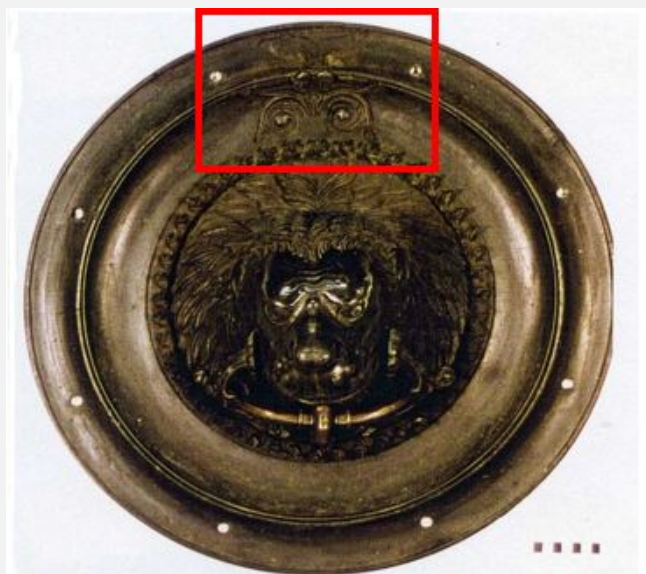
Fig. 2: Possible location of sampling area,

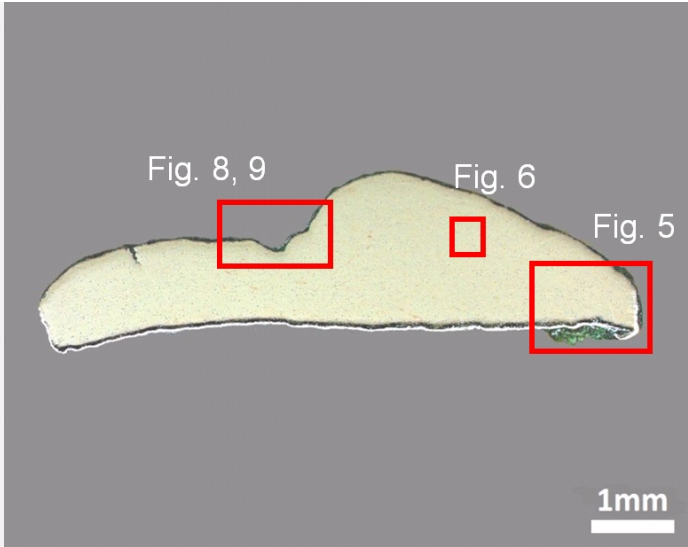
Fig. 3: Micrograph of the cross-section of the sample taken from the circular base showing the location of Figs. 5 to 6 and 8 to 9,

Description of sample	No information is given on where the sample has been taken. A supposed location is however illustrated in Fig. 2. The polished sample shows a well preserved metal surface with some cracks covered by a thin corrosion crust (Fig. 3).
Alloy	Cu Alloy
Technology	Rolled, annealed after cold working
Lab number of sample	MAH 94-156-001
Sample location	Musées d'art et d'histoire, Genève, Geneva
Responsible institution	Musées d'art et d'histoire, Genève, Geneva
Date and aim of sampling	1994, metallography and presence or not of a gilding treatment

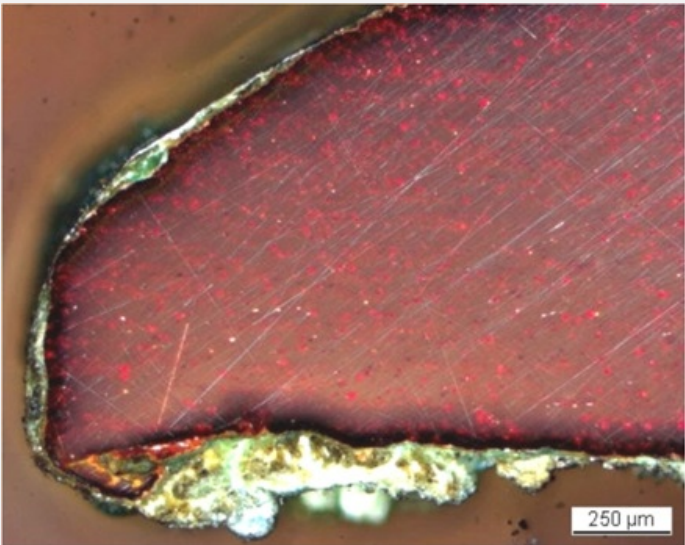
red (Figs. 5 and 8) while with SEM in BSE-mode they look light-grey (Fig. 9). Heavy metals inclusions appear white with SEM (BSE-mode, Fig. 9). Due to the rolling process the copper oxide inclusions are parallel to the longitudinal orientation of the sample (Figs. 5 and 6). They were identified as cuprite by Raman spectroscopy (Fig. 7). The etched alloy shows a structure of polygonal grains with annealing twins (Fig. 6). The grain size is variable. The average hardness of the alloy is HV1 80, which is quite high compared to the average hardness of a pure annealed copper of around HV1 40-50 (Schumann 1991, 627).

Fig. 5: Micrograph of the metal sample from Fig. 3 (reversed picture), unetched, polarised light. The red copper oxide inclusions form rows in the copper alloy matrix.,

The average thickness of the corrosion crust is about 90µm, but may be thinner or thicker depending on the area of origin (Fig. 5). Under polarized light, we observe a multilayer system with a dense and thin inner red corrosion layer (CP2, probably cuprite/Cu<sub>2</sub>O) on the metal (Fig. 8) containing chlorides (Fig. 9 and Table 3). This is followed by bands of heterogeneous green corrosion products (CP1, possibly copper chloride / sulphate / carbonate). This outer corrosion layer is contaminated with atmospheric components (Si, Al, Cl, C and O and perhaps gypsum particles (CaSO<sub>4</sub>)) (Fig. 9).

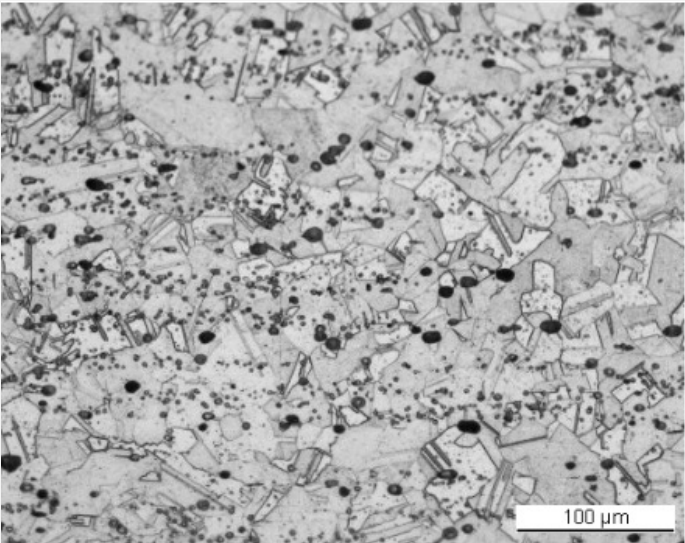
Fig. 6: Micrograph of the metal sample from Fig. 3 (detail), etched, bright field. The metal shows a structure of polygonal and twinned grains. Copper oxide inclusions are visible as dark spots,

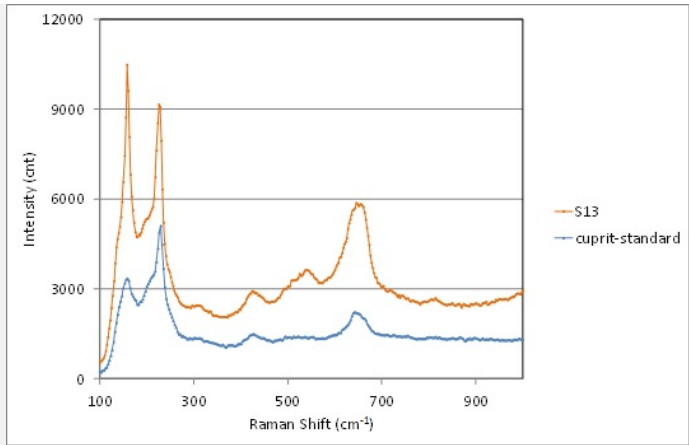
Fig. 7: Raman spectrum of a red inclusion (S13) of Fig. 5 compared to a cuprite standard spectrum. Settings: laser wavelength 532nm, acquisition time 100s, one accumulation, filter D2 (0.75-0.8mW), hole 500, slit 80, grating 600. Method of analysis: Raman spectroscopy. Lab of Swiss National Museum, Affoltern a. Albis ZH,

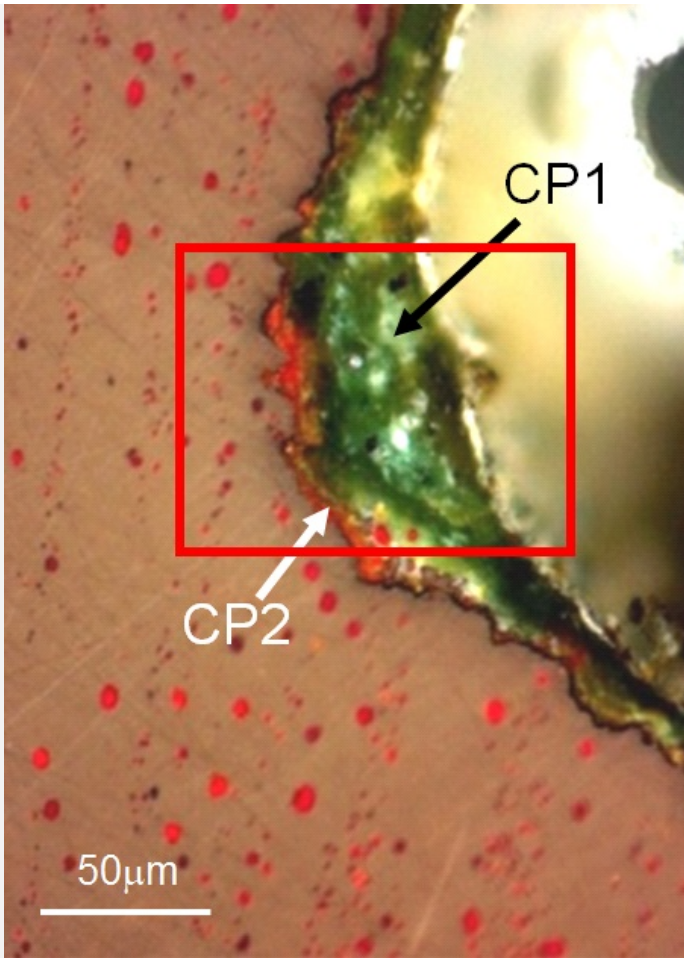
Fig. 8: Micrograph of the metal sample from Fig. 3 (rotated by 90°) and corresponding to the stratigraphy of Fig. 4, polarised light. Metal with red copper oxide inclusions. The black particles in the green corrosion layer are quartz inclusions. The area selected for elemental chemical distribution (Fig. 9) is marked by a red rectangle,

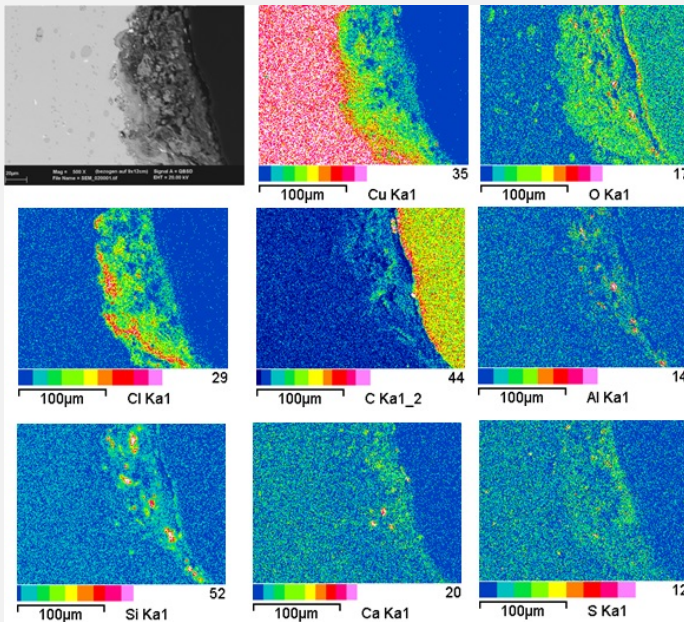
Table 2: Chemical composition (mass %) of the inclusions (light-grey and white in Fig. 9) in the metal. Method of analysis: SEM/EDS, Laboratory of Analytical Chemistry, Empa.

Fig. 9: SEM image, BSE-mode, and elemental chemical distribution of the selected area of Fig. 8. Method of examination: SEM/EDS, Laboratory of Analytical Chemistry, Empa,

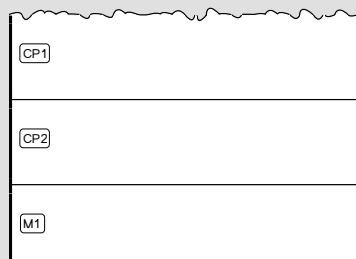
Fig. 4: Stratigraphic representation of the sample taken from the circular base in cross-section using the MiCorr application. The characteristics of the strata are only accessible by clicking on the drawing that redirects you to the search tool by stratigraphy representation. This representation can be compared to Fig. 8, Credit HE-Arc CR.
