# CIRCULAR DOOR KNOCKER STRIKING PLATE - CU ALLOY - MODERN TIMES - SWITZERLAND

| <b>Artefact name</b> | Circular door knocker striking plate |
| <b>Authors</b> | Marianne. Senn (EMPA, Dübendorf, Zurich, Switzerland) & Christian. Degriigny (HE-Arc CR, Neuchâtel, Neuchâtel, Switzerland) |

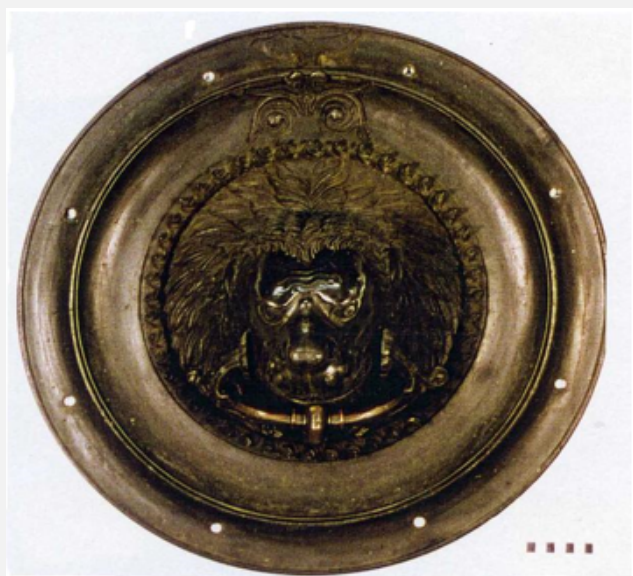
Fig. 1: Circular base from a door knocker (after Benoît, 1994),

| <b>Description of the artefact</b> | Circular base no 2 (from a set of two) of a door knocker with a protruding lion head holding a hinge in his fangs, Ø.ext = 64cm. The circular base is covered by a gilded (?) decorative relief (Fig. 1, Benoit, 1994, 6). |

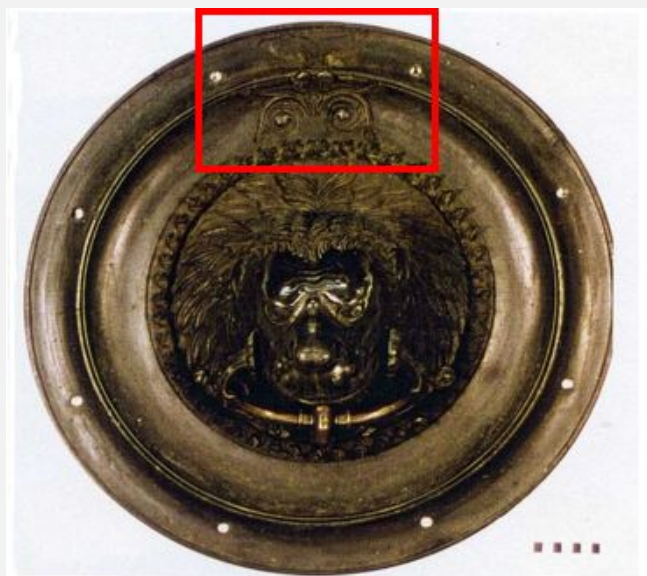
Fig. 2: Possible location of sampling area,

| <b>Description of sample</b> | No information is given on where the sample has been taken. A supposed location is however illustrated in Fig. 2. The polished sample shows a well preserved metal surface with some cracks covered by a thin corrosion crust (Fig. 3). |

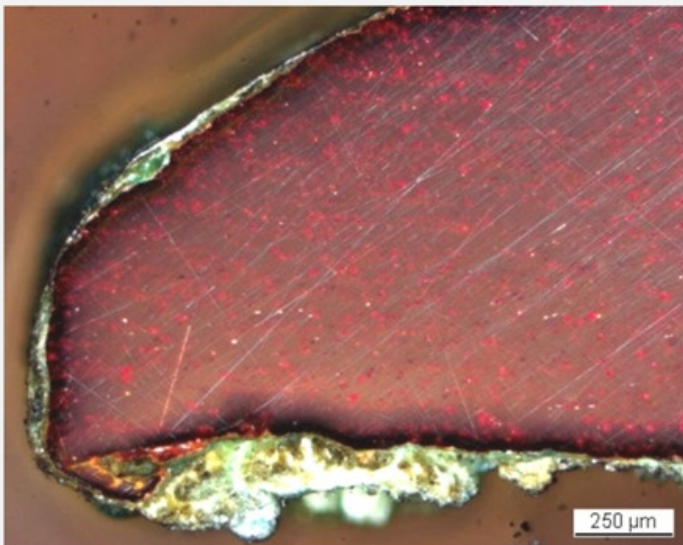
red (Figs. 5 and 8) while with SEM in BSE-mode they look light-grey (Fig. 9). Heavy metals inclusions appear white with SEM (BSE-mode, Fig. 9). Due to the rolling process the copper oxide inclusions are parallel to the longitudinal orientation of the sample (Figs. 5 and 6). They were identified as cuprite by Raman spectroscopy (Fig. 7). The etched alloy shows a structure of polygonal grains with annealing twins (Fig. 6). The grain size is variable. The average hardness of the alloy is HV1 80, which is quite high compared to the average hardness of a pure annealed copper of around HV1 40-50 (Schumann 1991, 627).

Fig. 5: Micrograph of the metal sample from Fig. 3 (reversed picture), unetched, polarised light. The red copper oxide inclusions form rows in the copper alloy matrix.,

The average thickness of the corrosion crust is about 90µm, but may be thinner or thicker depending on the area of origin (Fig. 5). Under polarized light, we observe a multilayer system with a dense and thin inner red corrosion layer (CP2, probably cuprite/Cu<sub>2</sub>O) on the metal (Fig. 8) containing chlorides (Fig. 9 and Table 3). This is followed by bands of heterogeneous green corrosion products (CP1, possibly copper chloride / sulphate / carbonate). This outer corrosion layer is contaminated with atmospheric components (Si, Al, Cl, C and O and perhaps gypsum particles (CaSO<sub>4</sub>)) (Fig. 9).

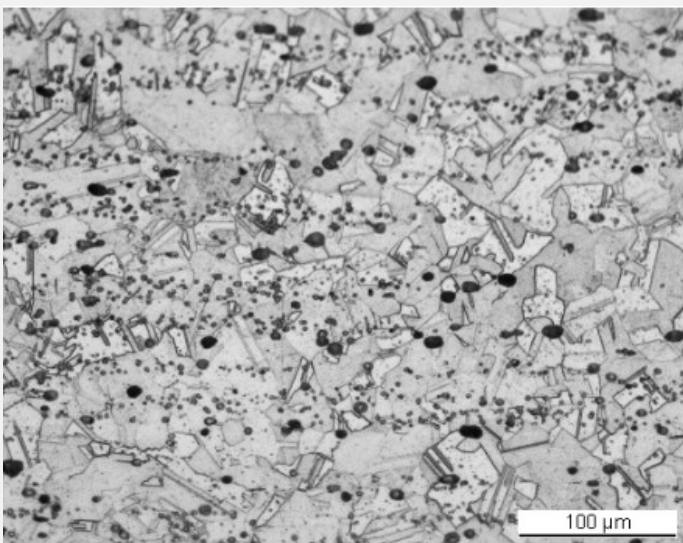
Fig. 6: Micrograph of the metal sample from Fig. 3 (detail), etched, bright field. The metal shows a structure of polygonal and twinned grains. Copper oxide inclusions are visible as dark spots,

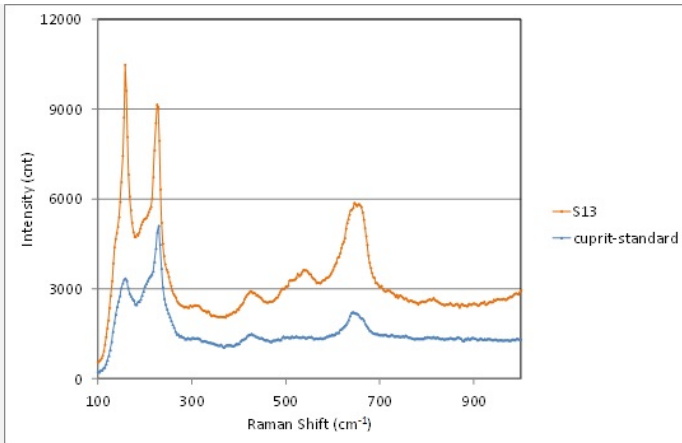
Fig. 7: Raman spectrum of a red inclusion (S13) of Fig. 5 compared to a cuprite standard spectrum. Settings: laser wavelength 532nm, acquisition time 100s, one accumulation, filter D2 (0.75-0.8mW), hole 500, slit 80, grating 600. Method of analysis: Raman spectroscopy. Lab of Swiss National Museum, Affoltern a. Albis ZH,

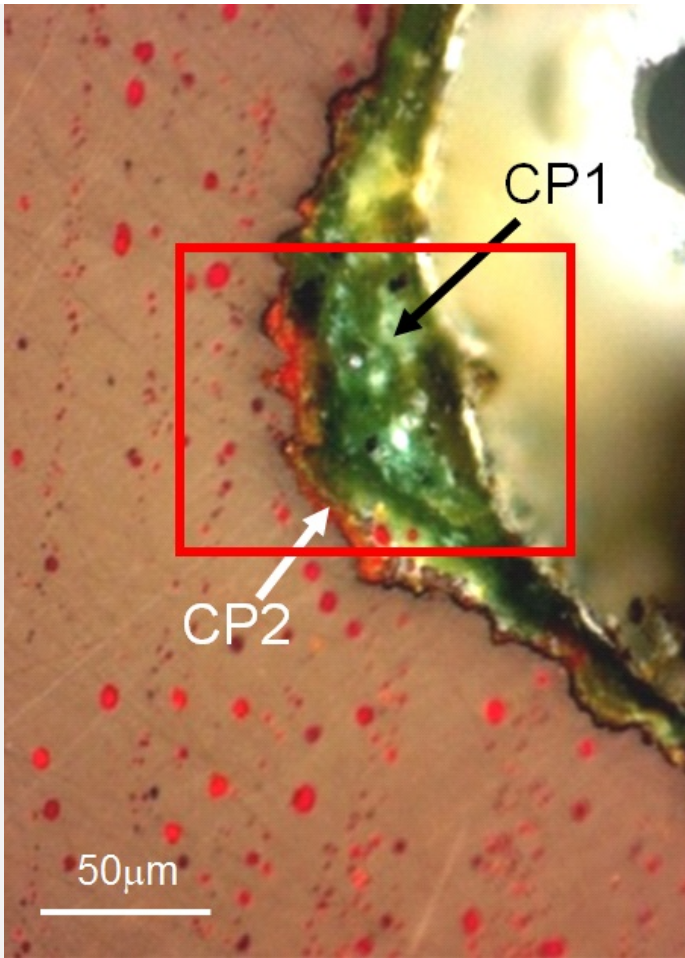
Fig. 8: Micrograph of the metal sample from Fig. 3 (rotated by 90°) and corresponding to the stratigraphy of Fig. 4, polarised light. Metal with red copper oxide inclusions. The black particles in the green corrosion layer are quartz inclusions. The area selected for elemental chemical distribution (Fig. 9) is marked by a red rectangle.

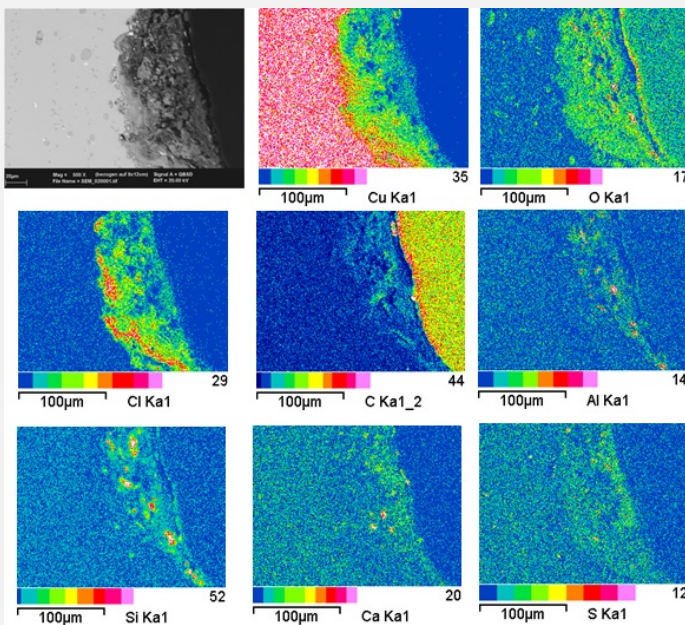
Fig. 9: SEM image, BSE-mode, and elemental chemical distribution of the selected area of Fig. 8. Method of examination: SEM/EDS, Laboratory of Analytical Chemistry, Empa,

Table 2: Chemical composition (mass %) of the inclusions (light-grey and white in Fig. 9) in the metal. Method of analysis: SEM/EDS, Laboratory of Analytical Chemistry, Empa.

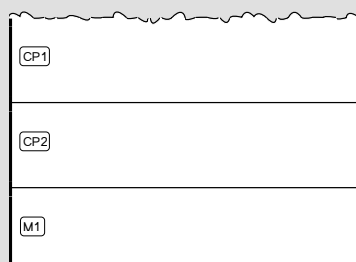
Fig. 4: Stratigraphic representation of the sample taken from the circular base in cross-section using the MiCorr application. The characteristics of the strata are only accessible by clicking on the drawing that redirects you to the search tool by stratigraphy representation. This representation can be compared to Fig. 8, Credit HE-Arc CR.
