# CIRCULAR DOOR KNOCKER STRIKING PLATE – CU ALLOY – MODERN TIMES – SWITZERLAND

Artefact name	Circular door knocker striking plate
Authors	Marianne. Senn (EMPA, Dübendorf, Zurich, Switzerland) & Christian. Degrigny (HE-Arc CR, Neuchâtel, Neuchâtel, Switzerland)
Url	/artefacts/526/

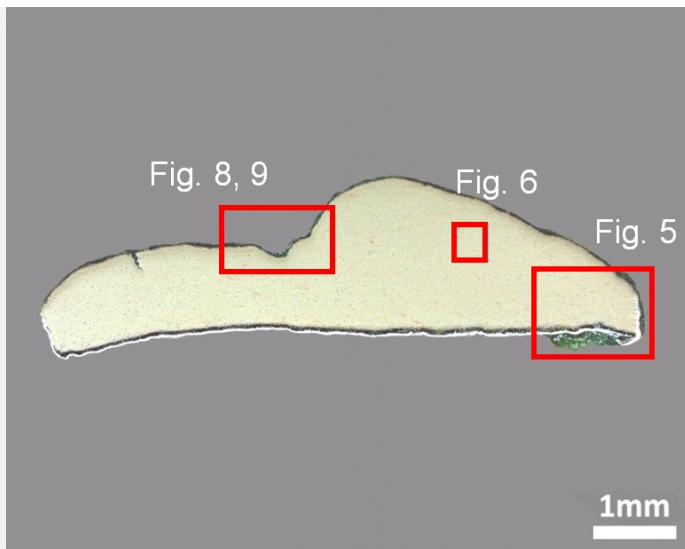
Fig. 3: Micrograph of the cross-section of the sample taken from the circular base showing the location of Figs. 5 to 6 and 8 to 9,

<b>Description of sample</b>	No information is given on where the sample has been taken. A supposed location is however illustrated in Fig. 2. The polished sample shows a well preserved metal surface with some cracks covered by a thin corrosion crust (Fig. 3).
<b>Alloy</b>	Cu Alloy
<b>Technology</b>	Rolled, annealed after cold working
<b>Lab number of sample</b>	MAH 94-156-001
<b>Sample location</b>	Musées d'art et d'histoire, Genève, Geneva
<b>Responsible institution</b>	Musées d'art et d'histoire, Genève, Geneva
<b>Date and aim of sampling</b>	1994, metallography and presence or not of a gilding treatment

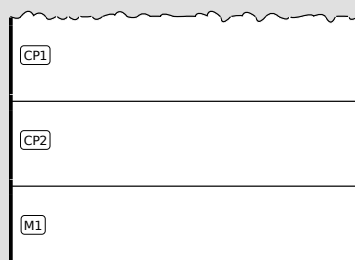
Fig. 4: Stratigraphic representation of the sample taken from the circular base in cross-section using the MiCorr application. The characteristics of the strata are only accessible by clicking on the drawing that redirects you to the search tool by stratigraphy representation. This representation can be compared to Fig. 8, Credit HE-Arc CR.
