CIRCULAR DOOR KNOCKER STRIKING PLATE - CU ALLOY - MODERN TIMES - SWITZERLAND

Artefact name	Circular door knocker striking plate
Authors	Marianne. Senn (EMPA, Dübendorf, Zurich, Switzerland) & Christian. Degrigny (HE-Arc CR, Neuchâtel, Neuchâtel, Switzerland)
Url	/artefacts/526/

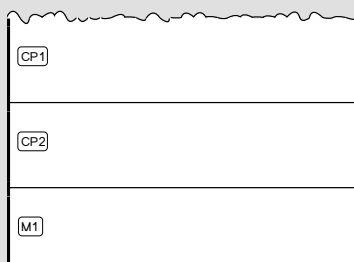
Fig. 4: Stratigraphic representation of the sample taken from the circular base in cross-section using the MiCorr application. The characteristics of the strata are only accessible by clicking on the drawing that redirects you to the search tool by stratigraphy representation. This representation can be compared to Fig. 8, Credit HE-Arc CR.
