CIRCULAR DOOR KNOCKER STRIKING PLATE - CU ALLOY - MODERN TIMES - SWITZERLAND

Artefact name	Circular door knocker striking plate
Authors	Marianne. Senn (EMPA, Dübendorf, Zurich, Switzerland) & Christian. Degriigny (HE-Arc CR, Neuchâtel, Neuchâtel, Switzerland)
Url	/artefacts/526/

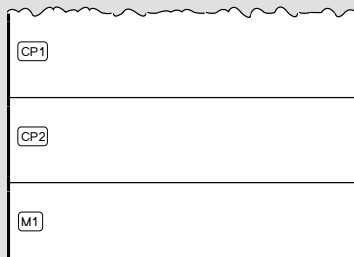
Fig. 4: Stratigraphic representation of the sample taken from the circular base in cross-section using the MiCorr application. The characteristics of the strata are only accessible by clicking on the drawing that redirects you to the search tool by stratigraphy representation. This representation can be compared to Fig. 8, Credit HE-Arc CR.
