CORRODED METAL SHEET FN 655.13.01 – FE ALLOY – MODERN TIMES – SWITZERLAND

Artefact name	Corroded metal sheet FN 655.13.01
Authors	Marianne. Senn (EMPA, Dübendorf, Zurich, Switzerland) & Christian. Degrigny (HE-Arc CR, Neuchâtel, Neuchâtel, Switzerland)
Url	/artefacts/529/

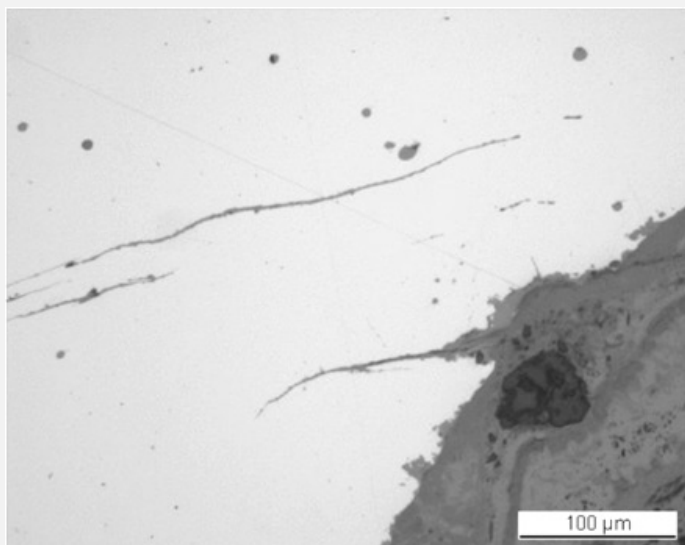
The remaining metal is an iron containing elevated (more than 1g/kg) concentrations of Co and Ni (Table 1), small round slag inclusions and cracks resulting from corrosion and deformation (Fig. 5). The composition of the round, elongated slag inclusions is similar to wüstite-FeO (Table 2). Iron reduced in the direct smelting process never contains such pure compounds and only FeO inclusions. In modern steels FeO occurs in low carbon alloys and Armco-iron (Schumann 1991, 474). After etching, the cross-section shows a heavily deformed ferritic microstructure from cold working (Fig. 6). The cracks have the same orientation as the deformation. The average hardness of the metal is HV1 195.

Fig. 5: Micrograph of metal sample from Fig. 3 (inverted picture, detail), unetched, bright field. In white the metal with round slag inclusions as well as cracks filled with corrosion products,

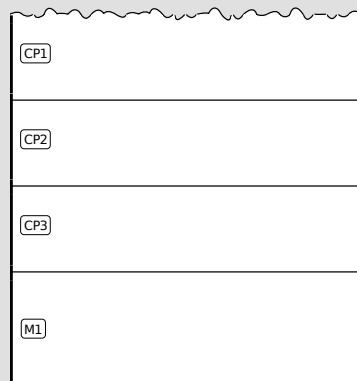
Fig. 4: Stratigraphic representation of the iron-based sheet in cross-section using the MiCorr application. The characteristics of the strata are only accessible by clicking on the drawing that redirects you to the search tool by stratigraphy representation. This representation can be compared to Figs. 7 and 8, Credit HE-Arc CR.

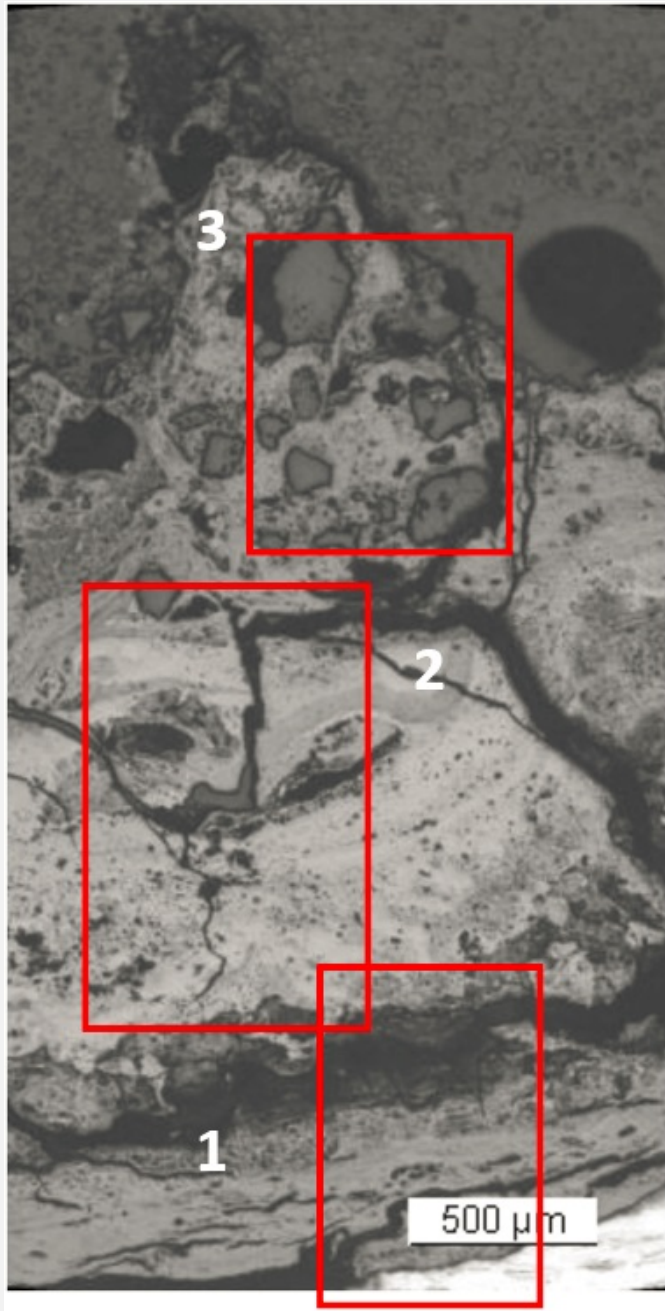
Fig. 7: Micrograph of the corrosion layer from Fig. 3 showing the metal - corrosion crust interface (detail, rotated by 45°) and corresponding to the stratigraphy of Fig. 4, unetched, bright field. The areas 1 (for CP3), 2 (for CP2) and 3 (for CP3) selected for elemental chemical distribution (Fig. 9) are marked by red rectangles,
