# CORRODED METAL SHEET FN 655.13.01 – FE ALLOY – MODERN TIMES – SWITZERLAND

<b>Artefact name</b>	Corroded metal sheet FN 655.13.01
<b>Authors</b>	Marianne. Senn (EMPA, Dübendorf, Zurich, Switzerland) & Christian. Degrigny (HE-Arc CR, Neuchâtel, Neuchâtel, Switzerland)
<b>Url</b>	/artefacts/529/

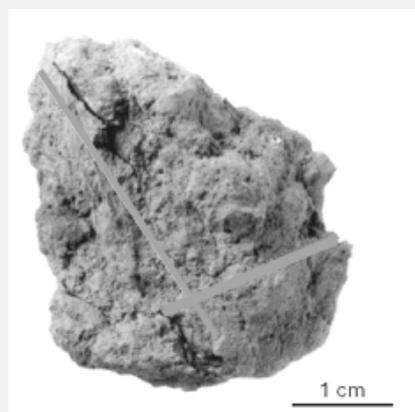
Fig. 1: Metal sheet (after Senn Bischofberger 2005, 137),

<b>Description of the artefact</b>	Metal (iron-based) sheet with middle rib. The shape is no longer discernible (Fig. 1). The metal is covered by a thick corrosion crust. Dimensions: L = 4.5cm; WT = 35g.
<b>Type of artefact</b>	Iron (and steel) sheet
<b>Origin</b>	Steinmöri, Neftenbach / Dorf Neftenbach, Zurich, Switzerland
<b>Recovering date</b>	Excavation of the Roman villa, 1986-1990, phase S2, StbII.2 (2nd/3rd century AD)
<b>Chronology category</b>	Modern Times
<b>chronology tpq</b>	<input type="text" value="1900"/> A.D. ▼
<b>chronology taq</b>	<input type="text" value="2000"/> A.D. ▼
<b>Chronology comment</b>	Product of the 20th century AD introduced accidentally into a Roman layer
<b>Burial conditions / environment</b>	Soil
<b>Artefact location</b>	Kantonsarchäologie, Dübendorf, Zurich
<b>Owner</b>	Kantonsarchäologie, Dübendorf, Zurich

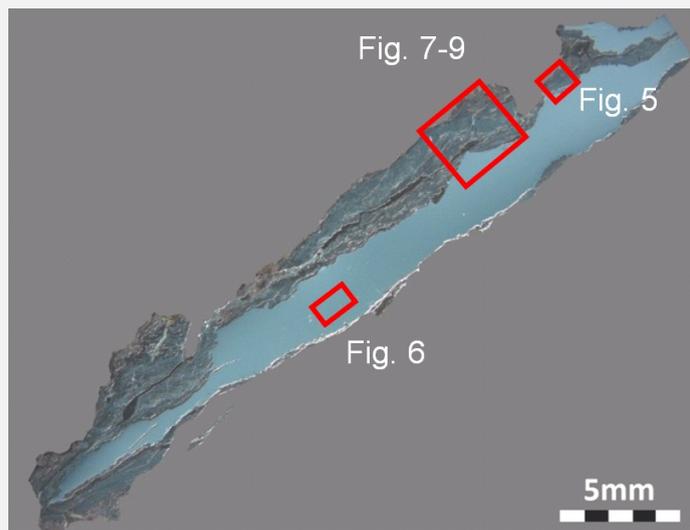
Fig. 3: Micrograph of the cross-section of the iron-based sheet showing the location of Figs. 5 to 9,

<b>Description of sample</b>	A longitudinal cut has been made through the sheet (Fig. 2). Large parts of the corrosion crust fell off during sampling (Fig. 3).
<b>Alloy</b>	Fe Alloy
<b>Technology</b>	Forged with final cold work
<b>Lab number of sample</b>	NEF 655
<b>Sample location</b>	Empa (Marianne Senn)
<b>Responsible institution</b>	Kantonsarchäologie, Dübendorf, Zurich
<b>Date and aim of sampling</b>	2000, metallography

The corrosion is massive and large parts of the outer corrosion layers have been lost during the sample preparation. The heavily cracked corrosion crust represents about one third of the thickness of the sample (Fig. 3) and is located on one side of the metal (the rest having been lost during the cutting process). It does not show well defined layers. Despite this, three areas can be distinguished (Figs. 7 and 8). Adhering to the metal (area 1), we find an orange-red-brown layer enriched in Cl (CP3 in Fig. 4, Fig. 9

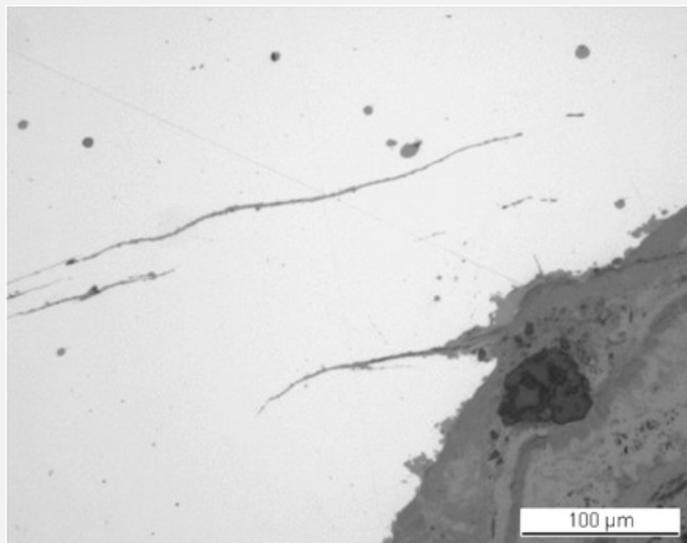
The remaining metal is an iron containing elevated (more than 1g/kg) concentrations of Co and Ni (Table 1), small round slag inclusions and cracks resulting from corrosion and deformation (Fig. 5). The composition of the round, elongated slag inclusions is similar to wüstite-FeO (Table 2). Iron reduced in the direct smelting process never contains such pure compounds and only FeO inclusions. In modern steels FeO occurs in low carbon alloys and Armco-iron (Schumann 1991, 474). After etching, the cross-section shows a heavily deformed ferritic microstructure from cold working (Fig. 6). The cracks have the same orientation as the deformation. The average hardness of the metal is HV1 195.

Fig. 5: Micrograph of metal sample from Fig. 3 (inverted picture, detail), unetched, bright field. In white the metal with round slag inclusions as well as cracks filled with corrosion products,

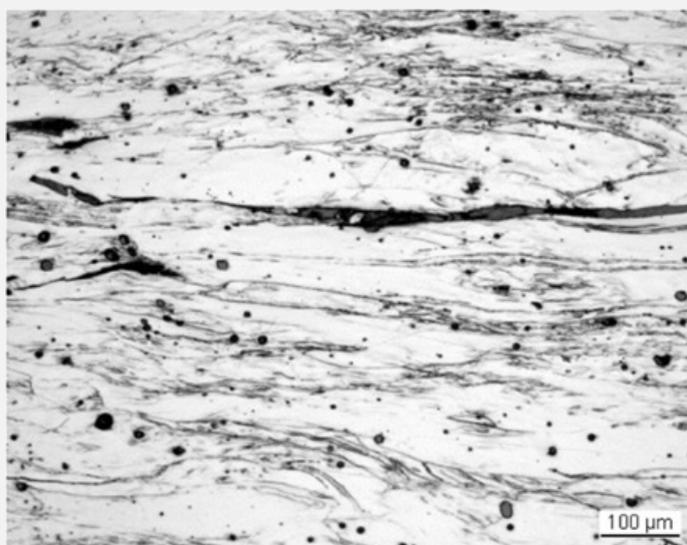
Fig. 6: Micrograph of metal sample from Fig. 3 (detail), etched, bright field. The heavily cold worked metal shows elongated grains with nearly invisible grain boundaries and cracks parallel to the grains,

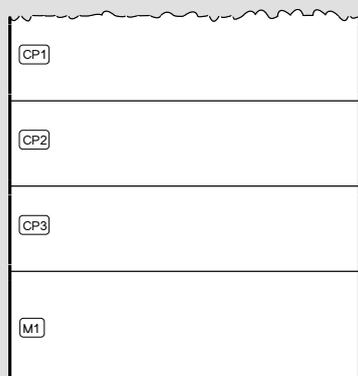
and Table 3). The dark or violet middle area 2 is richer in Fe (CP2 in Fig. 4). The outer area 3 is red-brown (CP1 in Fig. 4) and strongly contaminated by soil material (rock fragment inclusion and elements like Si, Al, P etc.). This layer is enriched in O (Fig. 9).

Fig. 4: Stratigraphic representation of the iron-based sheet in cross-section using the MiCorr application. The characteristics of the strata are only accessible by clicking on the drawing that redirects you to the search tool by stratigraphy representation. This representation can be compared to Figs. 7 and 8, Credit HE-Arc CR.

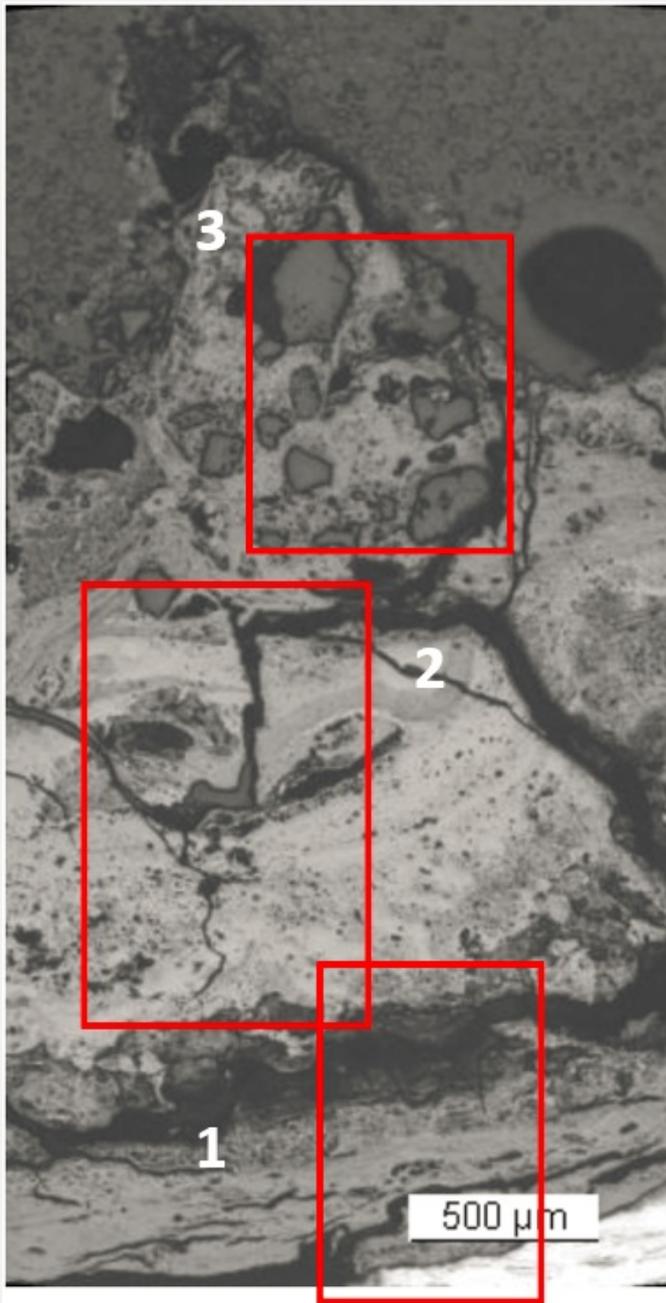
Fig. 7: Micrograph of the corrosion layer from Fig. 3 showing the metal - corrosion crust interface (detail, rotated by 45°) and corresponding to the stratigraphy of Fig. 4, unetched, bright field. The areas 1 (for CP3), 2 (for CP2) and 3 (for CP3) selected for elemental chemical distribution (Fig. 9) are marked by red rectangles,

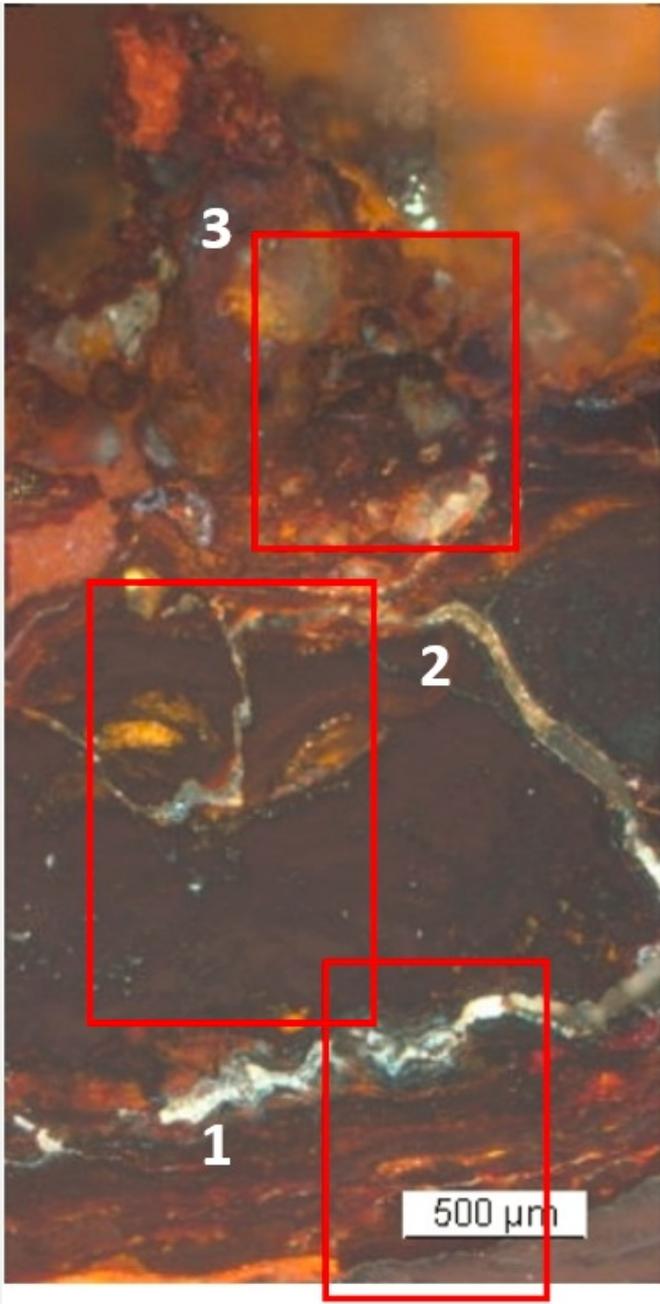
Fig. 8: Micrograph (same as Fig.7) and corresponding to the stratigraphy of Fig. 4, polarised light. The inner layer (CP3) is red-brown, area 2 is brown-violet (CP2) and the outer pale brown area contains rock fragment inclusions (CP1),

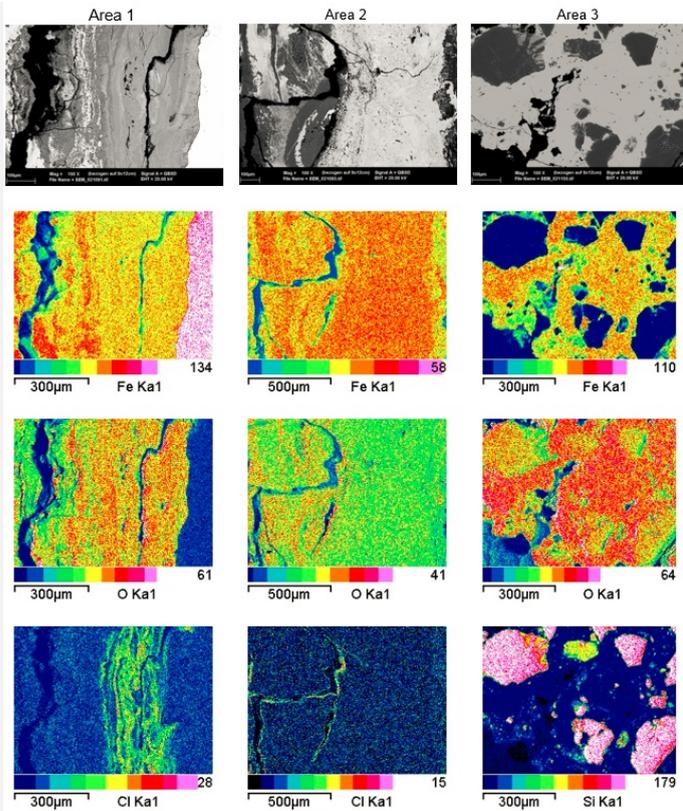
Fig. 9: SEM images, BSE-mode, and elemental chemical distribution of the selected areas from Figs. 7 and 8 (reversed picture rotated by 270°, details). First column: mapping on area 1 (CP3) where an inner layer enriched in Cl appears near the metal surface. 2nd column: area 2 (CP2) where iron oxides prevail. 3rd column: area 3 (CP1) where the outer O-rich layer includes rock fragments rich in Si. Method of examination: SEM/EDS, Lab. Anal. Chem. Empa,

This iron-based sheet is entirely cold worked and hard compared to an annealed metal. The corrosion is massive and masks the shape of the object. The presence of Cl adjacent to the metal surface indicates that the corrosion front is potentially active. The very thick top corrosion layers may have slowed down the corrosion. The object was mentioned as being Roman in Senn Bischofberger 2005, however the chemical composition of the slag inclusions shows that it is a product of the 20<sup>th</sup> century AD which has been accidentally introduced into a Roman layer.
