CORRODED METAL SHEET FN 655.13.01 – FE ALLOY – MODERN TIMES – SWITZERLAND

Artefact name	Corroded metal sheet FN 655.13.01
Authors	Marianne. Senn (EMPA, Dübendorf, Zurich, Switzerland) & Christian. Degrigny (HE-Arc CR, Neuchâtel, Neuchâtel, Switzerland)
Url	/artefacts/529/

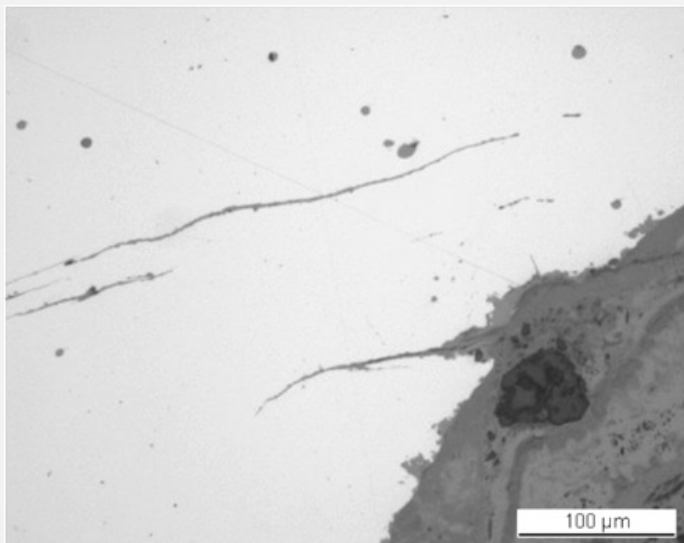
The remaining metal is an iron containing elevated (more than 1g/kg) concentrations of Co and Ni (Table 1), small round slag inclusions and cracks resulting from corrosion and deformation (Fig. 5). The composition of the round, elongated slag inclusions is similar to wüstite-FeO (Table 2). Iron reduced in the direct smelting process never contains such pure compounds and only FeO inclusions. In modern steels FeO occurs in low carbon alloys and Armco-iron (Schumann 1991, 474). After etching, the cross-section shows a heavily deformed ferritic microstructure from cold working (Fig. 6). The cracks have the same orientation as the deformation. The average hardness of the metal is HV1 195.

Fig. 5: Micrograph of metal sample from Fig. 3 (inverted picture, detail), unetched, bright field. In white the metal with round slag inclusions as well as cracks filled with corrosion products,

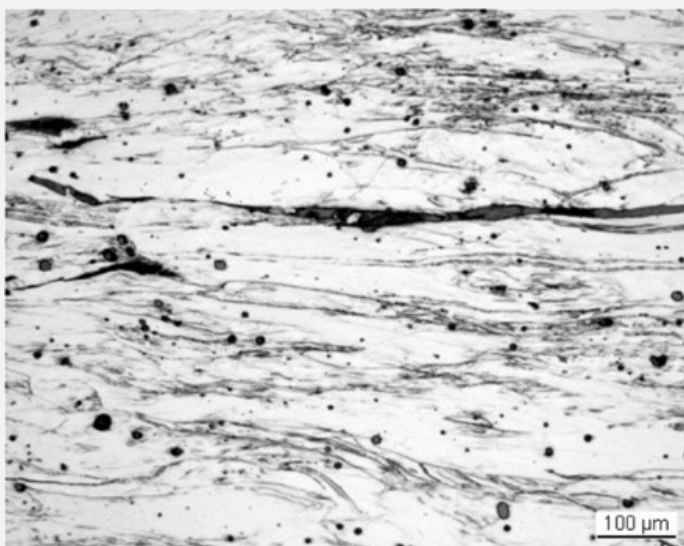
Fig. 6: Micrograph of metal sample from Fig. 3 (detail), etched, bright field. The heavily cold worked metal shows elongated grains with nearly invisible grain boundaries and cracks parallel to the grains,

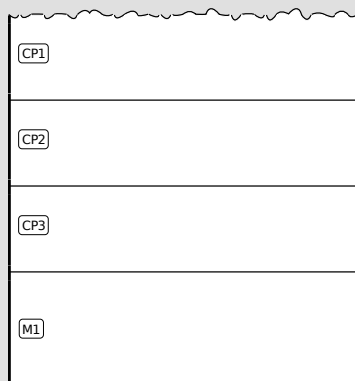
Fig. 4: Stratigraphic representation of the iron-based sheet in cross-section using the MiCorr application. The characteristics of the strata are only accessible by clicking on the drawing that redirects you to the search tool by stratigraphy representation. This representation can be compared to Figs. 7 and 8, Credit HE-Arc CR.

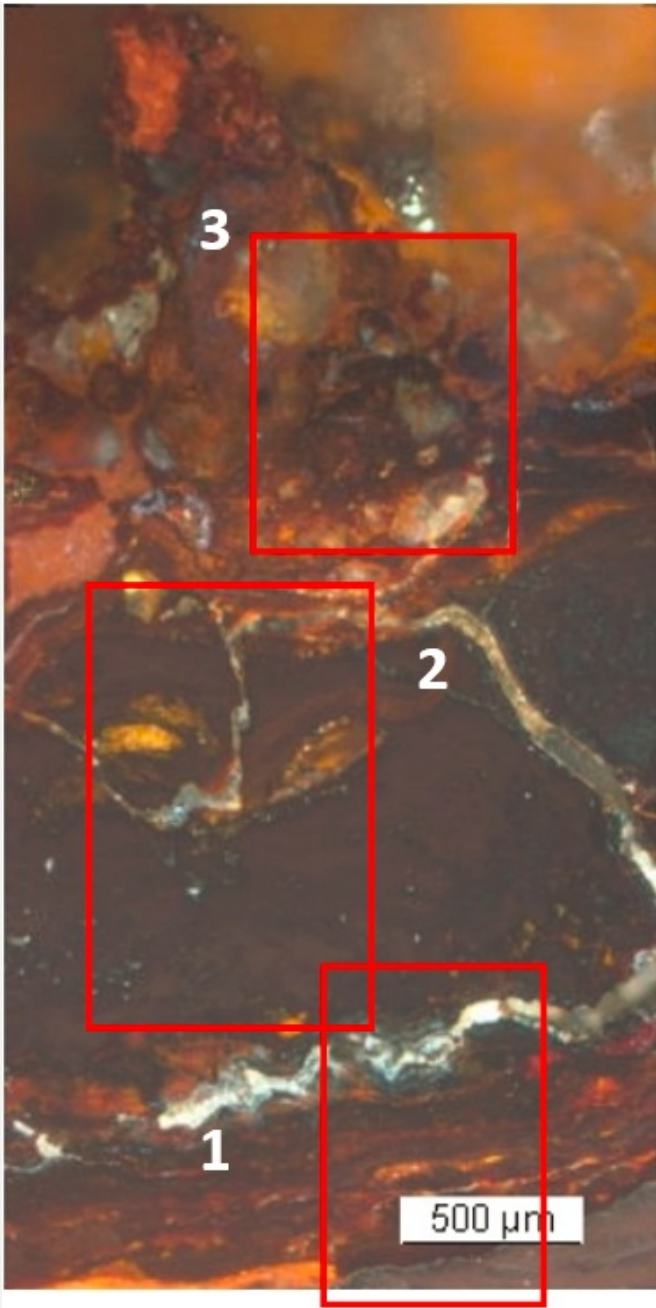
Fig. 8: Micrograph (same as Fig.7) and corresponding to the stratigraphy of Fig. 4, polarised light. The inner layer (CP3) is red-brown, area 2 is brown-violet (CP2) and the outer pale brown area contains rock fragment inclusions (CP1),

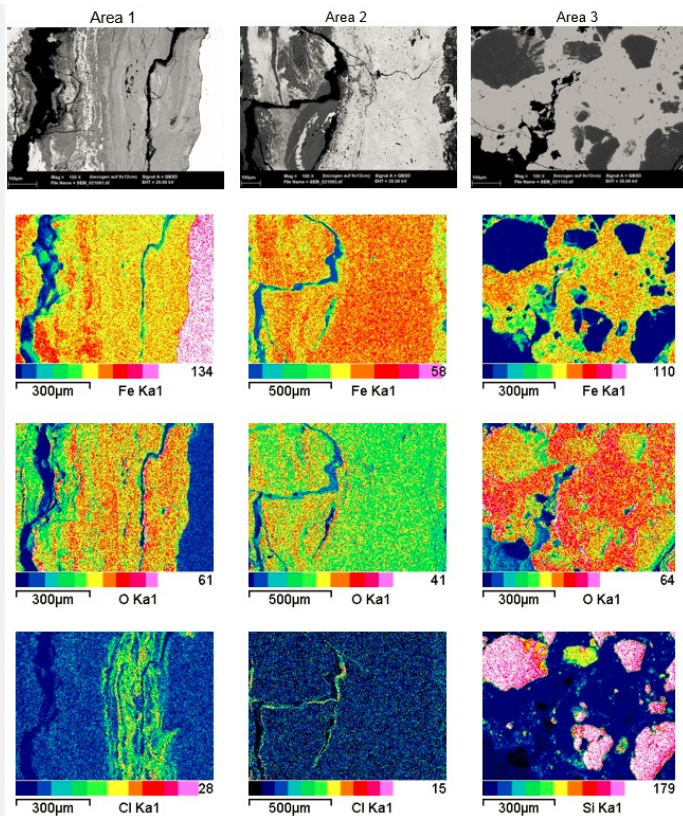
Fig. 9: SEM images, BSE-mode, and elemental chemical distribution of the selected areas from Figs. 7 and 8 (reversed picture rotated by 270°, details). First column: mapping on area 1 (CP3) where an inner layer enriched in Cl appears near the metal surface. 2nd column: area 2 (CP2) where iron oxides prevail. 3rd column: area 3 (CP1) where the outer O-rich layer includes rock fragments rich in Si. Method of examination: SEM/EDS, Lab. Anal. Chem. Empa,

This iron-based sheet is entirely cold worked and hard compared to an annealed metal. The corrosion is massive and masks the shape of the object. The presence of Cl adjacent to the metal surface indicates that the corrosion front is potentially active. The very thick top corrosion layers may have slowed down the corrosion. The object was mentioned as being Roman in Senn Bischofberger 2005, however the chemical composition of the slag inclusions shows that it is a product of the 20th century AD which has been accidentally introduced into a Roman layer.
