CORRODED METAL SHEET FN 655.13.01 – FE ALLOY – MODERN TIMES – SWITZERLAND

Artefact name	Corroded metal sheet FN 655.13.01
Authors	Marianne. Senn (EMPA, Dübendorf, Zurich, Switzerland) & Christian. Degriigny (HE-Arc CR, Neuchâtel, Neuchâtel, Switzerland)
Url	/artefacts/529/

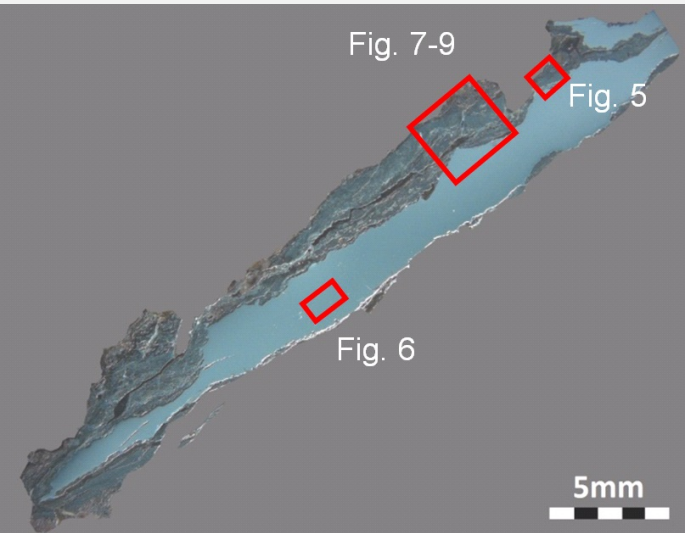
Fig. 3: Micrograph of the cross-section of the iron-based sheet showing the location of Figs. 5 to 9,

Description of sample	A longitudinal cut has been made through the sheet (Fig. 2). Large parts of the corrosion crust fell off during sampling (Fig. 3).
Alloy	Fe Alloy
Technology	Forged with final cold work
Lab number of sample	NEF 655
Sample location	Empa (Marianne Senn)
Responsible institution	Kantonsarchäologie, Dübendorf, Zurich
Date and aim of sampling	2000, metallography

The corrosion is massive and large parts of the outer corrosion layers have been lost during the sample preparation. The heavily cracked corrosion crust represents about one third of the thickness of the sample (Fig. 3) and is located on one side of the metal (the rest having been lost during the cutting process). It does not show well defined layers. Despite this, three areas can be distinguished (Figs. 7 and 8). Adhering to the metal (area 1), we find an orange-red-brown layer enriched in Cl (CP3 in Fig. 4, Fig. 9 and Table 3). The dark or violet middle area 2 is richer in Fe (CP2 in Fig. 4). The outer area 3 is red-brown (CP1 in Fig. 4) and strongly contaminated by soil material (rock fragment inclusion and elements like Si, Al, P etc.). This layer is enriched in O (Fig. 9).

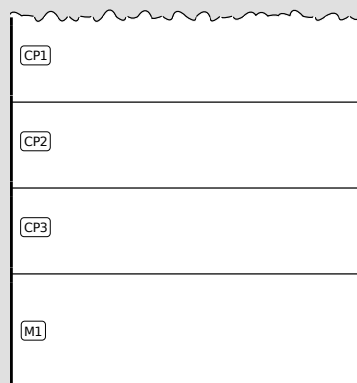
Fig. 4: Stratigraphic representation of the iron-based sheet in cross-section using the MiCorr application. The characteristics of the strata are only accessible by clicking on the drawing that redirects you to the search tool by stratigraphy representation. This representation can be compared to Figs. 7 and 8, Credit HE-Arc CR.

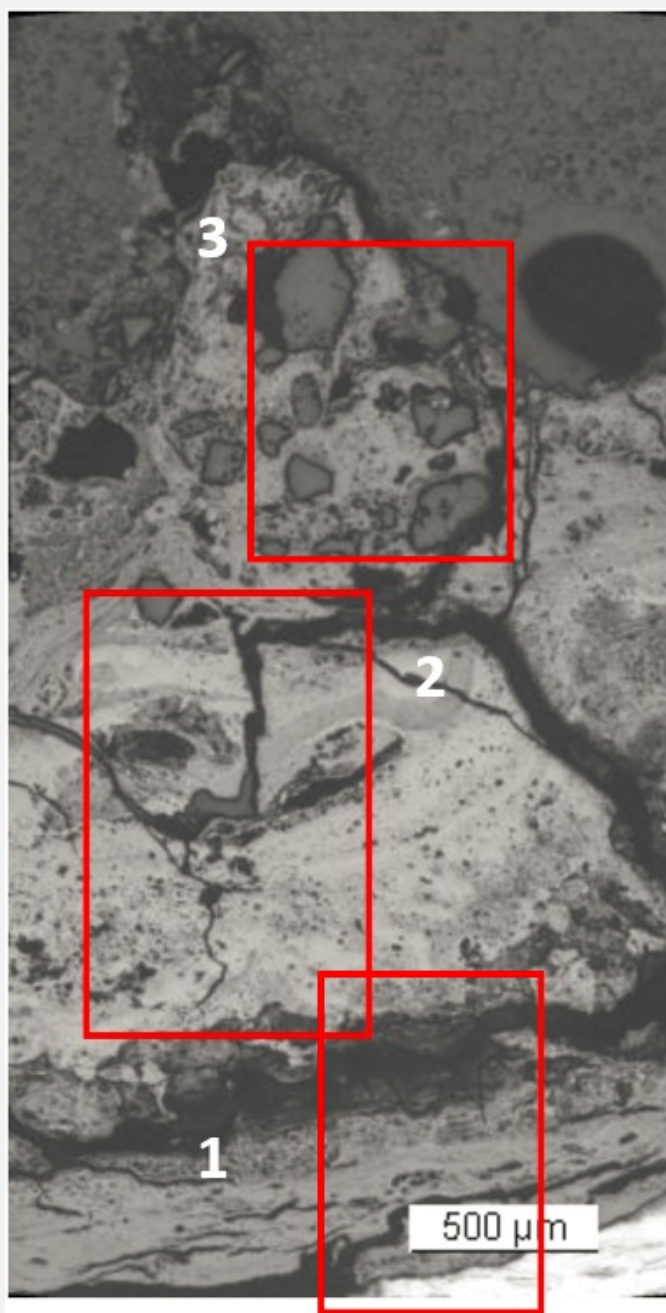
Fig. 7: Micrograph of the corrosion layer from Fig. 3 showing the metal - corrosion crust interface (detail, rotated by 45°) and corresponding to the stratigraphy of Fig. 4, unetched, bright field. The areas 1 (for CP3), 2 (for CP2) and 3 (for CP3) selected for elemental chemical distribution (Fig. 9) are marked by red rectangles,

Fig. 8: Micrograph (same as Fig.7) and corresponding to the stratigraphy of Fig. 4, polarised light. The inner layer (CP3) is red-brown, area 2 is brown-violet (CP2) and the outer pale brown area contains rock fragment inclusions (CP1),

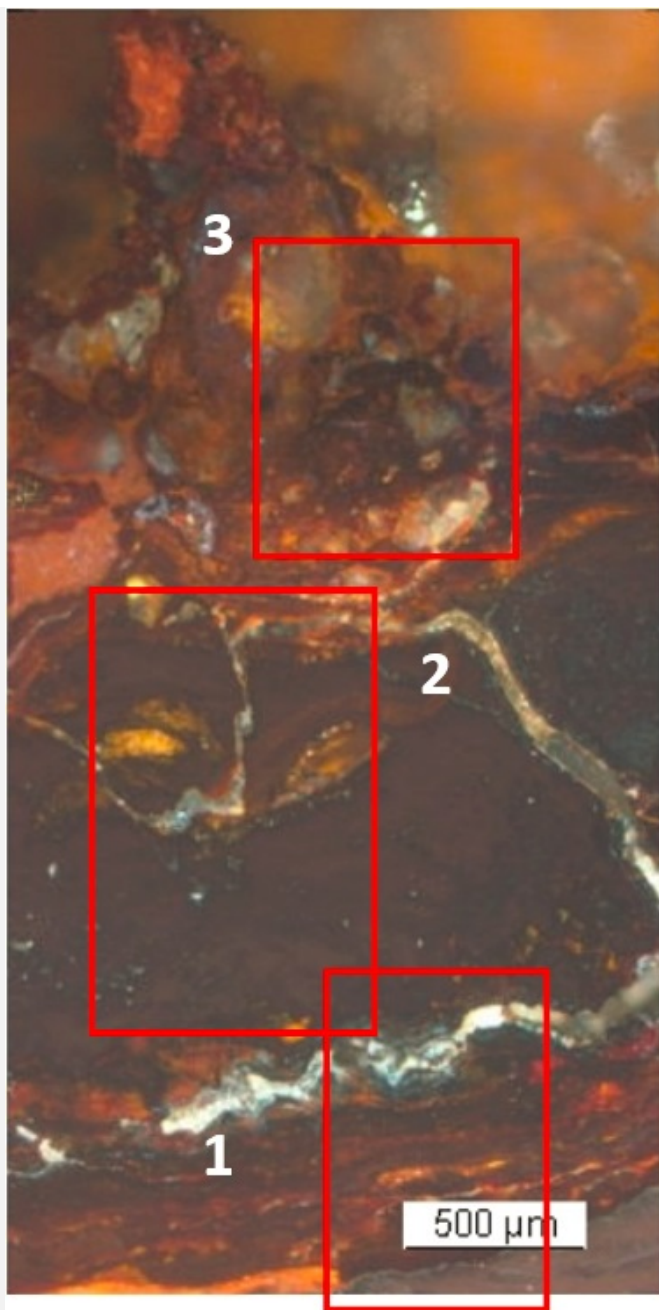
Fig. 9: SEM images, BSE-mode, and elemental chemical distribution of the selected areas from Figs. 7 and 8 (reversed picture rotated by 270°, details). First column: mapping on area 1 (CP3) where an inner layer enriched in Cl appears near the metal surface. 2nd column: area 2 (CP2) where iron oxides prevail. 3rd column: area 3 (CP1) where the outer O-rich layer includes rock fragments rich in Si. Method of examination: SEM/EDS, Lab. Anal. Chem. Empa,

This iron-based sheet is entirely cold worked and hard compared to an annealed metal. The corrosion is massive and masks the shape of the object. The presence of Cl adjacent to the metal surface indicates that the corrosion front is potentially active. The very thick top corrosion layers may have slowed down the corrosion. The object was mentioned as being Roman in Senn Bischofberger 2005, however the chemical composition of the slag inclusions shows that it is a product of the 20th century AD which has been accidentally introduced into a Roman layer.
