# CORRODED METAL SHEET FN 655.13.01 – FE ALLOY – MODERN TIMES – SWITZERLAND

<b>Artefact name</b>	Corroded metal sheet FN 655.13.01
<b>Authors</b>	Marianne. Senn (EMPA, Dübendorf, Zurich, Switzerland) & Christian. Degrigny (HE-Arc CR, Neuchâtel, Neuchâtel, Switzerland)
<b>Url</b>	/artefacts/529/

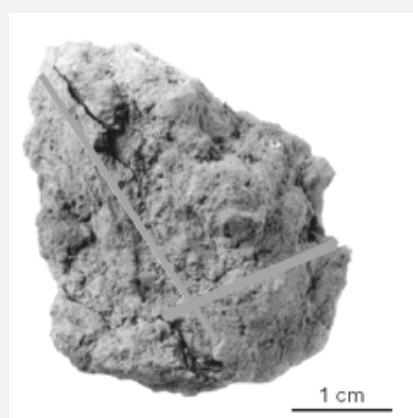
Fig. 1: Metal sheet (after Senn Bischofberger 2005, 137),

<b>Description of the artefact</b>	Metal (iron-based) sheet with middle rib. The shape is no longer discernible (Fig. 1). The metal is covered by a thick corrosion crust. Dimensions: L = 4.5cm; WT = 35g.
<b>Type of artefact</b>	Iron (and steel) sheet
<b>Origin</b>	Steinmöri, Neftenbach / Dorf Neftenbach, Zurich, Switzerland
<b>Recovering date</b>	Excavation of the Roman villa, 1986-1990, phase S2, StbII.2 (2nd/3rd century AD)
<b>Chronology category</b>	Modern Times
<b>chronology tpq</b>	<input type="text" value="1900"/> A.D. ▼
<b>chronology taq</b>	<input type="text" value="2000"/> A.D. ▼
<b>Chronology comment</b>	Product of the 20th century AD introduced accidentally into a Roman layer
<b>Burial conditions / environment</b>	Soil
<b>Artefact location</b>	Kantonsarchäologie, Dübendorf, Zurich
<b>Owner</b>	Kantonsarchäologie, Dübendorf, Zurich

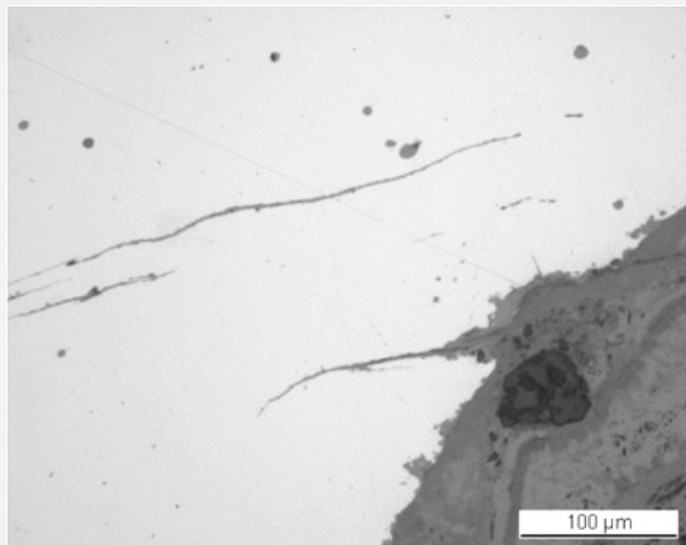
The remaining metal is an iron containing elevated (more than 1g/kg) concentrations of Co and Ni (Table 1), small round slag inclusions and cracks resulting from corrosion and deformation (Fig. 5). The composition of the round, elongated slag inclusions is similar to wüstite-FeO (Table 2). Iron reduced in the direct smelting process never contains such pure compounds and only FeO inclusions. In modern steels FeO occurs in low carbon alloys and Armco-iron (Schumann 1991, 474). After etching, the cross-section shows a heavily deformed ferritic microstructure from cold working (Fig. 6). The cracks have the same orientation as the deformation. The average hardness of the metal is HV1 195.

Fig. 5: Micrograph of metal sample from Fig. 3 (inverted picture, detail), unetched, bright field. In white the metal with round slag inclusions as well as cracks filled with corrosion products,

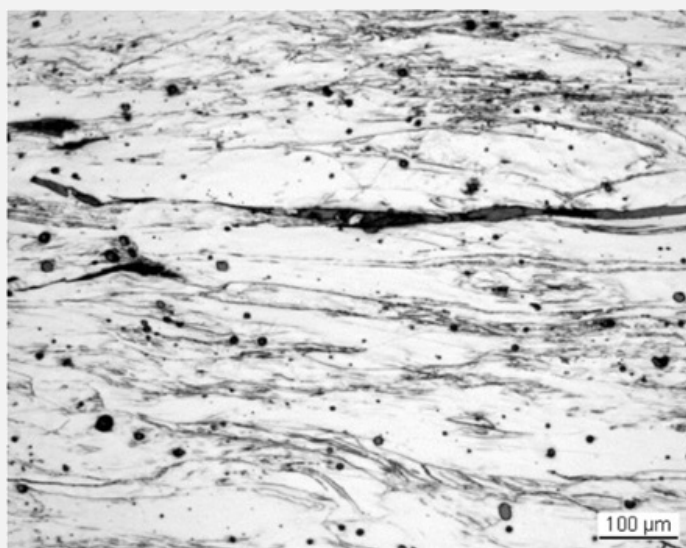
Fig. 6: Micrograph of metal sample from Fig. 3 (detail), etched, bright field. The heavily cold worked metal shows elongated grains with nearly invisible grain boundaries and cracks parallel to the grains,

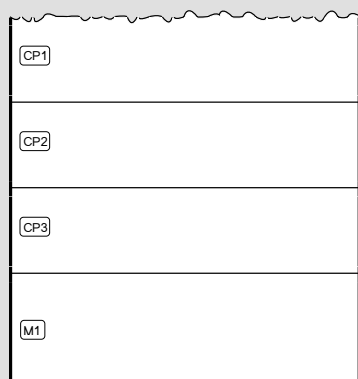
and Table 3). The dark or violet middle area 2 is richer in Fe (CP2 in Fig. 4). The outer area 3 is red-brown (CP1 in Fig. 4) and strongly contaminated by soil material (rock fragment inclusion and elements like Si, Al, P etc.). This layer is enriched in O (Fig. 9).

Fig. 4: Stratigraphic representation of the iron-based sheet in cross-section using the MiCorr application. The characteristics of the strata are only accessible by clicking on the drawing that redirects you to the search tool by stratigraphy representation. This representation can be compared to Figs. 7 and 8, Credit HE-Arc CR.

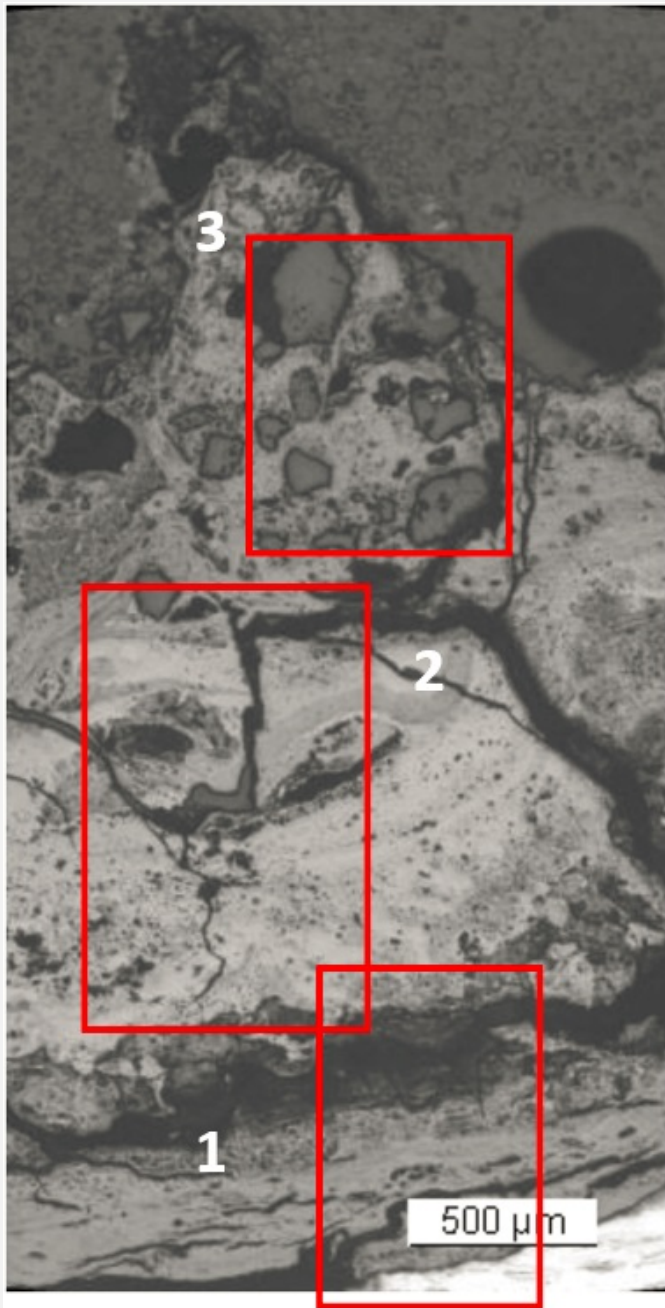
Fig. 7: Micrograph of the corrosion layer from Fig. 3 showing the metal - corrosion crust interface (detail, rotated by 45°) and corresponding to the stratigraphy of Fig. 4, unetched, bright field. The areas 1 (for CP3), 2 (for CP2) and 3 (for CP3) selected for elemental chemical distribution (Fig. 9) are marked by red rectangles,
