# CHISEL POINT DEV 995 1069 PR – EUTECTOID TO HYPEREUTECTOID STEEL – EARLY MEDIEVAL TIMES – SWITZERLAND

<b>Artefact name</b>	Chisel point DEV 995 1069 PR
<b>Authors</b>	Marianne. Senn (EMPA, Dübendorf, Zurich, Switzerland) & Christian. Degriigny (HE-Arc CR, Neuchâtel, Neuchâtel, Switzerland)
<b>Url</b>	/artefacts/530/

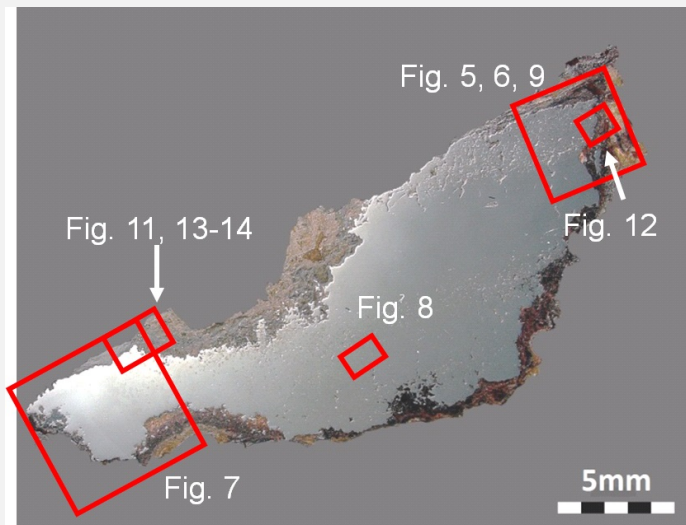
Fig. 3: Micrograph of the cross-section of the chisel point showing the location of Figs. 5 to 9 and 11 to 14,

A longitudinal cut from a chisel point (Figs. 2 and 3) undertaken after restoration. Dimensions: L = 30mm; W = 11mm (approximately).

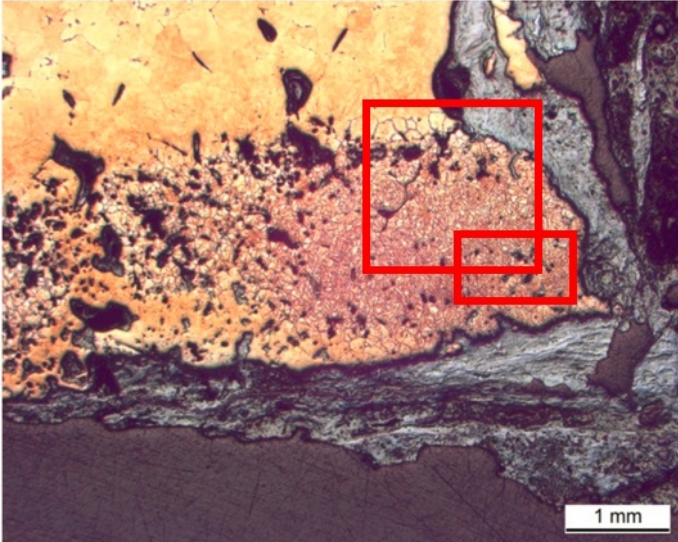
The remaining metal is a eutectoid to hypereutectoid steel (C 0.8-1 mass%) with cracks and porosity (Figs. 5 and 6). Its composition is given in Table 1 (except Fe). Of the trace elements, only Ni reaches a medium concentration (Ni 0.07 mass%). The composition and the high Ni/Co ratio are atypical for iron worked in smithies of the settlement at Develier-Courtételle JU, CH. The few slag inclusions and their chemical composition confirm this (Table 2). The slag is rich in CaO whereas the pisolithic or bean ore worked in the Central Jura smelting district is rich in Al<sub>2</sub>O<sub>3</sub>. The slag inclusions cannot be smithing slag because the artefact is formed from one piece of metal. The slag probably incorporated while refining the bloom or during the bloom smelting process. The ore from which this metal was smelted cannot yet be identified. Intergranular corrosion has developed, penetrating into the metal structure (Fig. 6). The etched metal shows a dominant martensitic structure, typical of quench hardened steel (Figs. 5, 7, 8 and 9). The characteristic forms of the martensite are non-organised needles (Fig. 8). In restricted areas bainite nodules occur (Figs. 7 and 8). In the centre of the point, hypereutectoid steel is composed of cementite in the grain boundaries and in needle like shapes within the grains (Fig. 10). Hypereutectoid regions also occur in the centre of the shaft and on its left surface (Fig. 5). Here the hypereutectoid steel is composed of martensite and cementite in the grain boundaries and in needle form within the grains (Figs. 6 and 9). Nevertheless, most of the chisel is dominated by eutectoid steel. The average hardness of the quench hardened eutectoid steel is about HV1 690. In the bainite nodules the average hardness drops to about HV1 350, the martensite has an average hardness of HV1 750.

Fig. 5: Micrograph of the metal sample from Fig. 3 (inverted picture, detail), etched, bright field. The metal contains porosity and cracks (in black). The micrographs of Figs. 6 and 9 are marked by the top and bottom rectangles respectively,

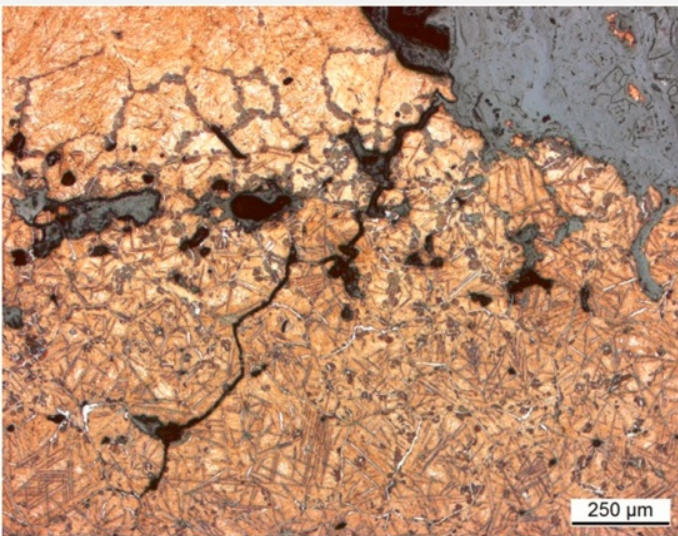
Fig. 6: Micrograph of the metal sample, detail from Fig. 5, etched, bright field. We observe martensite (in orange), cementite (in grey), porosity and intergranular cracks (in black) and corrosion,

The tool is made of hard, eutectoid to hypereutectoid steel and was, as a last manufacturing step, entirely quenched. In this state it is too hard and brittle to be used. It is likely that the quenched hypereutectoid structure provoked the breakage of the tool when it was first used. The absence of a tempering process at the end is unclear. The chemical composition of the metal and the slag inclusions indicate that the artefact was imported to the hamlet of Develier-Courtételle JU. The corrosion has, in areas, replaced the metal structure retaining a ghost structure; the outer layer has been mostly removed during surface cleaning. Extensive pitting corrosion has occurred, typical for steel with an elevated C content. The presence of S in the inner layer can be explained by putrefaction processes in the soil. Chlorides are still present at the metal-corrosion interface as no desalination process was attempted. Iron carbonates are present in the centre of a corrosion pit. The corrosion is of terrestrial type.

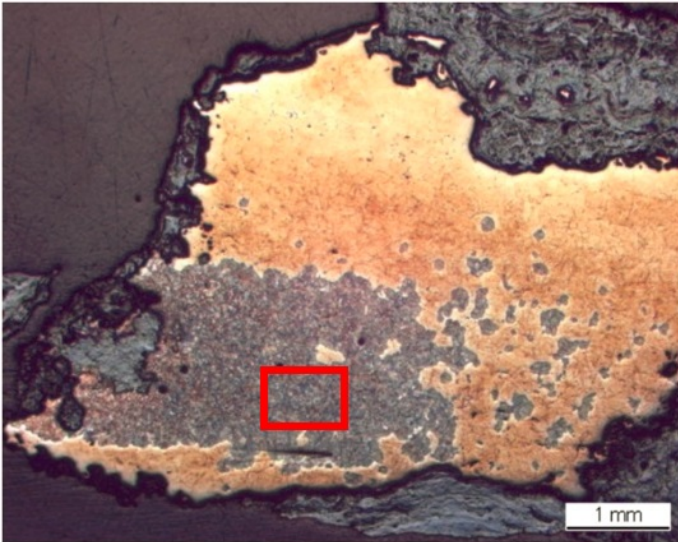
Fig. 8: Micrograph of the metal sample from Fig. 3 (detail), etched, bright field. We observe dark bainite nodules combined with martensite needles,

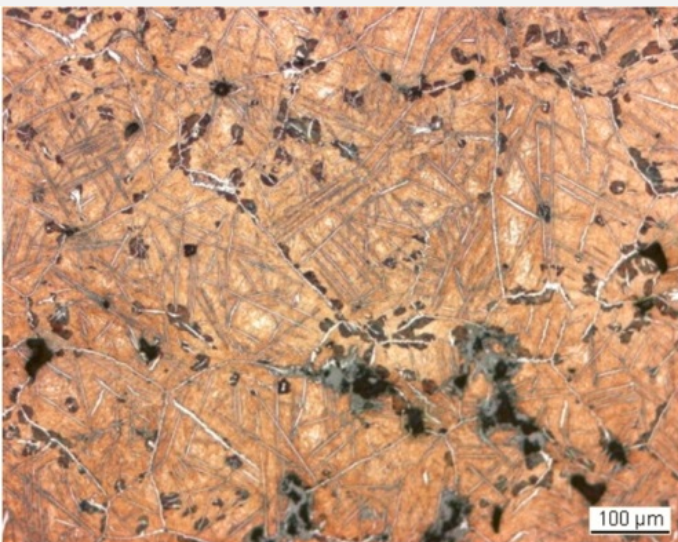
Fig. 10: Micrograph of the metal sample, detail from Fig. 7, etched, bright field. Hypereutectoid steel with a structure of cementite in white in the grain boundaries and in needle form combined with bainite (dark),

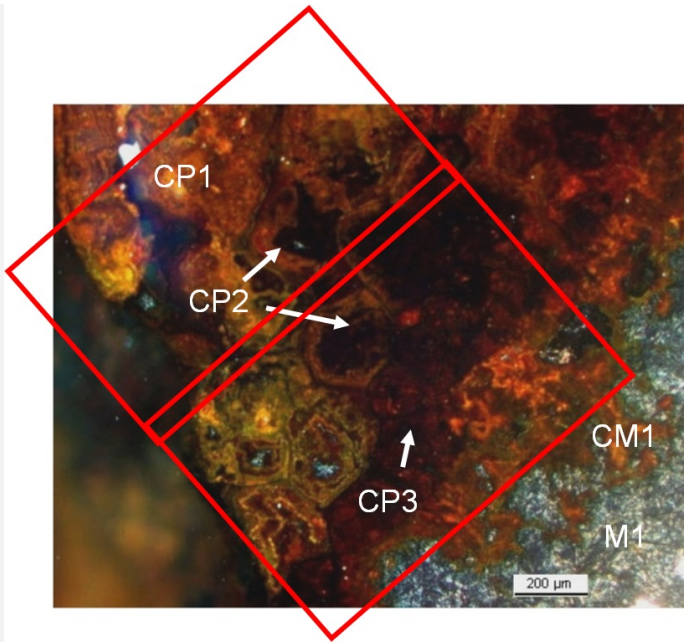
The metal is heavily corroded and the thickness of the corrosion crust is irregular, but averages about 0.5mm. The corrosion products enclose different ghost structures: the corrosion crust has preserved the shape of polygonal grains (Figs. 11 and 13) and cementite needles (Fig. 12). Under polarised light, the corrosion products at the metal - corrosion crust interface are dark-red and form an inner S-rich layer (CP3, Figs. 11 and 13). Cl occurs locally (CP3) and C is present in layers CP2 and CP3 (Fig. 13). The outer layer of the corrosion products (CP1) is orange and contains more O than the inner layer CP3 (Figs. 11 and 14).

Fig. 11: Micrograph showing the metal - corrosion crust interface from Fig. 3 (rotated by 270°, detail) and corresponding to the stratigraphy of Fig. 4, unetched, polarised light. Polygonal grains are visible as ghost structure in the corrosion crust. The selected areas for elemental chemical distribution (Figs. 13 and 14) are marked by two rectangles (bottom: Fig. 13 and top: Fig. 14),

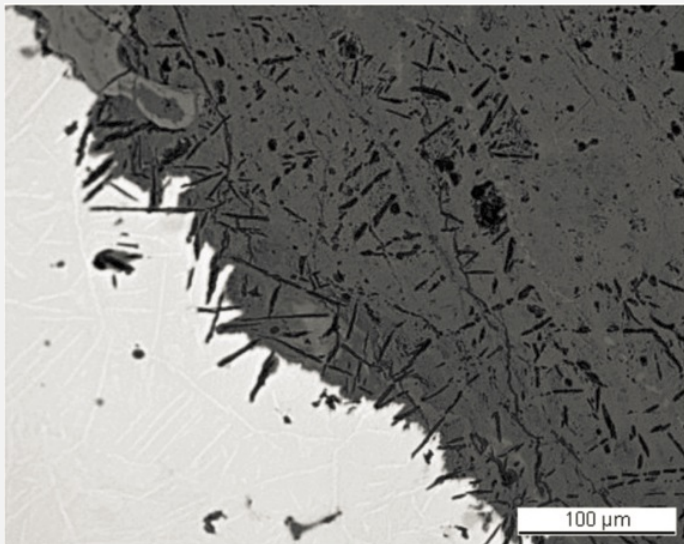
Fig. 12: Micrograph showing the metal - corrosion crust interface from Fig. 3 (detail), unetched, bright field. The cementite is visible as white needles in the metal and its ghost structure as black needles in the corrosion crust,

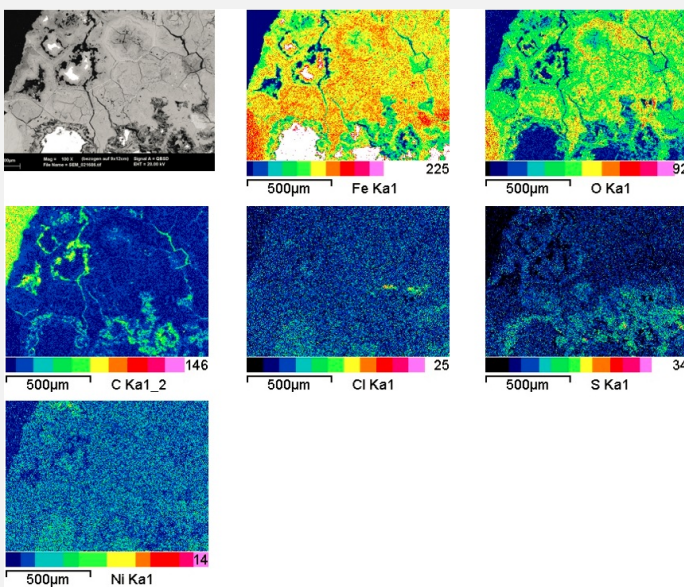
Fig. 13: SEM image, BSE-mode, and elemental chemical distribution of the selected area from Fig. 11 (rotated by 45°). Method of examination: SEM/EDS, Laboratory of Analytical Chemistry, Empa,

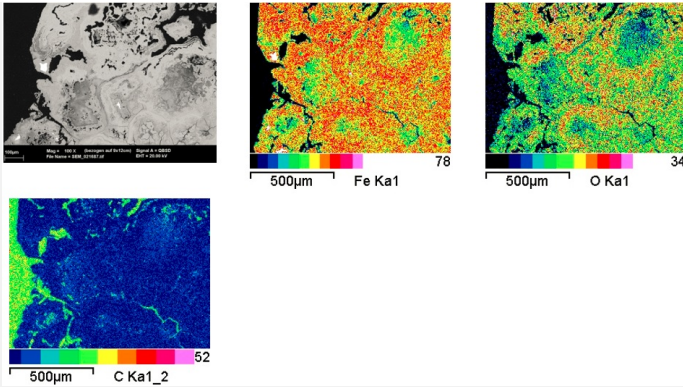
Fig. 14: SEM image, BSE-mode, and elemental chemical distribution of the selected area from Fig. 11 (rotated by 45°). Method of examination: SEM/EDS, Laboratory of Analytical Chemistry, Empa,

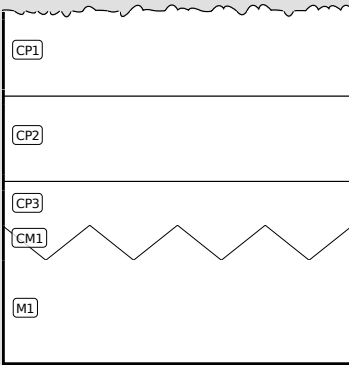
Fig. 4: Stratigraphic representation of the chisel point in cross-section using the MiCorr application. The characteristics of the strata are only accessible by clicking on the drawing that redirects you to the search tool by stratigraphy representation. This representation can be compared to Fig. 11, Credit HE-Arc CR.
