CHISEL POINT DEV 995 1069 PR – EUTECTOID TO HYPEREUTECTOID STEEL – EARLY MEDIEVAL TIMES – SWITZERLAND

Artefact name	Chisel point DEV 995 1069 PR
Authors	Marianne. Senn (EMPA, Dübendorf, Zurich, Switzerland) & Christian. Degrieny (HE-Arc CR, Neuchâtel, Neuchâtel, Switzerland)
Url	/artefacts/530/

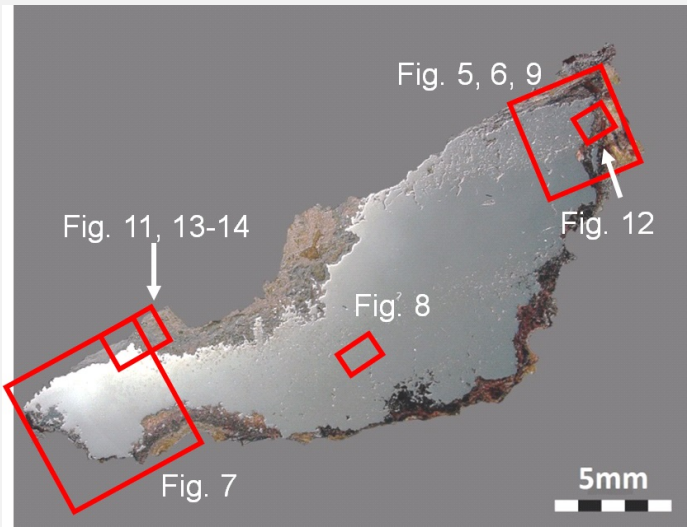
Fig. 3: Micrograph of the cross-section of the chisel point showing the location of Figs. 5 to 9 and 11 to 14,

A longitudinal cut from a chisel point (Figs. 2 and 3) undertaken after restoration. Dimensions: L = 30mm; W = 11mm (approximately).

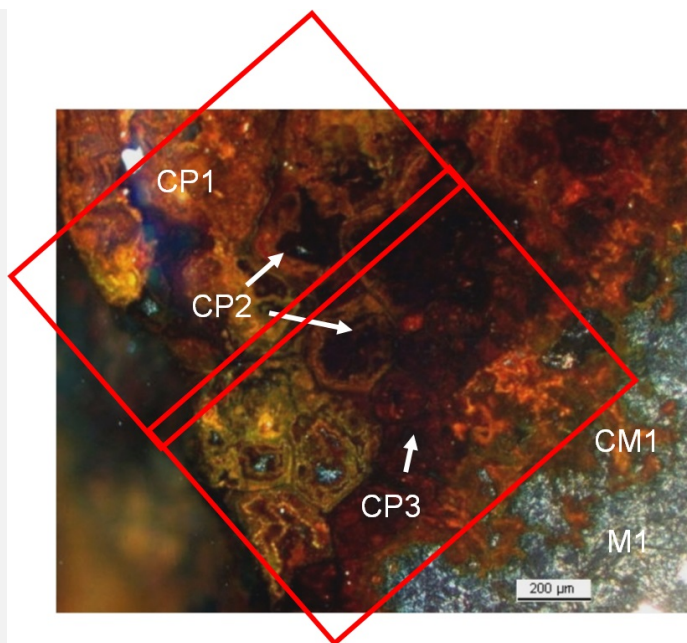
The metal is heavily corroded and the thickness of the corrosion crust is irregular, but averages about 0.5mm. The corrosion products enclose different ghost structures: the corrosion crust has preserved the shape of polygonal grains (Figs. 11 and 13) and cementite needles (Fig. 12). Under polarised light, the corrosion products at the metal - corrosion crust interface are dark-red and form an inner S-rich layer (CP3, Figs. 11 and 13). Cl occurs locally (CP3) and C is present in layers CP2 and CP3 (Fig. 13). The outer layer of the corrosion products (CP1) is orange and contains more O than the inner layer CP3 (Figs. 11 and 14).

Fig. 11: Micrograph showing the metal - corrosion crust interface from Fig. 3 (rotated by 270°, detail) and corresponding to the stratigraphy of Fig. 4, unetched, polarised light. Polygonal grains are visible as ghost structure in the corrosion crust. The selected areas for elemental chemical distribution (Figs. 13 and 14) are marked by two rectangles (bottom: Fig. 13 and top: Fig. 14),

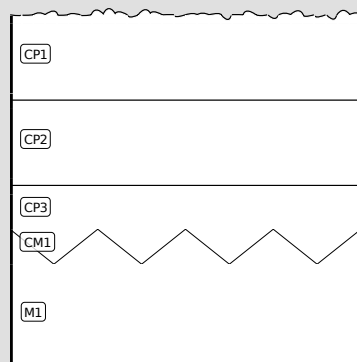
Fig. 4: Stratigraphic representation of the chisel point in cross-section using the MiCorr application. The characteristics of the strata are only accessible by clicking on the drawing that redirects you to the search tool by stratigraphy representation. This representation can be compared to Fig. 11, Credit HE-Arc CR.
