CHISEL POINT DEV 995 1069 PR – EUTECTOID TO HYPEREUTECTOID STEEL – EARLY MEDIEVAL TIMES – SWITZERLAND

Artefact name Chisel point DEV 995 1069 PR

Authors Marianne. Senn (EMPA, Dübendorf, Zurich, Switzerland) & Christian. Degriigny (HE-Arc CR, Neuchâtel, Neuchâtel, Switzerland)

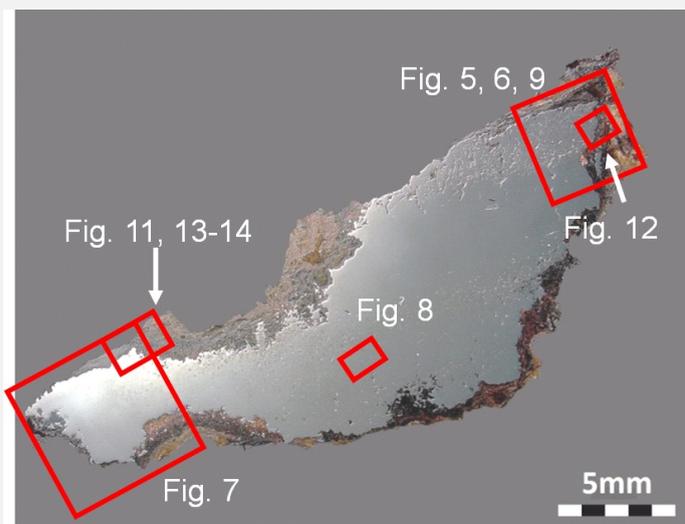
Fig. 3: Micrograph of the cross-section of the chisel point showing the location of Figs. 5 to 9 and 11 to 14,

Description of sample	A longitudinal cut from a chisel point (Figs. 2 and 3) undertaken after restoration. Dimensions: L = 30mm; W = 11mm (approximately).
Alloy	Eutectoid to hypereutectoid steel
Technology	Quench hardened
Lab number of sample	DEV1069
Sample location	Empa (Marianne Senn)
Responsible institution	Office de la Culture, Porrentruy, Jura
Date and aim of sampling	2000, metallography and chemical composition of the metal

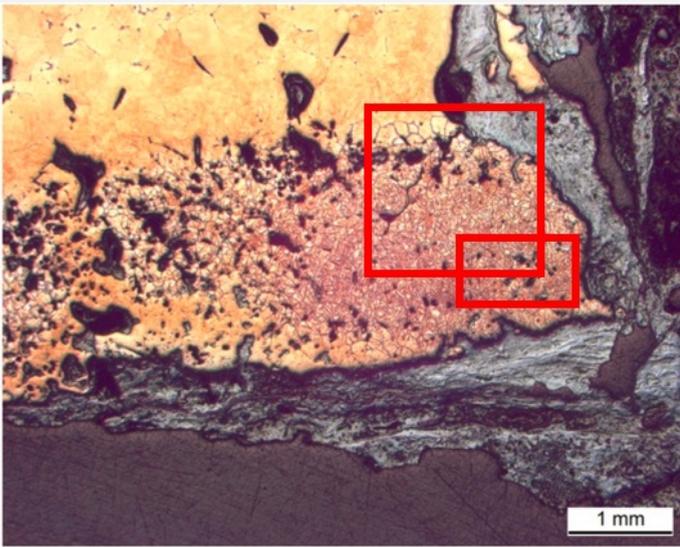
The remaining metal is a eutectoid to hypereutectoid steel (C 0.8-1 mass%) with cracks and porosity (Figs. 5 and 6). Its composition is given in Table 1 (except Fe). Of the trace elements, only Ni reaches a medium concentration (Ni 0.07 mass%). The composition and the high Ni/Co ratio are atypical for iron worked in smithies of the settlement at Develier-Courtételle JU, CH. The few slag inclusions and their chemical composition confirm this (Table 2). The slag is rich in CaO whereas the pisolithic or bean ore worked in the Central Jura smelting district is rich in Al₂O₃. The slag inclusions cannot be smithing slag because the artefact is formed from one piece of metal. The slag probably incorporated while refining the bloom or during the bloom smelting process. The ore from which this metal was smelted cannot yet be identified. Intergranular corrosion has developed, penetrating into the metal structure (Fig. 6). The etched metal shows a dominant martensitic structure, typical of quench hardened steel (Figs. 5, 7, 8 and 9). The characteristic forms of the martensite are non-organised needles (Fig. 8). In restricted areas bainite nodules occur (Figs. 7 and 8). In the centre of the point, hypereutectoid steel is composed of cementite in the grain boundaries and in needle like shapes within the grains (Fig. 10). Hypereutectoid regions also occur in the centre of the shaft and on its left surface (Fig. 5). Here the hypereutectoid steel is composed of martensite and cementite in the grain boundaries and in needle form within the grains (Figs. 6 and 9). Nevertheless, most of the chisel is dominated by eutectoid steel. The average hardness of the quench hardened eutectoid steel is about HV1 690. In the bainite nodules the average hardness drops to about HV1 350, the martensite has an average hardness of HV1 750.

Fig. 5: Micrograph of the metal sample from Fig. 3 (inverted picture, detail), etched, bright field. The metal contains porosity and cracks (in black). The micrographs of Figs. 6 and 9 are marked by the top and bottom rectangles respectively,

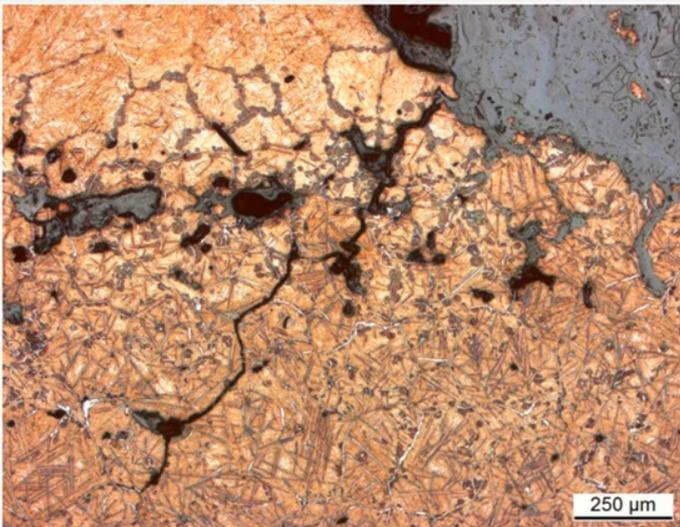
Fig. 6: Micrograph of the metal sample, detail from Fig. 5, etched, bright field. We observe martensite (in orange), cementite (in grey), porosity and intergranular cracks (in black) and corrosion,

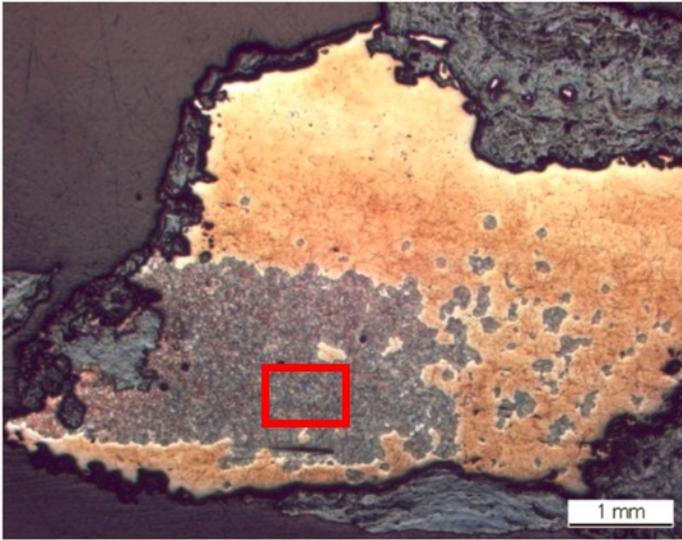
Fig. 7: Micrograph of the metal sample from Fig. 3 (inverted picture, detail), etched, bright field. We observe the metal with martensite (orange) and bainite nodules (blue). The micrograph of Fig. 10 is marked by a rectangle,

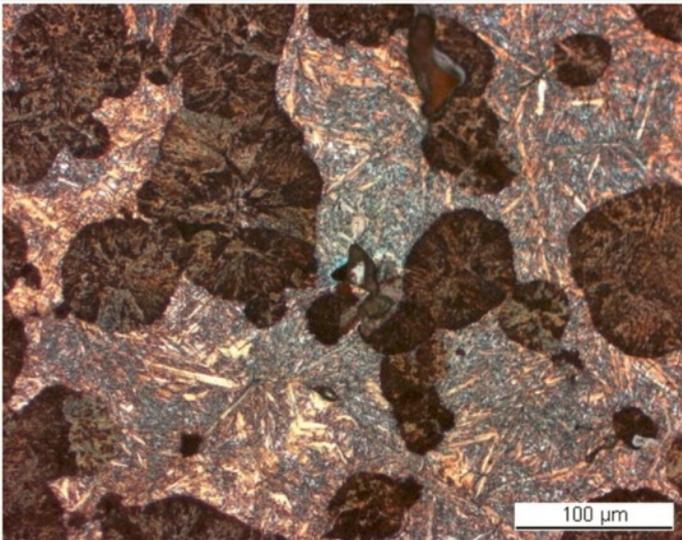
Fig. 8: Micrograph of the metal sample from Fig. 3 (detail), etched, bright field. We observe dark bainite nodules combined with martensite needles,

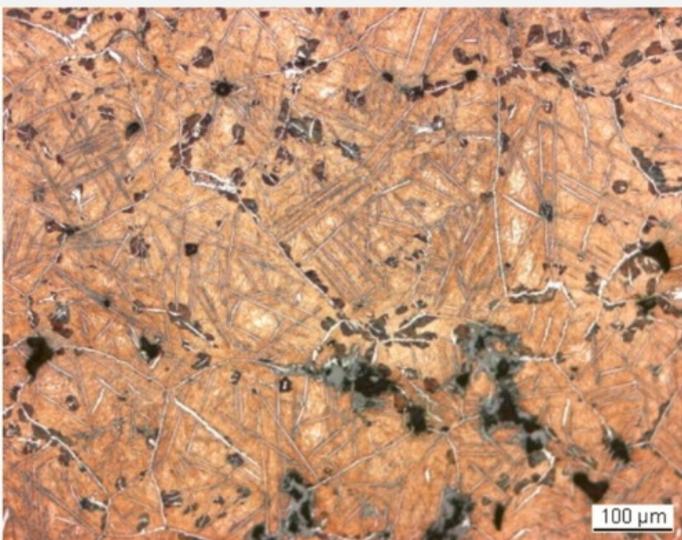
Fig. 9: Micrograph of the metal sample, detail from Fig. 5, etched, bright field. Hypereutectoid steel with a structure of cementite in white in the grain boundaries and in needle form combined with martensite (pink). Some bainite occurs around the grain boundaries,

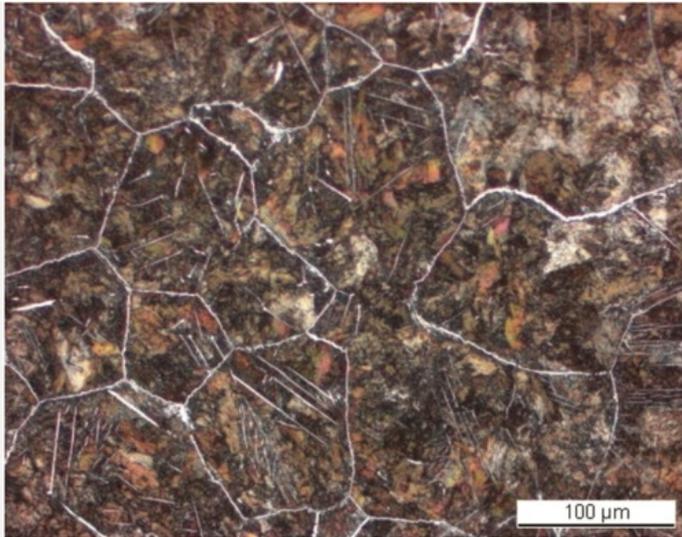
Fig. 10: Micrograph of the metal sample, detail from Fig. 7, etched, bright field. Hypereutectoid steel with a structure of cementite in white in the grain boundaries and in needle form combined with bainite (dark),

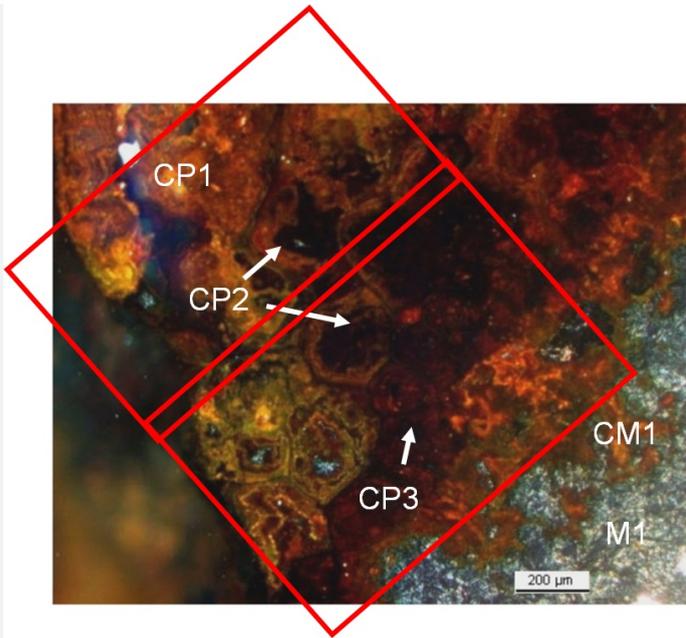
The metal is heavily corroded and the thickness of the corrosion crust is irregular, but averages about 0.5mm. The corrosion products enclose different ghost structures: the corrosion crust has preserved the shape of polygonal grains (Figs. 11 and 13) and cementite needles (Fig. 12). Under polarised light, the corrosion products at the metal - corrosion crust interface are dark-red and form an inner S-rich layer (CP3, Figs. 11 and 13). Cl occurs locally (CP3) and C is present in layers CP2 and CP3 (Fig. 13). The outer layer of the corrosion products (CP1) is orange and contains more O than the inner layer CP3 (Figs. 11 and 14).

Fig. 11: Micrograph showing the metal - corrosion crust interface from Fig. 3 (rotated by 270°, detail) and corresponding to the stratigraphy of Fig. 4, unetched, polarised light. Polygonal grains are visible as ghost structure in the corrosion crust. The selected areas for elemental chemical distribution (Figs. 13 and 14) are marked by two rectangles (bottom: Fig. 13 and top: Fig. 14),

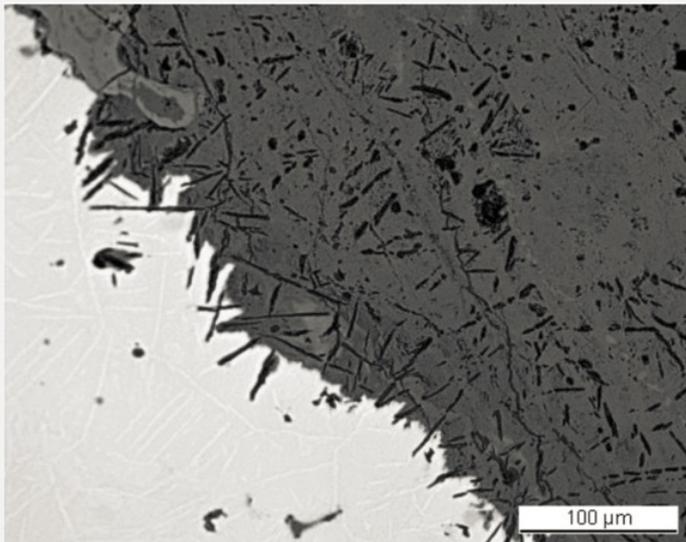
Fig. 12: Micrograph showing the metal - corrosion crust interface from Fig. 3 (detail), unetched, bright field. The cementite is visible as white needles in the metal and its ghost structure as black needles in the corrosion crust,

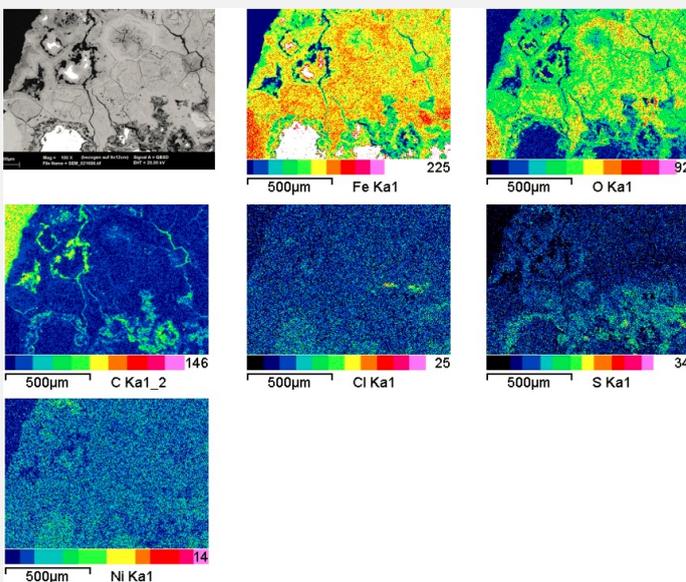
Fig. 13: SEM image, BSE-mode, and elemental chemical distribution of the selected area from Fig. 11 (rotated by 45°). Method of examination: SEM/EDS, Laboratory of Analytical Chemistry, Empa,

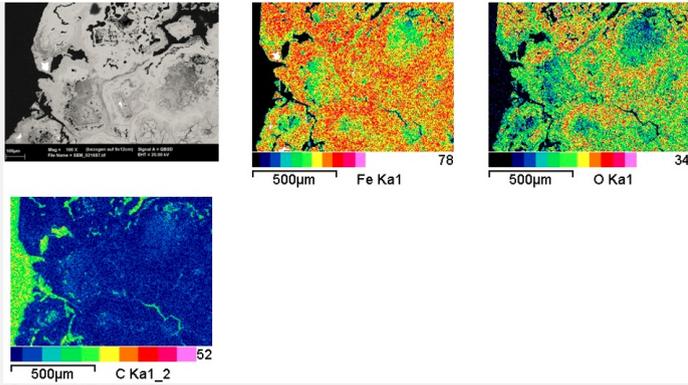
Fig. 14: SEM image, BSE-mode, and elemental chemical distribution of the selected area from Fig. 11 (rotated by 45°). Method of examination: SEM/EDS, Laboratory of Analytical Chemistry, Empa,

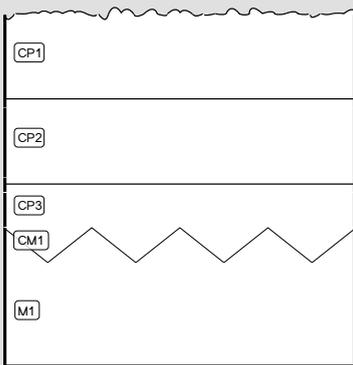
Fig. 4: Stratigraphic representation of the chisel point in cross-section using the MiCorr application. The characteristics of the strata are only accessible by clicking on the drawing that redirects you to the search tool by stratigraphy representation. This representation can be compared to Fig. 11, Credit HE-Arc CR.
