# CHISEL POINT DEV 995 1069 PR - EUTECTOID TO HYPEREUTECTOID STEEL - EARLY MEDIEVAL TIMES - SWITZERLAND

**Artefact name** Chisel point DEV 995 1069 PR

**Authors** Marianne. Senn (EMPA, Dübendorf, Zurich, Switzerland) & Christian. Degrigny (HE-Arc CR, Neuchâtel, Neuchâtel, Switzerland)

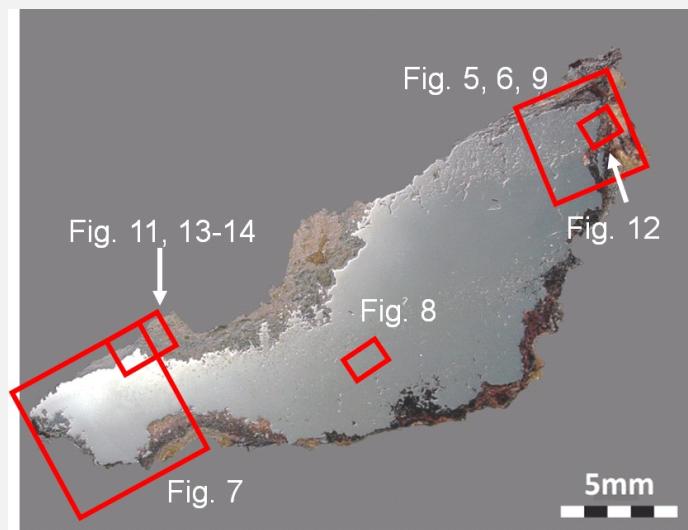
Fig. 3: Micrograph of the cross-section of the chisel point showing the location of Figs. 5 to 9 and 11 to 14,

<b>Description of sample</b>	A longitudinal cut from a chisel point (Figs. 2 and 3) undertaken after restoration. Dimensions: L = 30mm; W = 11mm (approximately).
<b>Alloy</b>	Eutectoid to hypereutectoid steel
<b>Technology</b>	Quench hardened
<b>Lab number of sample</b>	DEV1069
<b>Sample location</b>	Empa (Marianne Senn)
<b>Responsible institution</b>	Office de la Culture, Porrentruy, Jura
<b>Date and aim of sampling</b>	2000, metallography and chemical composition of the metal

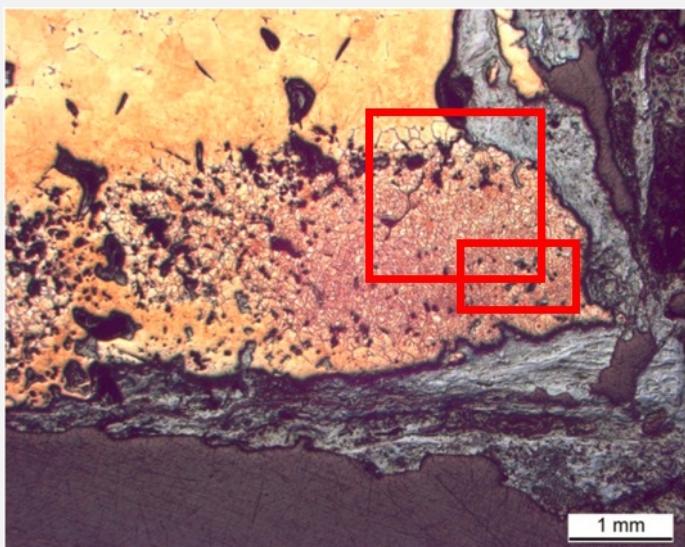
The remaining metal is a eutectoid to hypereutectoid steel (C 0.8-1 mass%) with cracks and porosity (Figs. 5 and 6). Its composition is given in Table 1 (except Fe). Of the trace elements, only Ni reaches a medium concentration (Ni 0.07 mass%). The composition and the high Ni/Co ratio are atypical for iron worked in smithies of the settlement at Develier-Courtételle JU, CH. The few slag inclusions and their chemical composition confirm this (Table 2). The slag is rich in CaO whereas the pisolithic or bean ore worked in the Central Jura smelting district is rich in Al<sub>2</sub>O<sub>3</sub>. The slag inclusions cannot be smithing slag because the artefact is formed from one piece of metal. The slag probably incorporated while refining the bloom or during the bloom smelting process. The ore from which this metal was smelted cannot yet be identified. Intergranular corrosion has developed, penetrating into the metal structure (Fig. 6). The etched metal shows a dominant martensitic structure, typical of quench hardened steel (Figs. 5, 7, 8 and 9). The characteristic forms of the martensite are non-organised needles (Fig. 8). In restricted areas bainite nodules occur (Figs. 7 and 8). In the centre of the point, hypereutectoid steel is composed of cementite in the grain boundaries and in needle like shapes within the grains (Fig. 10). Hypereutectoid regions also occur in the centre of the shaft and on its left surface (Fig. 5). Here the hypereutectoid steel is composed of martensite and cementite in the grain boundaries and in needle form within the grains (Figs. 6 and 9). Nevertheless, most of the chisel is dominated by eutectoid steel. The average hardness of the quench hardened eutectoid steel is about HV1 690. In the bainite nodules the average hardness drops to about HV1 350, the martensite has an average hardness of HV1 750.

Fig. 5: Micrograph of the metal sample from Fig. 3 (inverted picture, detail), etched, bright field. The metal contains porosity and cracks (in black). The micrographs of Figs. 6 and 9 are marked by the top and bottom rectangles respectively,

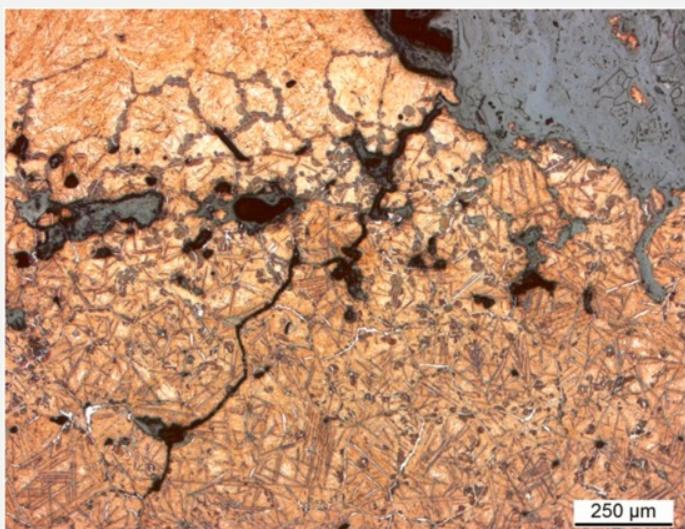
Fig. 6: Micrograph of the metal sample, detail from Fig. 5, etched, bright field. We observe martensite (in orange), cementite (in grey), porosity and intergranular cracks (in black) and corrosion,

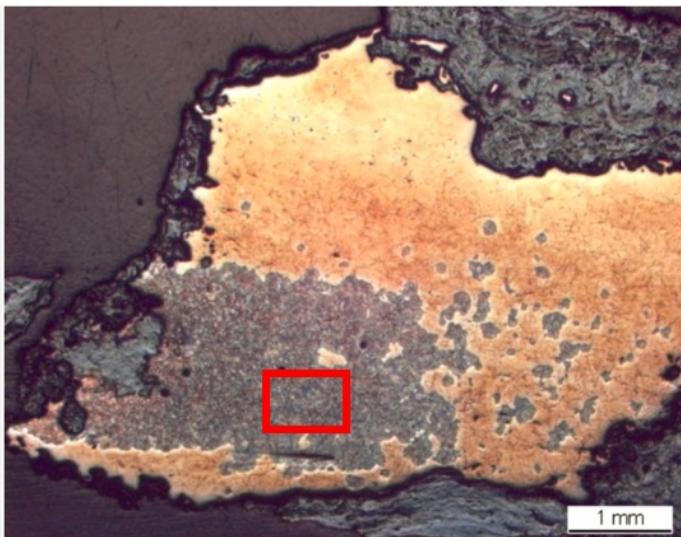
Fig. 7: Micrograph of the metal sample from Fig. 3 (inverted picture, detail), etched, bright field. We observe the metal with martensite (orange) and bainite nodules (blue). The micrograph of Fig. 10 is marked by a rectangle,

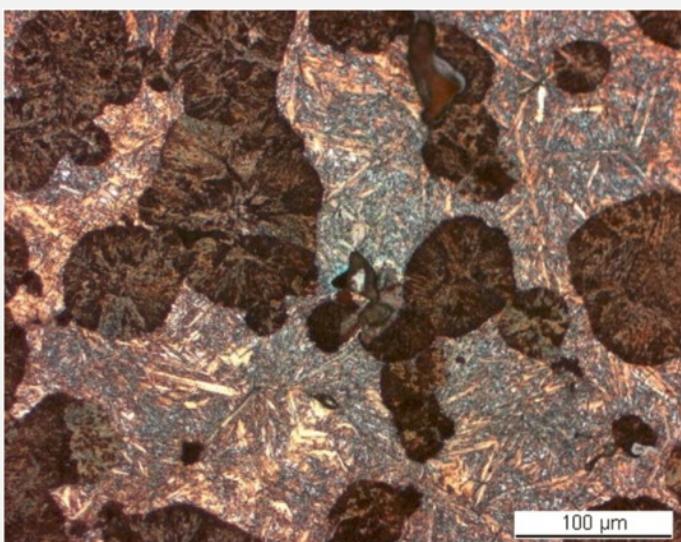
Fig. 8: Micrograph of the metal sample from Fig. 3 (detail), etched, bright field. We observe dark bainite nodules combined with martensite needles,

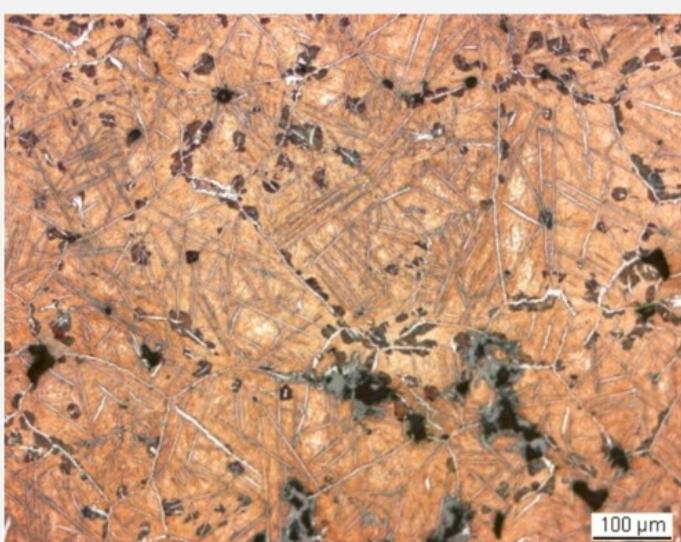
Fig. 9: Micrograph of the metal sample, detail from Fig. 5, etched, bright field. Hypereutectoid steel with a structure of cementite in white in the grain boundaries and in needle form combined with martensite (pink). Some bainite occurs around the grain boundaries,

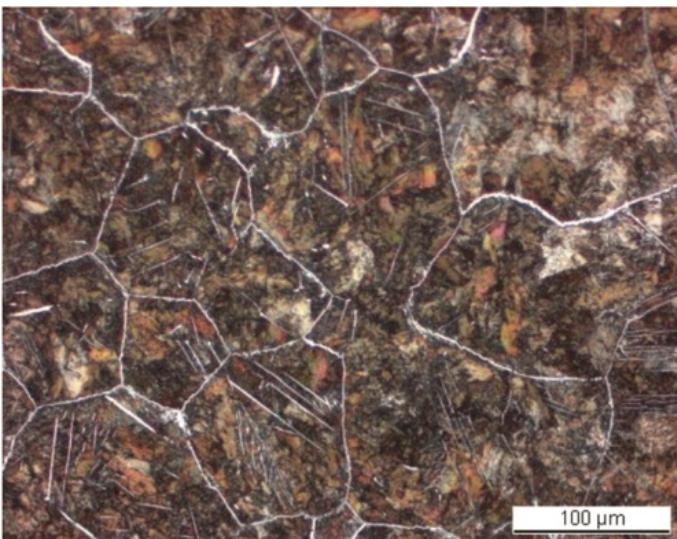
Fig. 10: Micrograph of the metal sample, detail from Fig. 7, etched, bright field. Hypereutectoid steel with a structure of cementite in white in the grain boundaries and in needle form combined with bainite (dark),

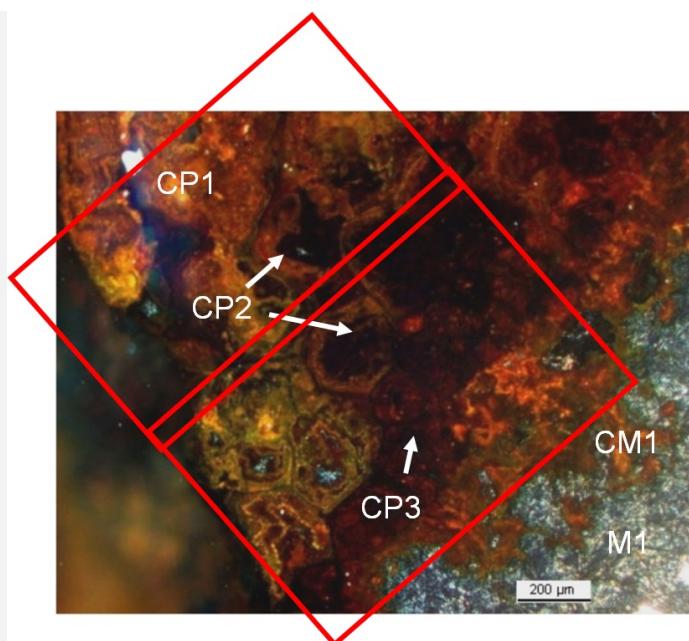
The metal is heavily corroded and the thickness of the corrosion crust is irregular, but averages about 0.5mm. The corrosion products enclose different ghost structures: the corrosion crust has preserved the shape of polygonal grains (Figs. 11 and 13) and cementite needles (Fig. 12). Under polarised light, the corrosion products at the metal - corrosion crust interface are dark-red and form an inner S-rich layer (CP3, Figs. 11 and 13). Cl occurs locally (CP3) and C is present in layers CP2 and CP3 (Fig. 13). The outer layer of the corrosion products (CP1) is orange and contains more O than the inner layer CP3 (Figs. 11 and 14).

Fig. 11: Micrograph showing the metal - corrosion crust interface from Fig. 3 (rotated by 270°, detail) and corresponding to the stratigraphy of Fig. 4, unetched, polarised light. Polygonal grains are visible as ghost structure in the corrosion crust. The selected areas for elemental chemical distribution (Figs. 13 and 14) are marked by two rectangles (bottom: Fig. 13 and top: Fig. 14),

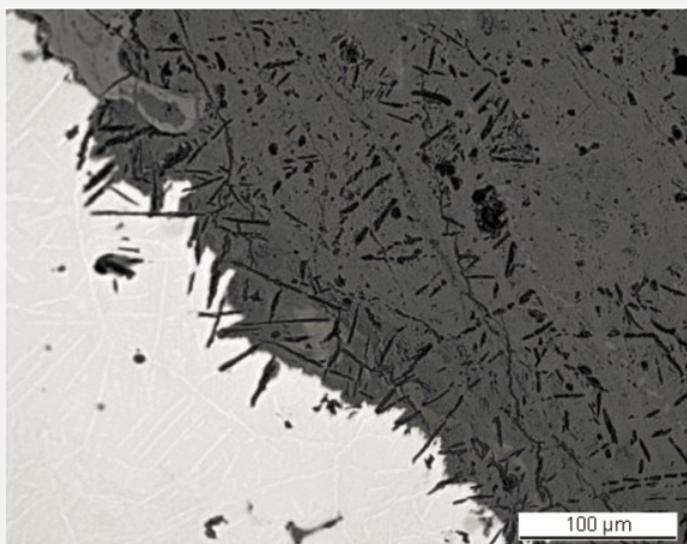
Fig. 12: Micrograph showing the metal - corrosion crust interface from Fig. 3 (detail), unetched, bright field. The cementite is visible as white needles in the metal and its ghost structure as black needles in the corrosion crust,

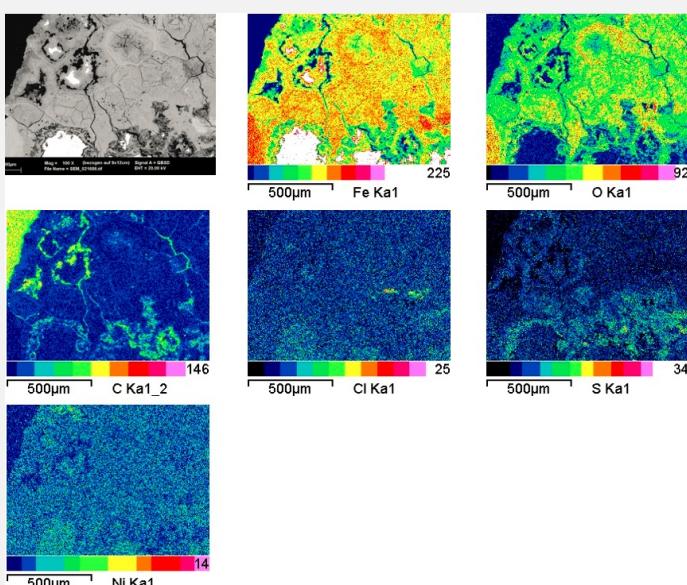
Fig. 13: SEM image, BSE-mode, and elemental chemical distribution of the selected area from Fig. 11 (rotated by 45°). Method of examination: SEM/EDS, Laboratory of Analytical Chemistry, Empa,

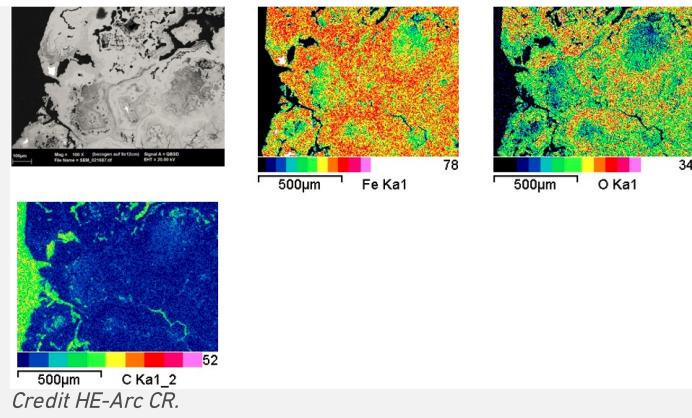
Fig. 14: SEM image, BSE-mode, and elemental chemical distribution of the selected area from Fig. 11 (rotated by 45°). Method of examination: SEM/EDS, Laboratory of Analytical Chemistry, Empa,

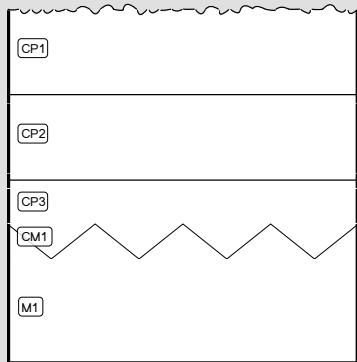
Fig. 4: Stratigraphic representation of the chisel point in cross-section using the MiCorr application. The characteristics of the strata are only accessible by clicking on the drawing that redirects you to the search tool by stratigraphy representation. This representation can be compared to Fig. 11, Credit HE-Arc CR.
