CHISEL POINT DEV 995 1069 PR - EUTECTOID TO HYPEREUTECTOID STEEL - EARLY MEDIEVAL TIMES - SWITZERLAND

Artefact name Chisel point DEV 995 1069 PR

Authors Marianne. Senn (EMPA, Dübendorf, Zurich, Switzerland) & Christian. Degrigny (HE-Arc CR, Neuchâtel, Neuchâtel,

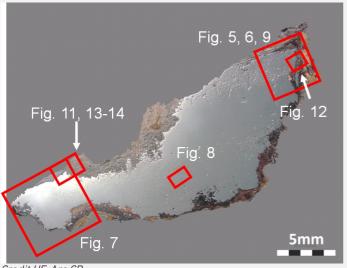
Fig. 3: Micrograph of the cross-section of the chisel point showing the location of Figs. 5 to 9 and 11 to 14,

A longitudinal cut from a chisel point (Figs. 2 and 3) undertaken after restoration. Dimensions: L = 30mm; W = 11mm (approximately).

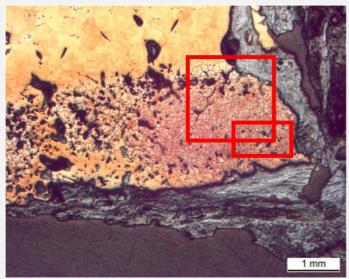
The remaining metal is a eutectoid to hypereutectoid steel (C 0.8-1 mass%) with cracks and porosity (Figs. 5 and 6). Its composition is given in Table 1 (except Fe). Of the trace elements, only Ni reaches a medium concentration (Ni 0.07 mass%). The composition and the high Ni/Co ratio are atypical for iron worked in smithies of the settlement at Develier-Courtételle JU, CH. The few slag inclusions and their chemical composition confirm this (Table 2). The slag is rich in CaO whereas the pisolithic or bean ore worked in the Central Jura smelting district is rich in Al_2O_3 . The slag inclusions cannot be smithing slag because the artefact is formed from one piece of metal. The slag probably incorporated while refining the bloom or during the bloom smelting process. The ore from which this metal was smelted cannot yet be identified. Intergranular corrosion has developed, penetrating into the metal structure (Fig. 6). The etched metal shows a dominant martensitic structure, typical of quench hardened steel (Figs. 5, 7, 8 and 9). The characteristic forms of the martensite are non-organised needles (Fig. 8). In restricted areas bainite nodules occur (Figs. 7 and 8). In the centre of the point, hypereutectoid steel is composed of cementite in the grain boundaries and in needle like shapes within the grains (Fig. 10). Hypereutectoid regions also occur in the centre of the shaft and on its left surface (Fig. 5). Here the hypereutectoid steel is composed of martensite and cementite in the grain boundaries and in needle form within the grains (Figs. 6 and 9). Nevertheless, most of the chisel is dominated by eutectoid steel. The average hardness of the quench hardened eutectoid steel is about HV1 690. In the bainite nodules the average hardness drops to about HV1 350, the martensite has an average hardness of HV1 750.

Fig. 5: Micrograph of the metal sample from Fig. 3 (inverted picture, detail), etched, bright field. The metal contains porosity and cracks (in black). The micrographs of Figs. 6 and 9 are marked by the top and bottom rectangles respectively,

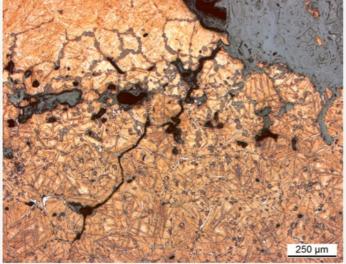
bright field. We observe martensite (in orange), cementite (in grey), porosity and intergranular cracks (in black) and corrosion,

Fig. 6: Micrograph of the metal sample, detail from Fig. 5, etched,

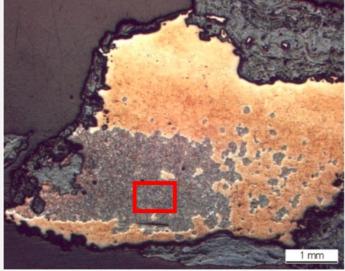
Fig. 7: Micrograph of the metal sample from Fig. 3 (inverted picture, detail), etched, bright field. We observe the metal with martensite (orange) and bainite nodules (blue). The micrograph of Fig. 10 is marked by a rectangle,

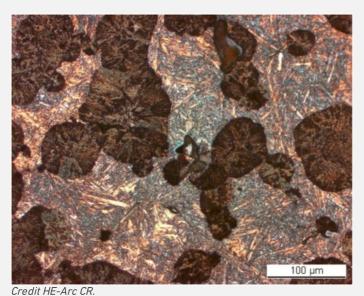
Fig. 8: Micrograph of the metal sample from Fig. 3 (detail), etched, bright field. We observe dark bainite nodules combined with martensite needles,

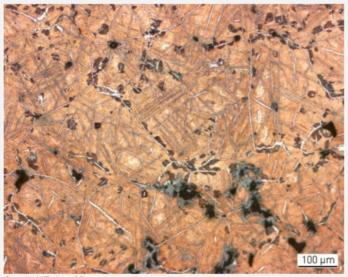
Fig. 9: Micrograph of the metal sample, detail from Fig. 5, etched, bright field. Hypereutectoid steel with a structure of cementite in white in the grain boundaries and in needle form combined with martensite (pink). Some bainite occurs around the grain boundaries,

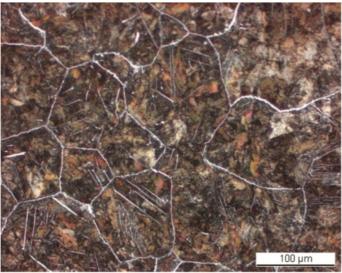
Fig. 10: Micrograph of the metal sample, detail from Fig. 7, etched, bright field. Hypereutectoid steel with a structure of cementite in white in the grain boundaries and in needle form combined with bainite (dark),

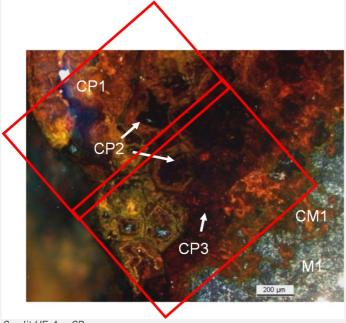
The metal is heavily corroded and the thickness of the corrosion crust is irregular, but averages about 0.5mm. The corrosion products enclose different ghost structures: the corrosion crust has preserved the shape of polygonal grains (Figs. 11 and 13) and cementite needles (Fig. 12). Under polarised light, the corrosion products at the metal - corrosion crust interface are dark-red and form an inner S-rich layer (CP3, Figs. 11 and 13). Cl occurs locally (CP3) and C is present in layers CP2 and CP3 (Fig. 13). The outer layer of the corrosion products (CP1) is orange and contains more 0 than the inner layer CP3 (Figs. 11 and 14).

Fig. 11: Micrograph showing the metal - corrosion crust interface from Fig. 3 (rotated by 270°, detail) and corresponding to the stratigraphy of Fig. 4, unetched, polarised light. Polygonal grains are visible as ghost structure in the corrosion crust. The selected areas for elemental chemical distribution (Figs. 13 and 14) are marked by two rectangles (bottom: Fig. 13 and top: Fig. 14),

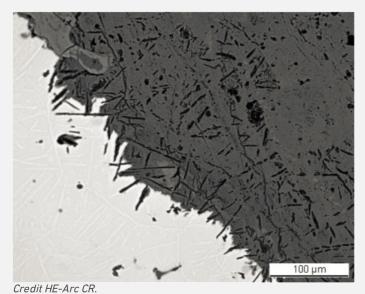
Fig. 12: Micrograph showing the metal - corrosion crust interface from Fig. 3 (detail), unetched, bright field. The cementite is visible as white needles in the metal and its ghost structure as black needles in the corrosion crust,

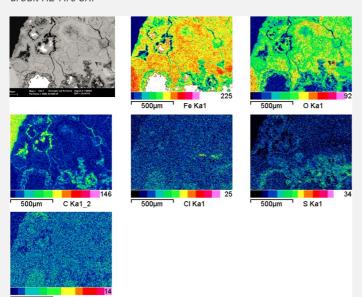
Fig. 13: SEM image, BSE-mode, and elemental chemical distribution of the selected area from Fig. 11 (rotated by 45°). Method of examination: SEM/EDS, Laboratory of Analytical Chemistry, Empa,
